# Completely-Weathered Sandstone Slope Failure During Highway Construction and its Remedy

Wu Zhenjun

Institute of rock and soil mechanics, Chinese academy of sciences

Dec. 16, 2016

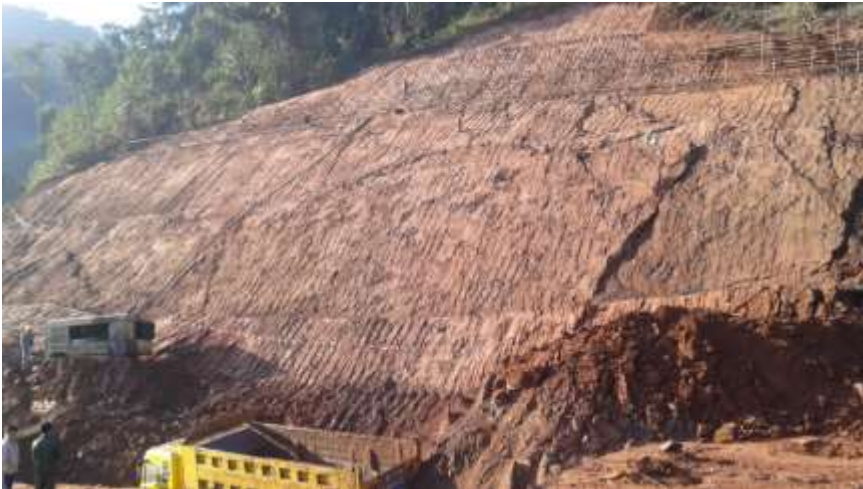
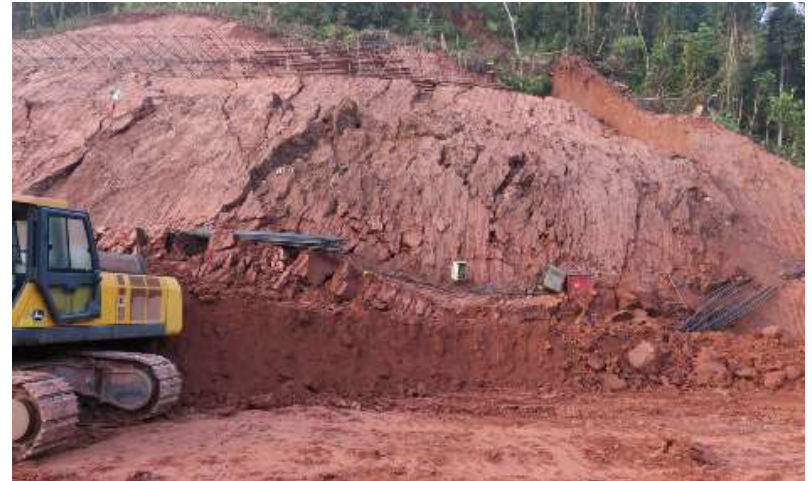
- The slope is 100m high weathered sand stone slope.
- Slope failure occurred during excavation. Volume is About 300,000m<sup>3</sup>.
- No reinforcement is employed before the slope failure.

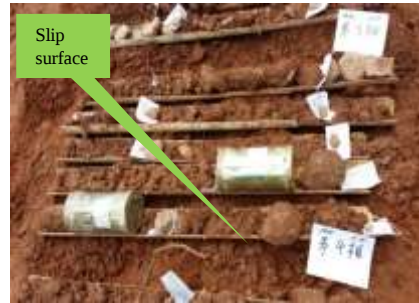
**CWS**

**Slip surface**

# Mudstone

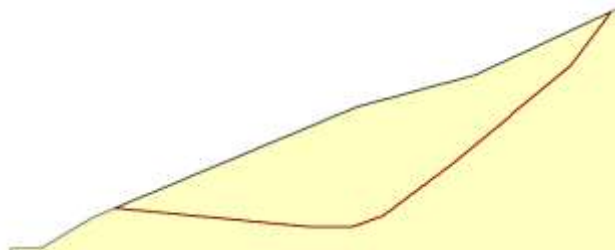
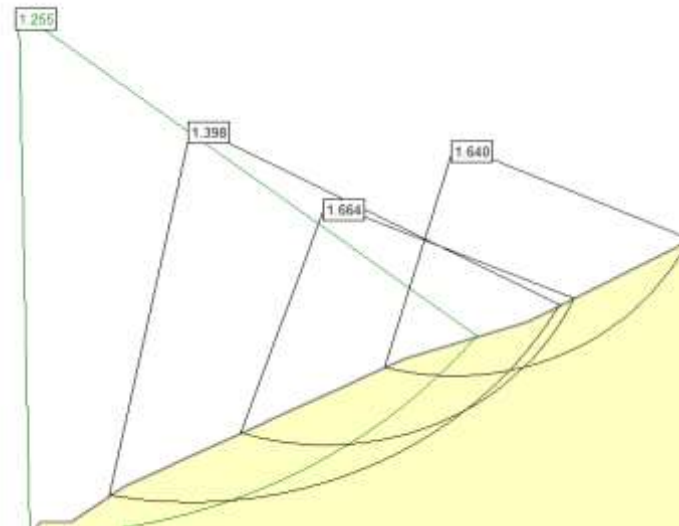
Failed slip surface  
 $F_s=1.76$

Critical slip surface by auto-search  
Minimal  $F_s=1.25$

Shear strength  $C1=33\text{kPa}, \phi1=24^\circ$

consistent with  
natural slope  
stability state

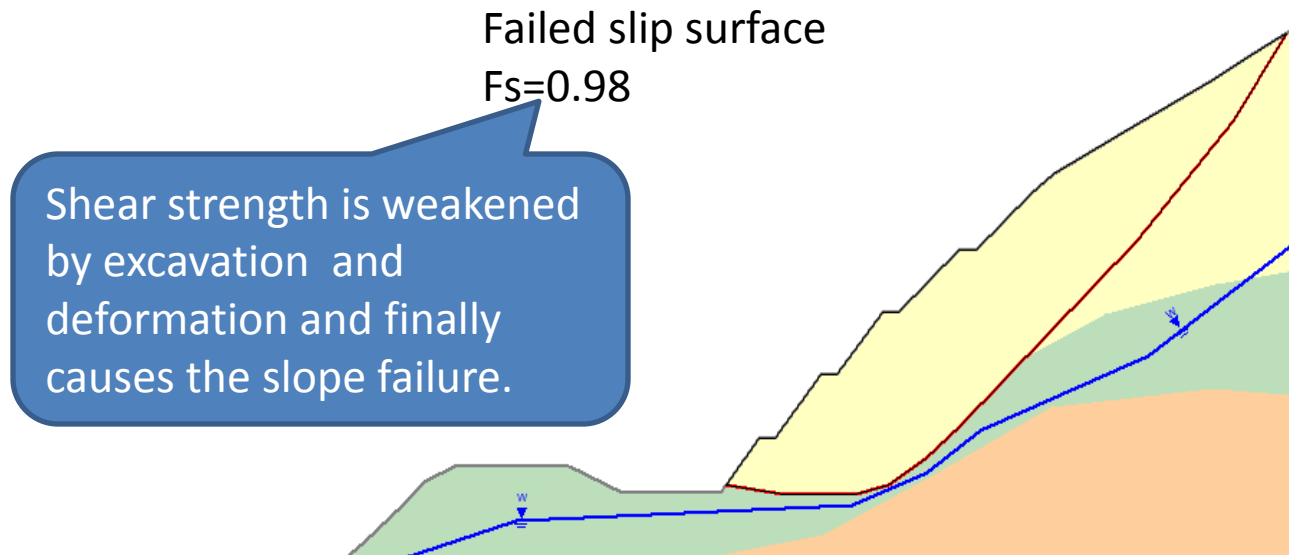
Shear strength  $C_2=25\text{kPa}, \phi_2=23^\circ$

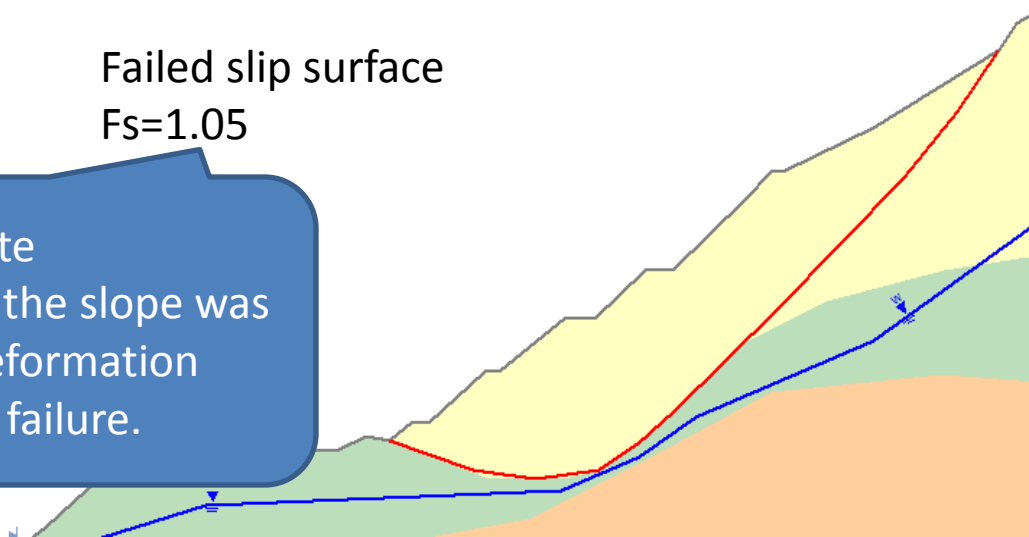
Failed slip surface  
 $F_s=1.05$

According to site investigation, the slope was still in creep deformation after the slope failure.

Shear strength  $C_3=21\text{kPa}, \phi_3=10^\circ$
