Cause and Mechanism of Fatal Zhenxiong Landslide of January 11, 2013

Zhong-qi Quentin Yue

Civil Engineering Department, The University of Hong Kong, Hong Kong, P.R. China

International Geotechnics Symposium cum
International Meeting of CSRME 14th Biennial National Congress
November 14-17, 2016, Hong Kong

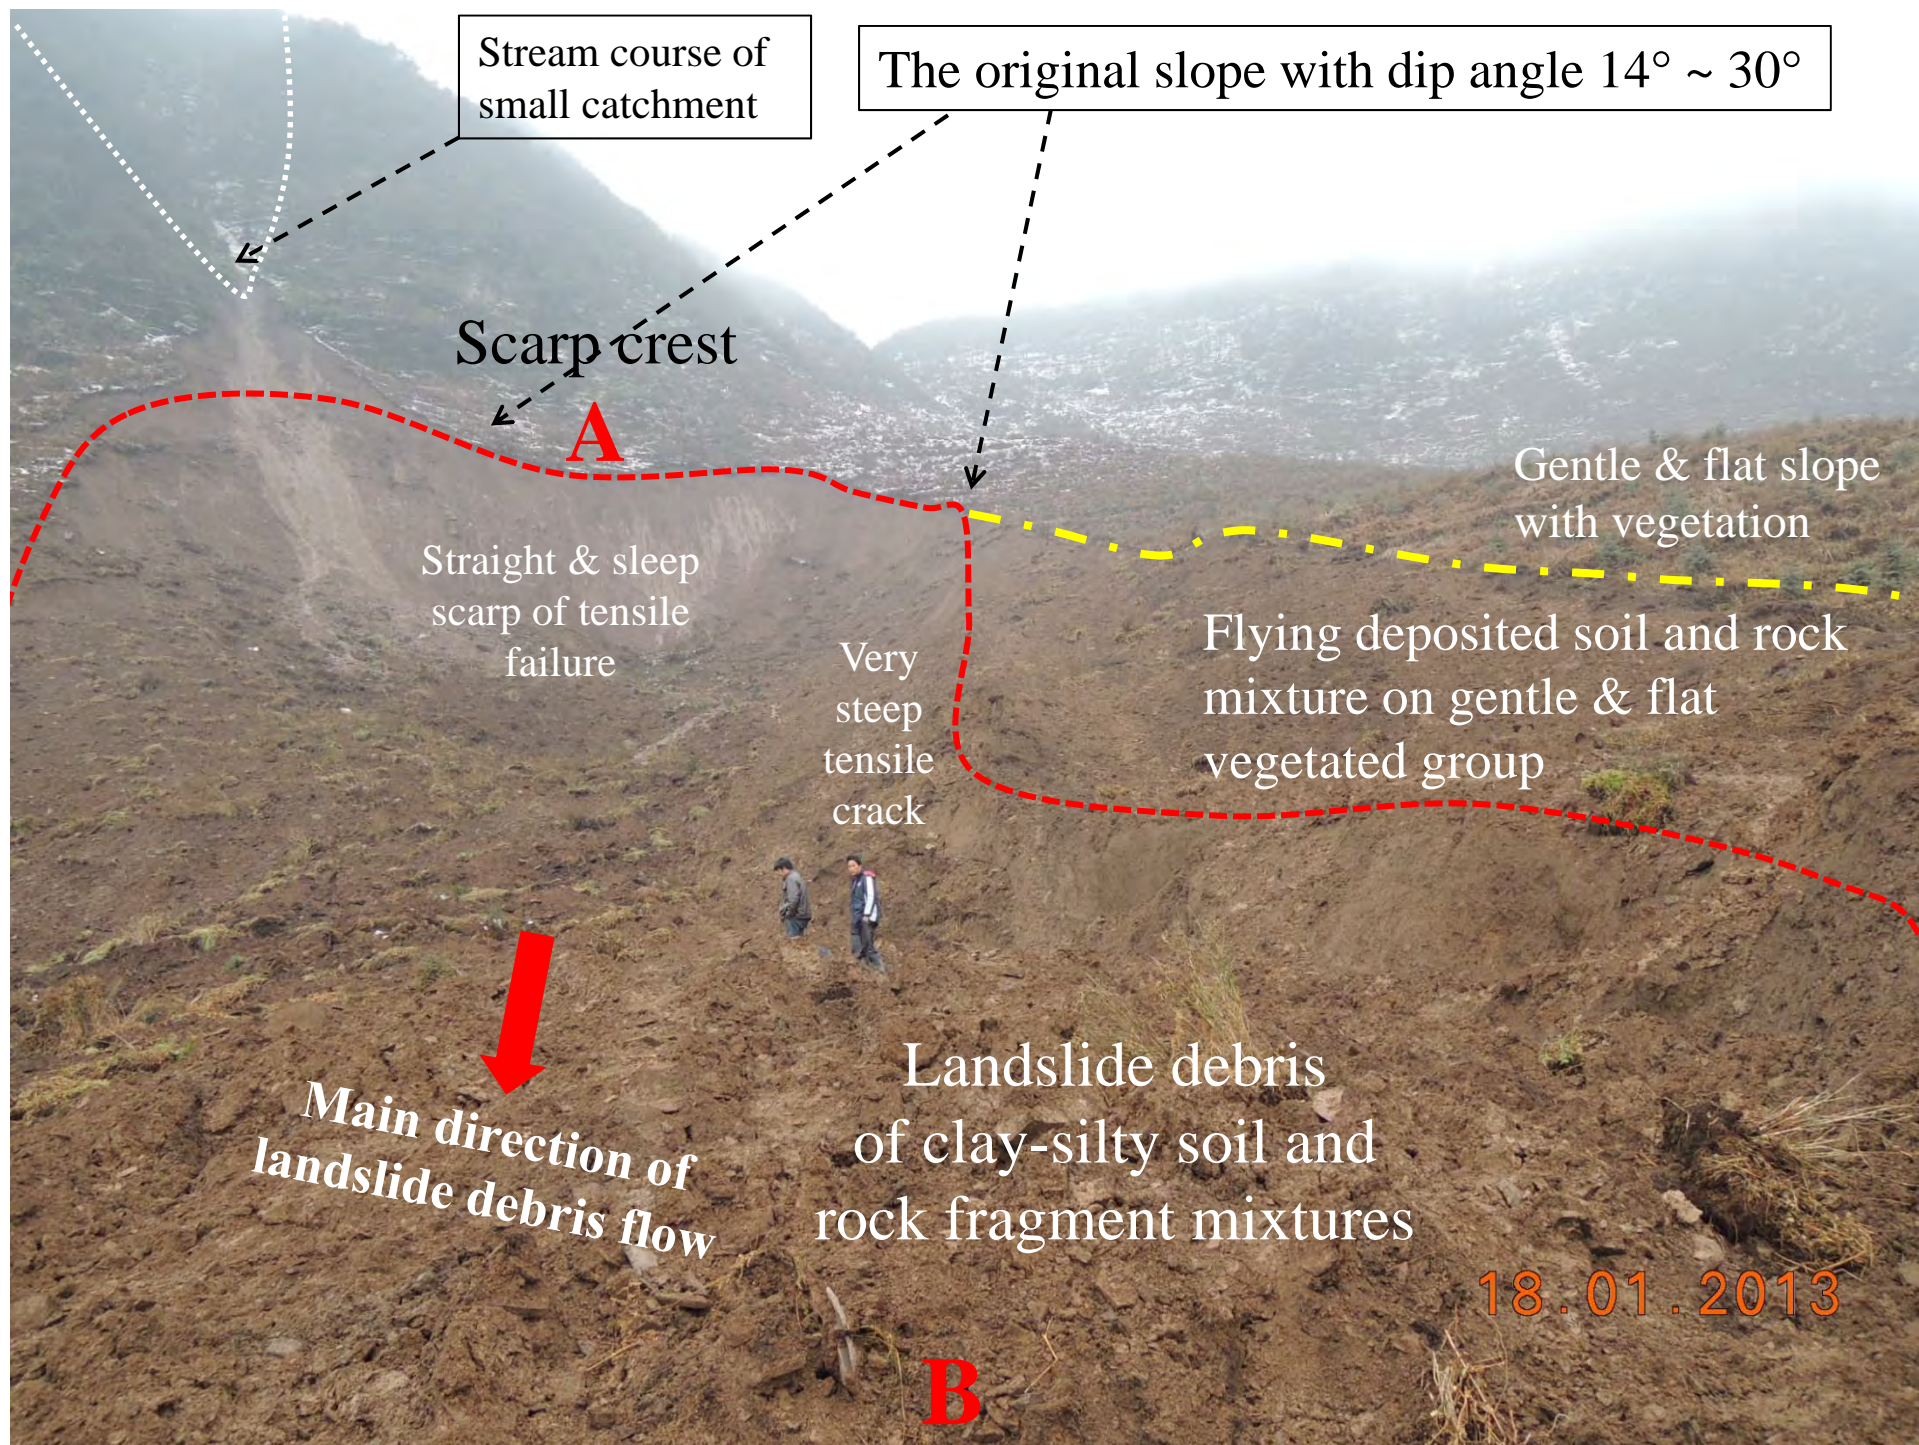
Deposition of
Soil-rock
mixtures on
north gentle
slope side

Deposition of
Soil-rock
mixtures on
south gentle
slope side

Main direction of debris flow

Relocated grass
cover from the
failed slope

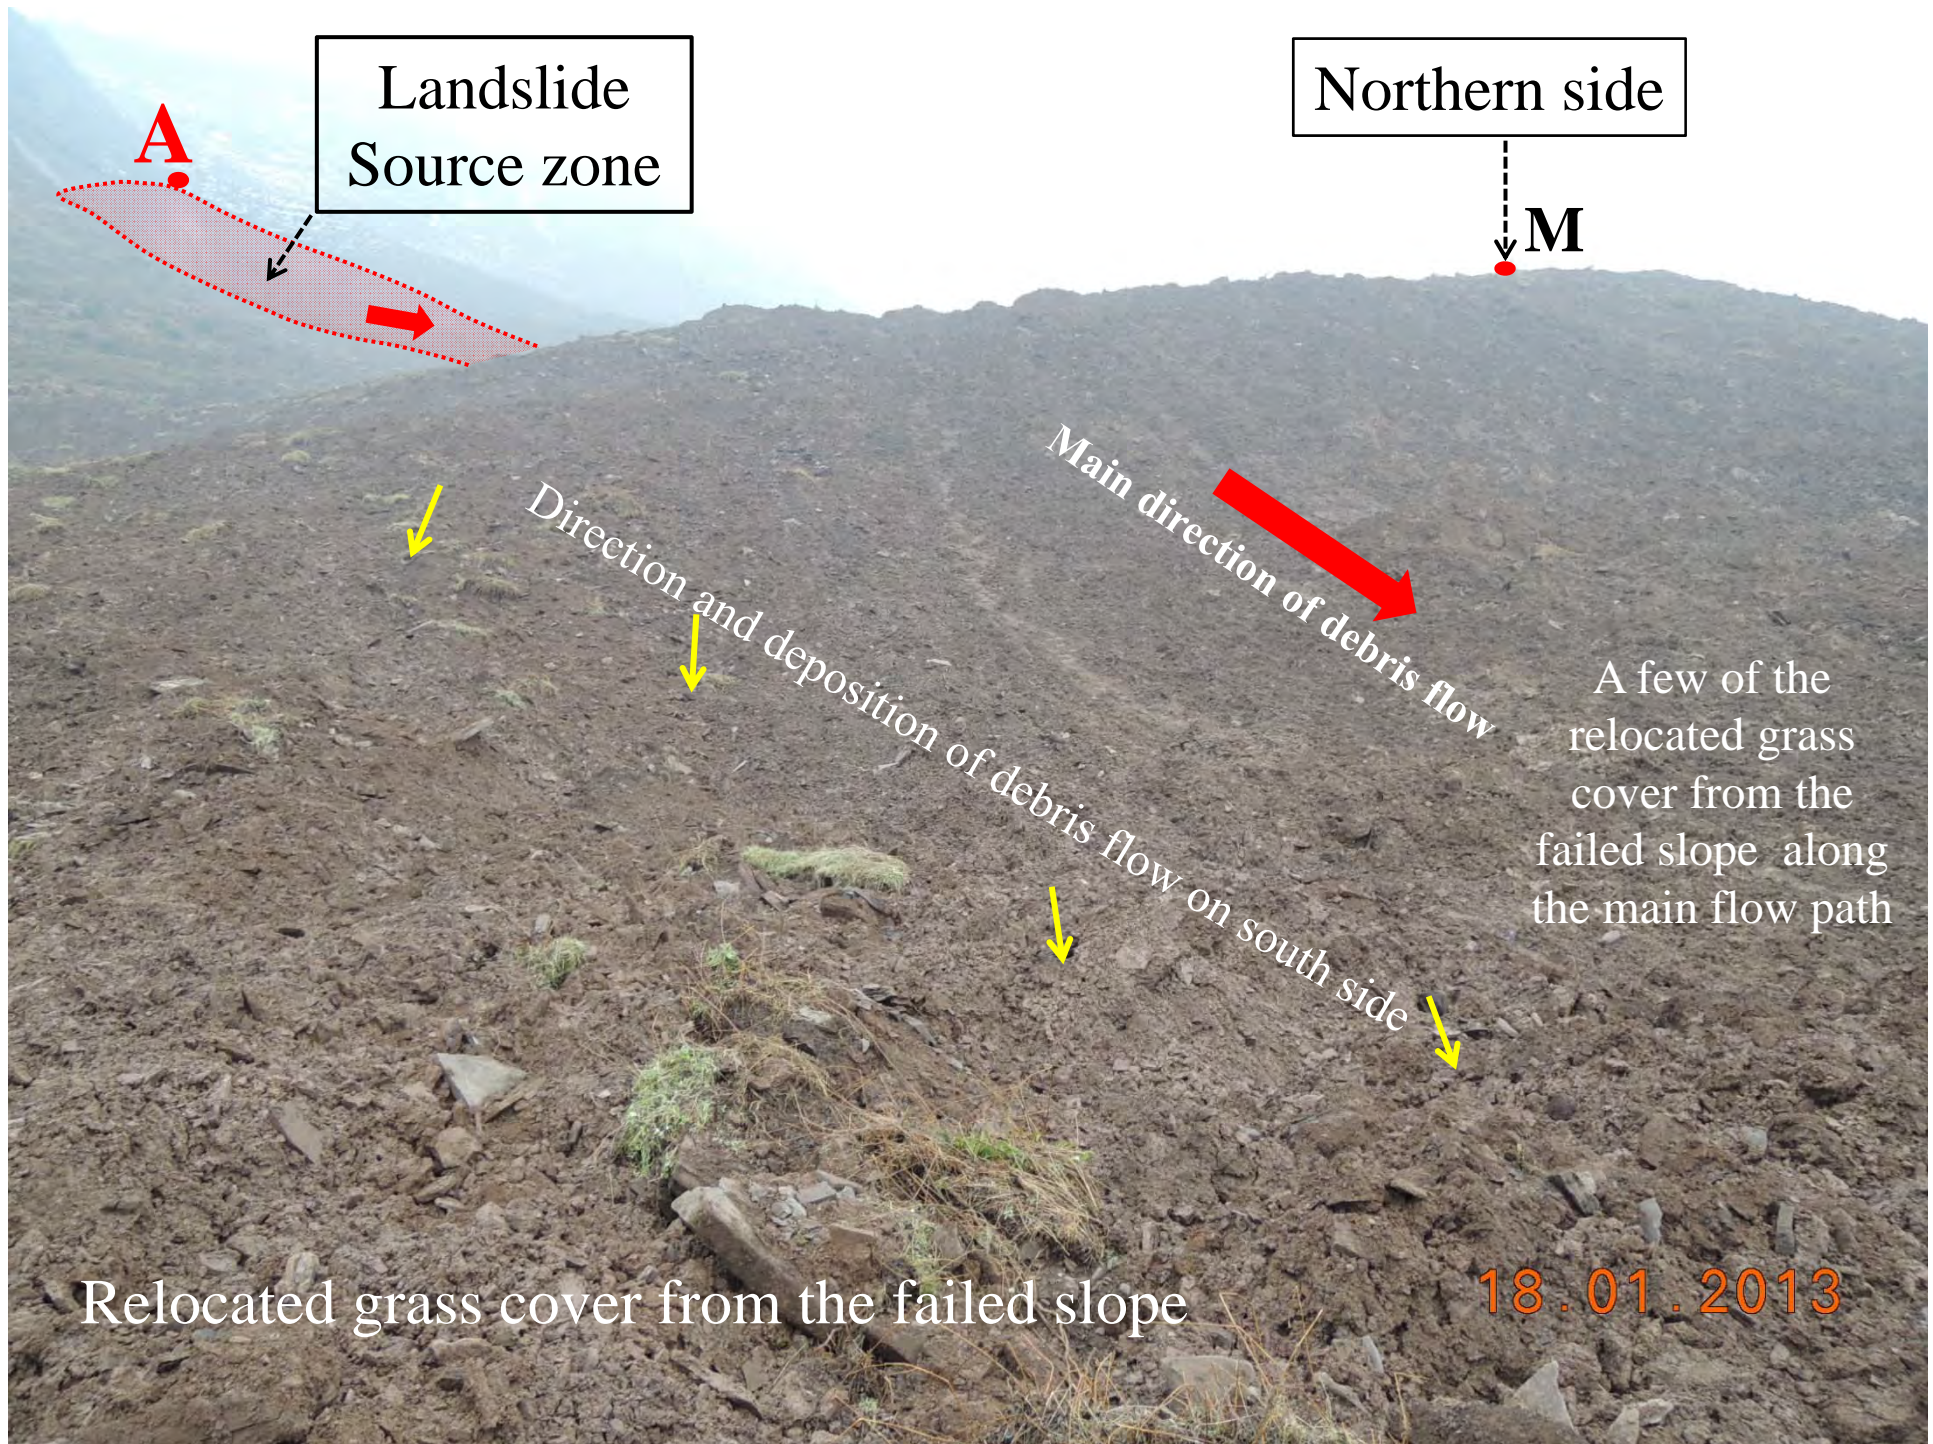
Landslide
Source zone

Main direction of debris flow

Direction and deposition of debris flow on south side

A few of the
relocated grass
cover from the
failed slope along
the main flow path

Relocated grass cover from the failed slope

at C to D
**The back-steep slope of small
mount of 4 to 5 m high
by deposition of debris flows**

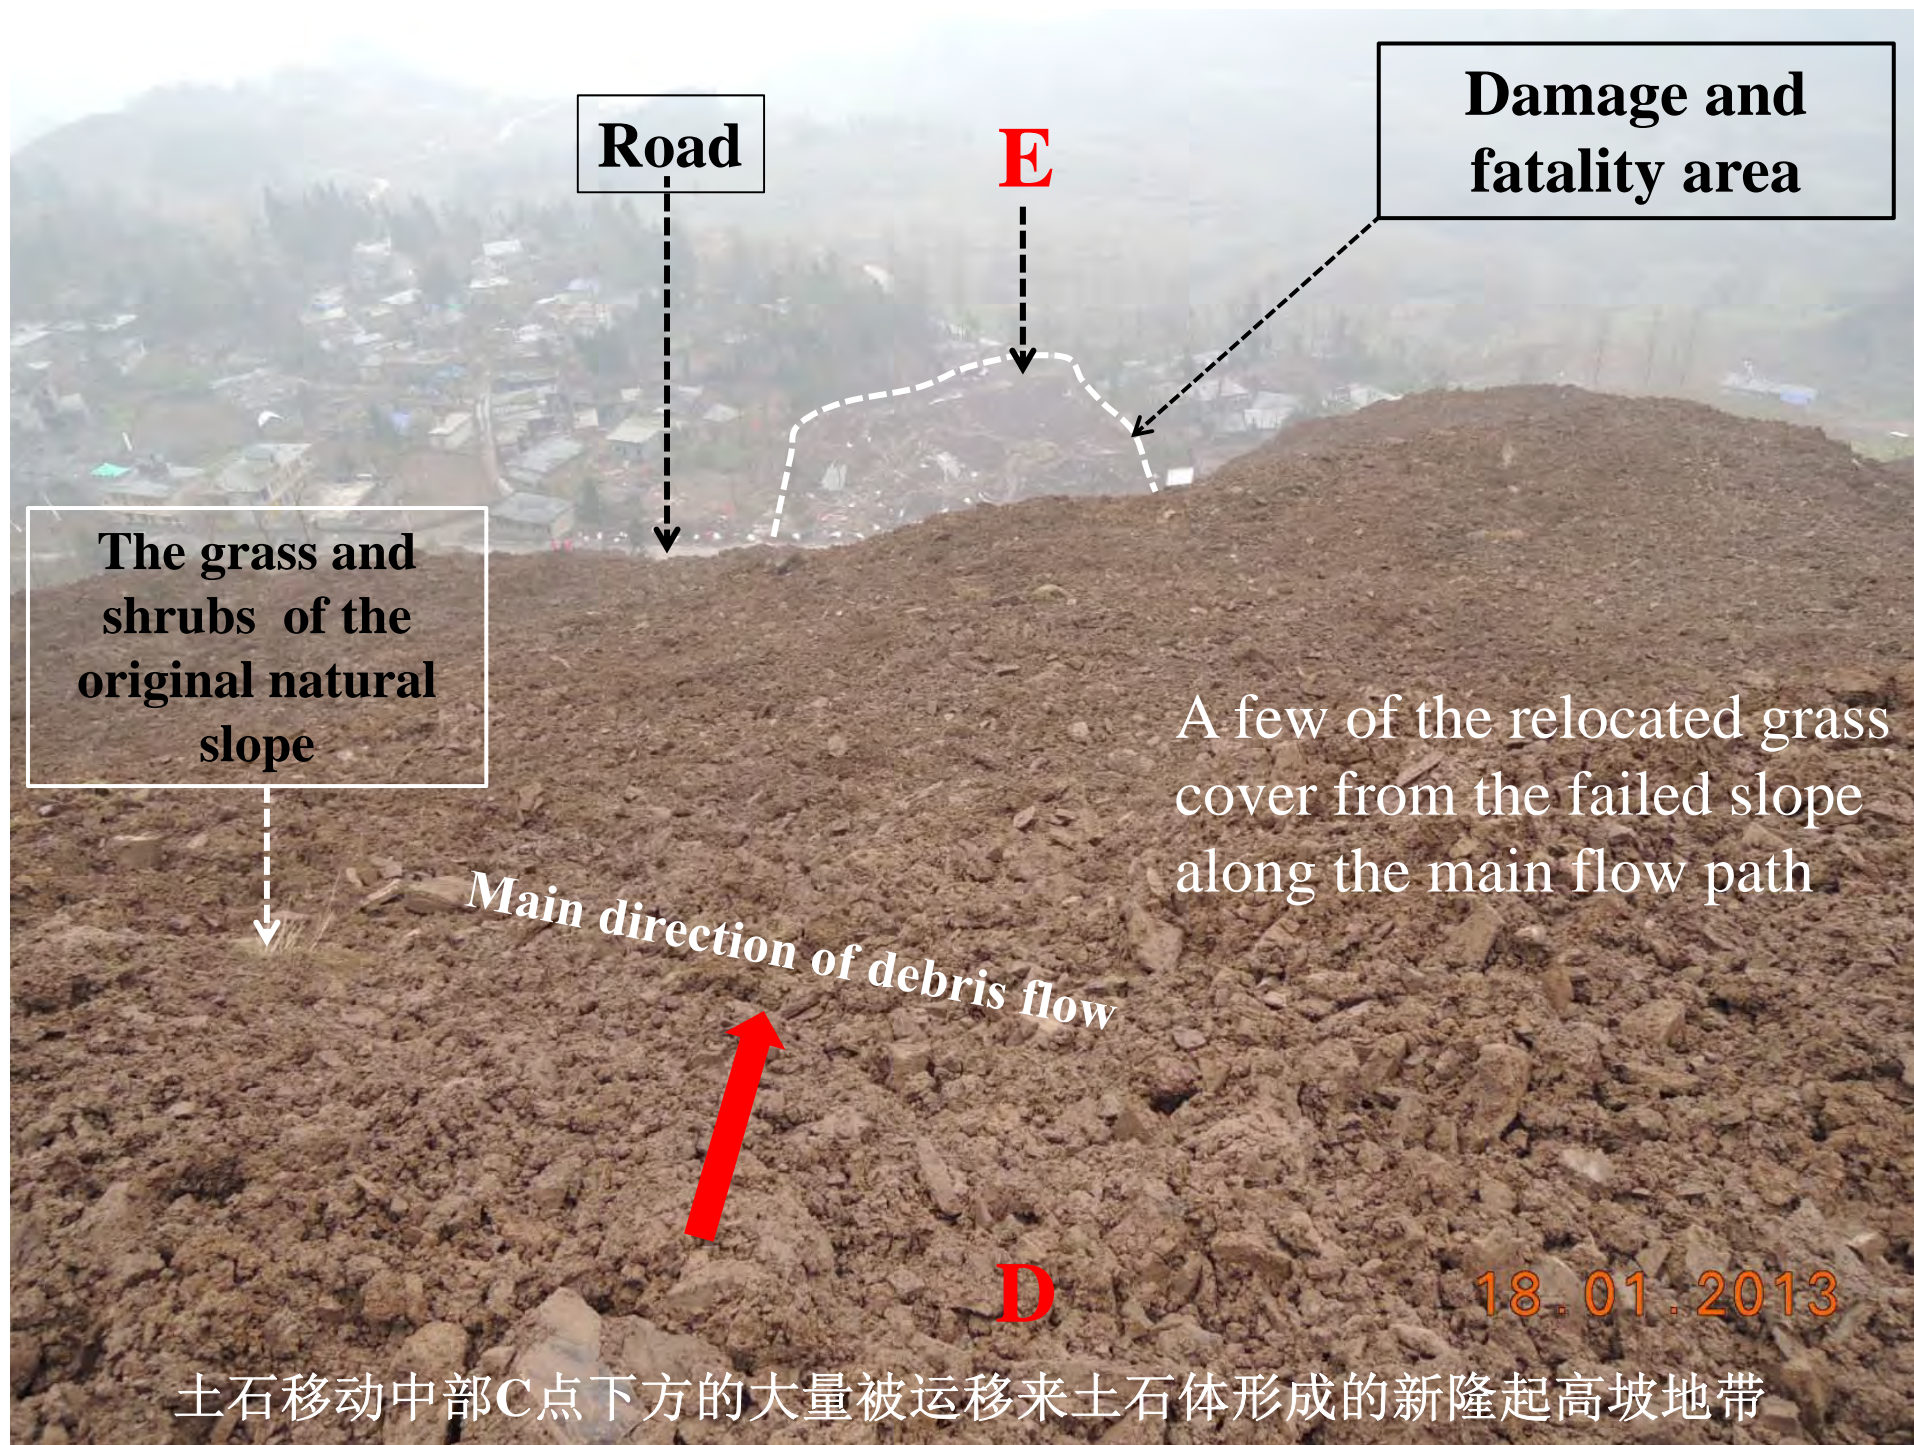
Damage and fatality area

The grass and shrubs of the original natural slope

A few of the relocated grass cover from the failed slope along the main flow path

Main direction of debris flow

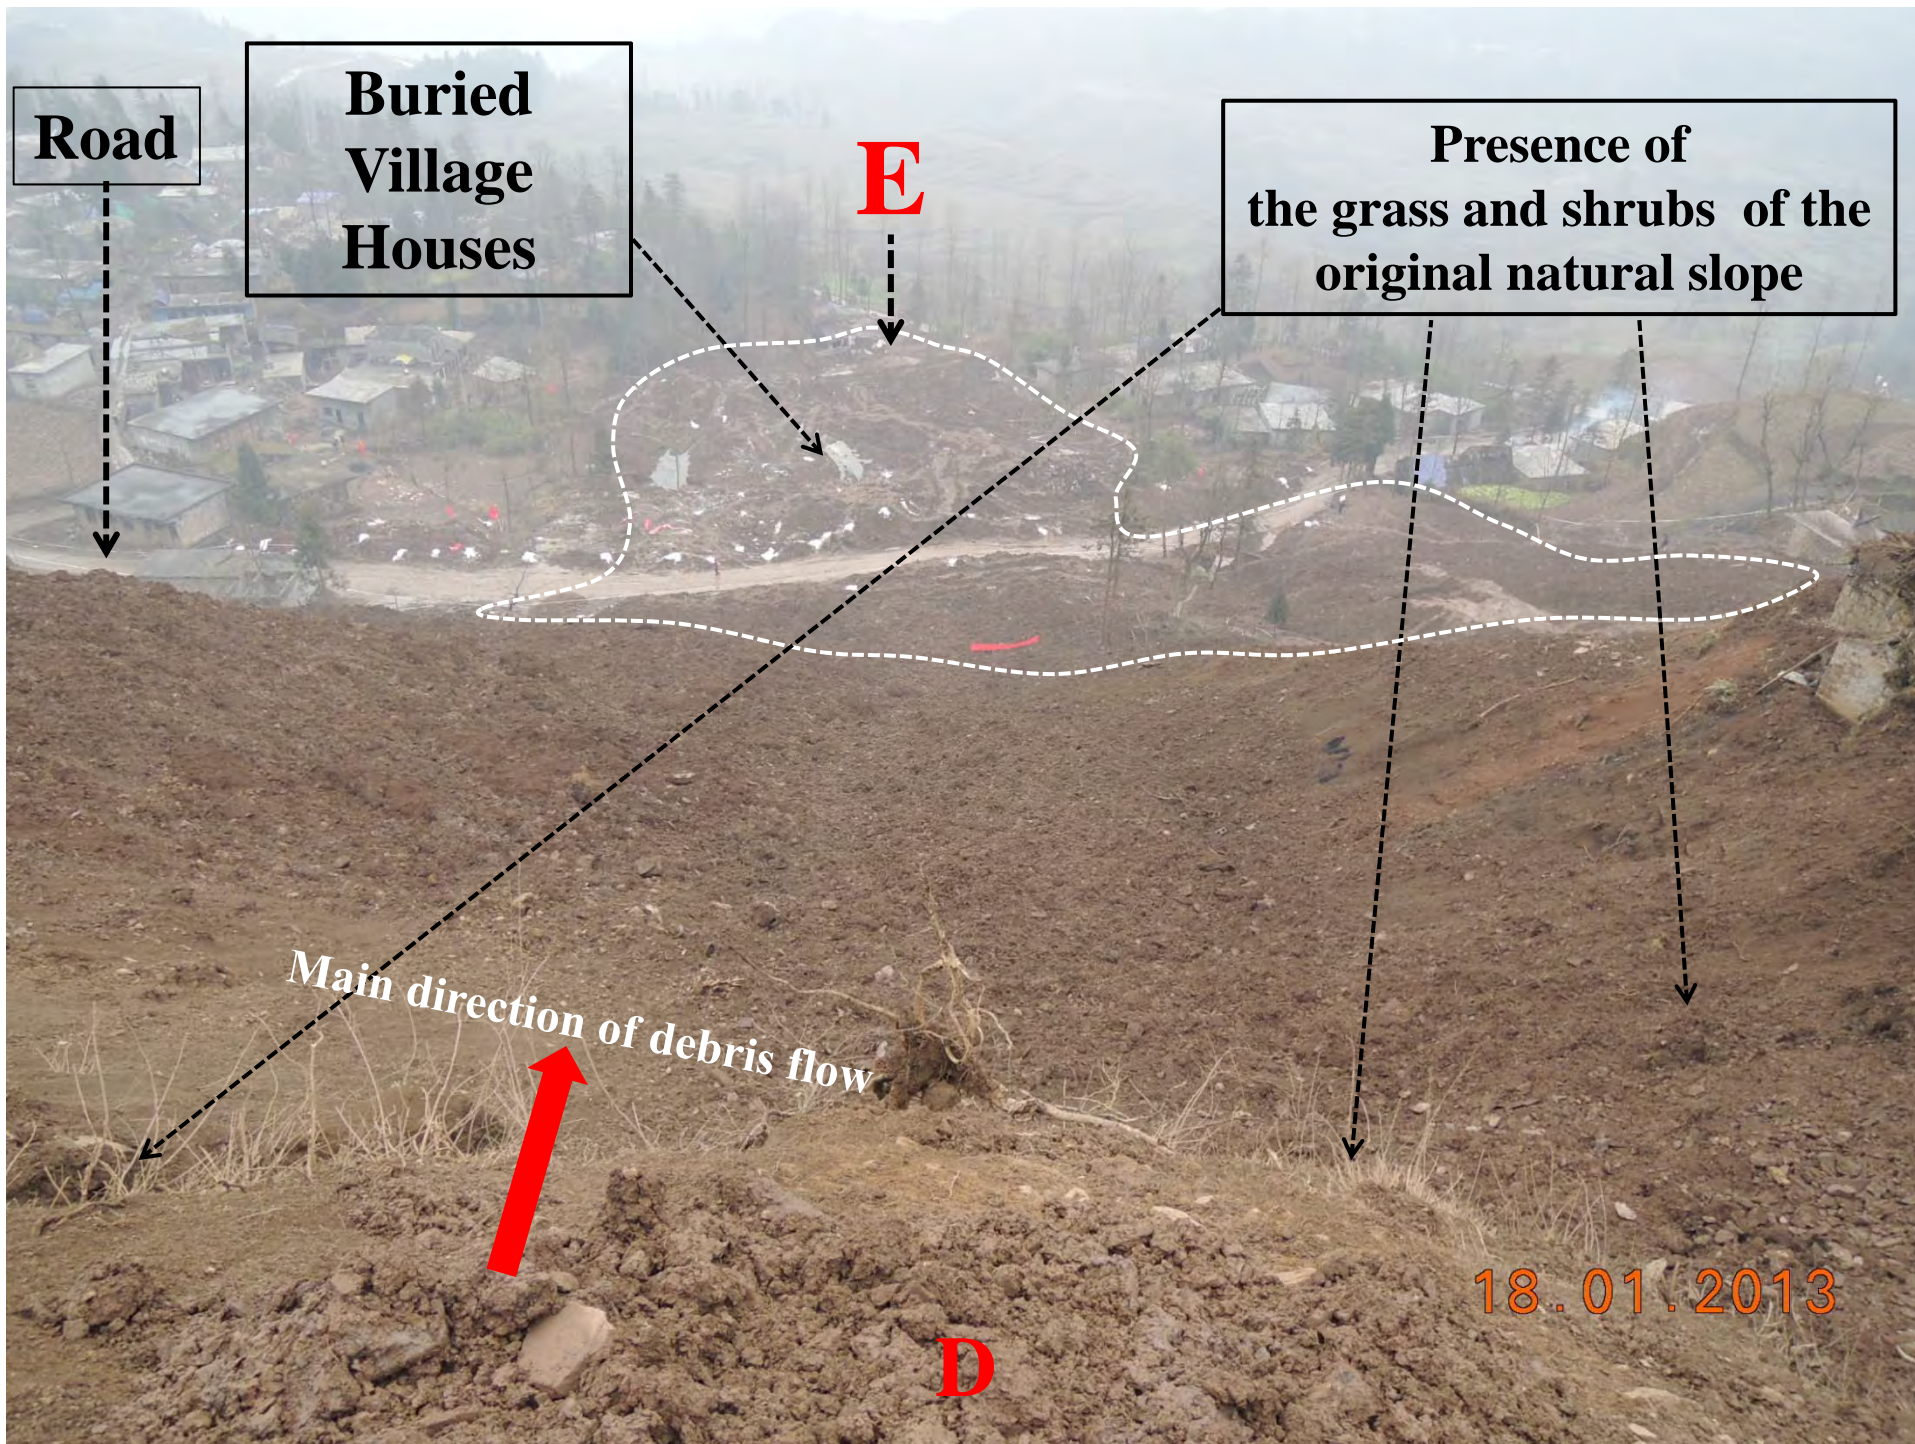
Buried Village Houses

**Presence of
the grass and shrubs of
the original natural
slope**

Main direction of debris flow

Few of the relocated grass
cover from the failed slope
along the main flow path

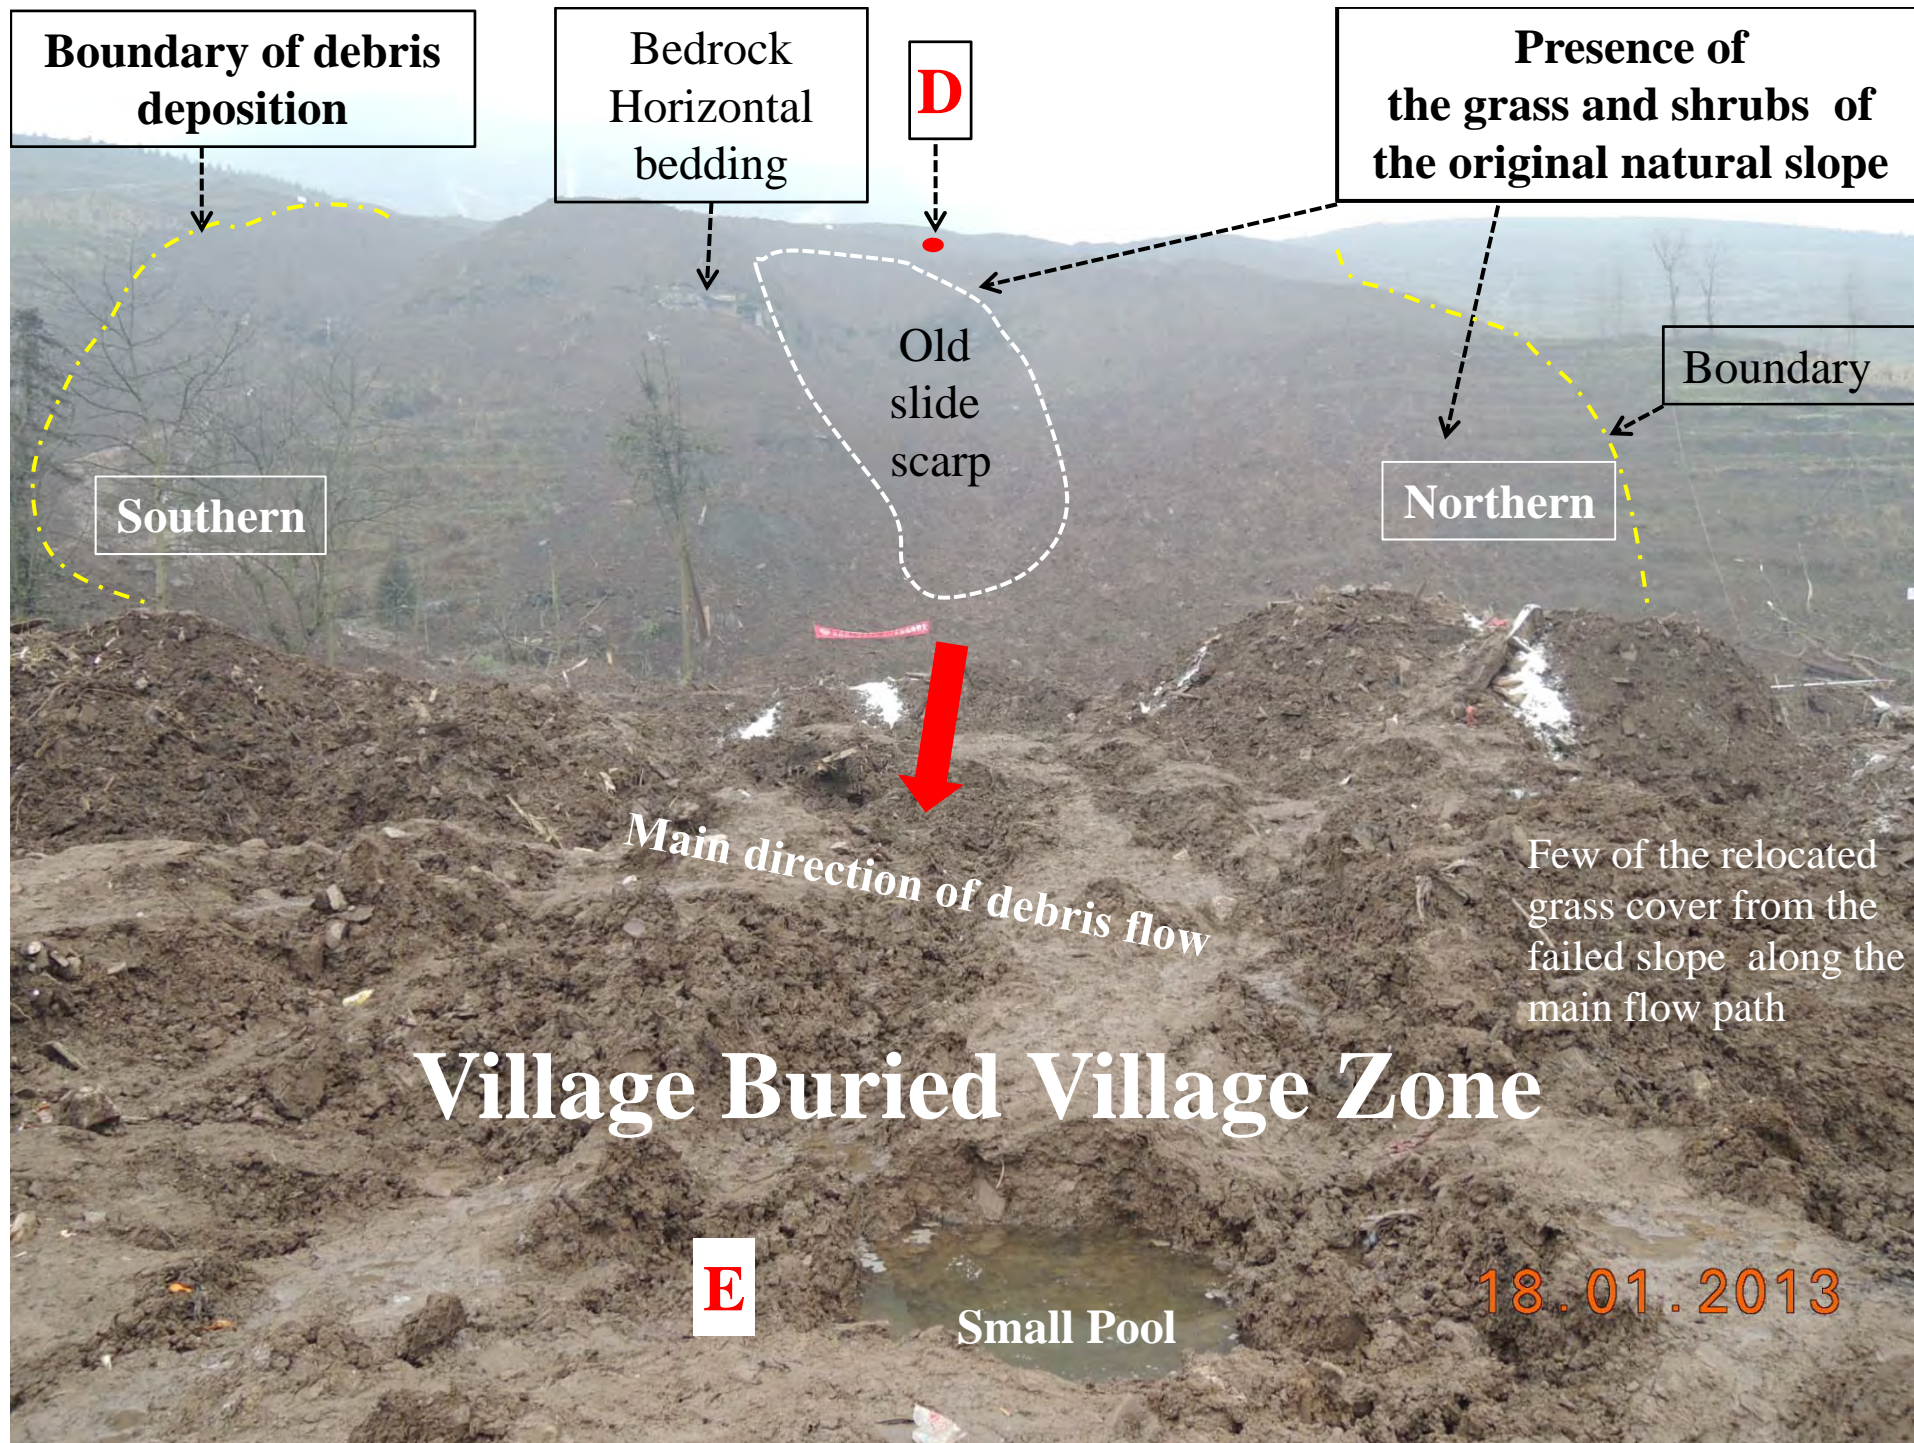
Boundary of debris deposition

Bedrock Horizontal bedding

Presence of the grass and shrubs of the original natural slope

Old slide scarp

Few of the relocated grass cover from the failed slope along the main flow path

Village Buried Village Zone

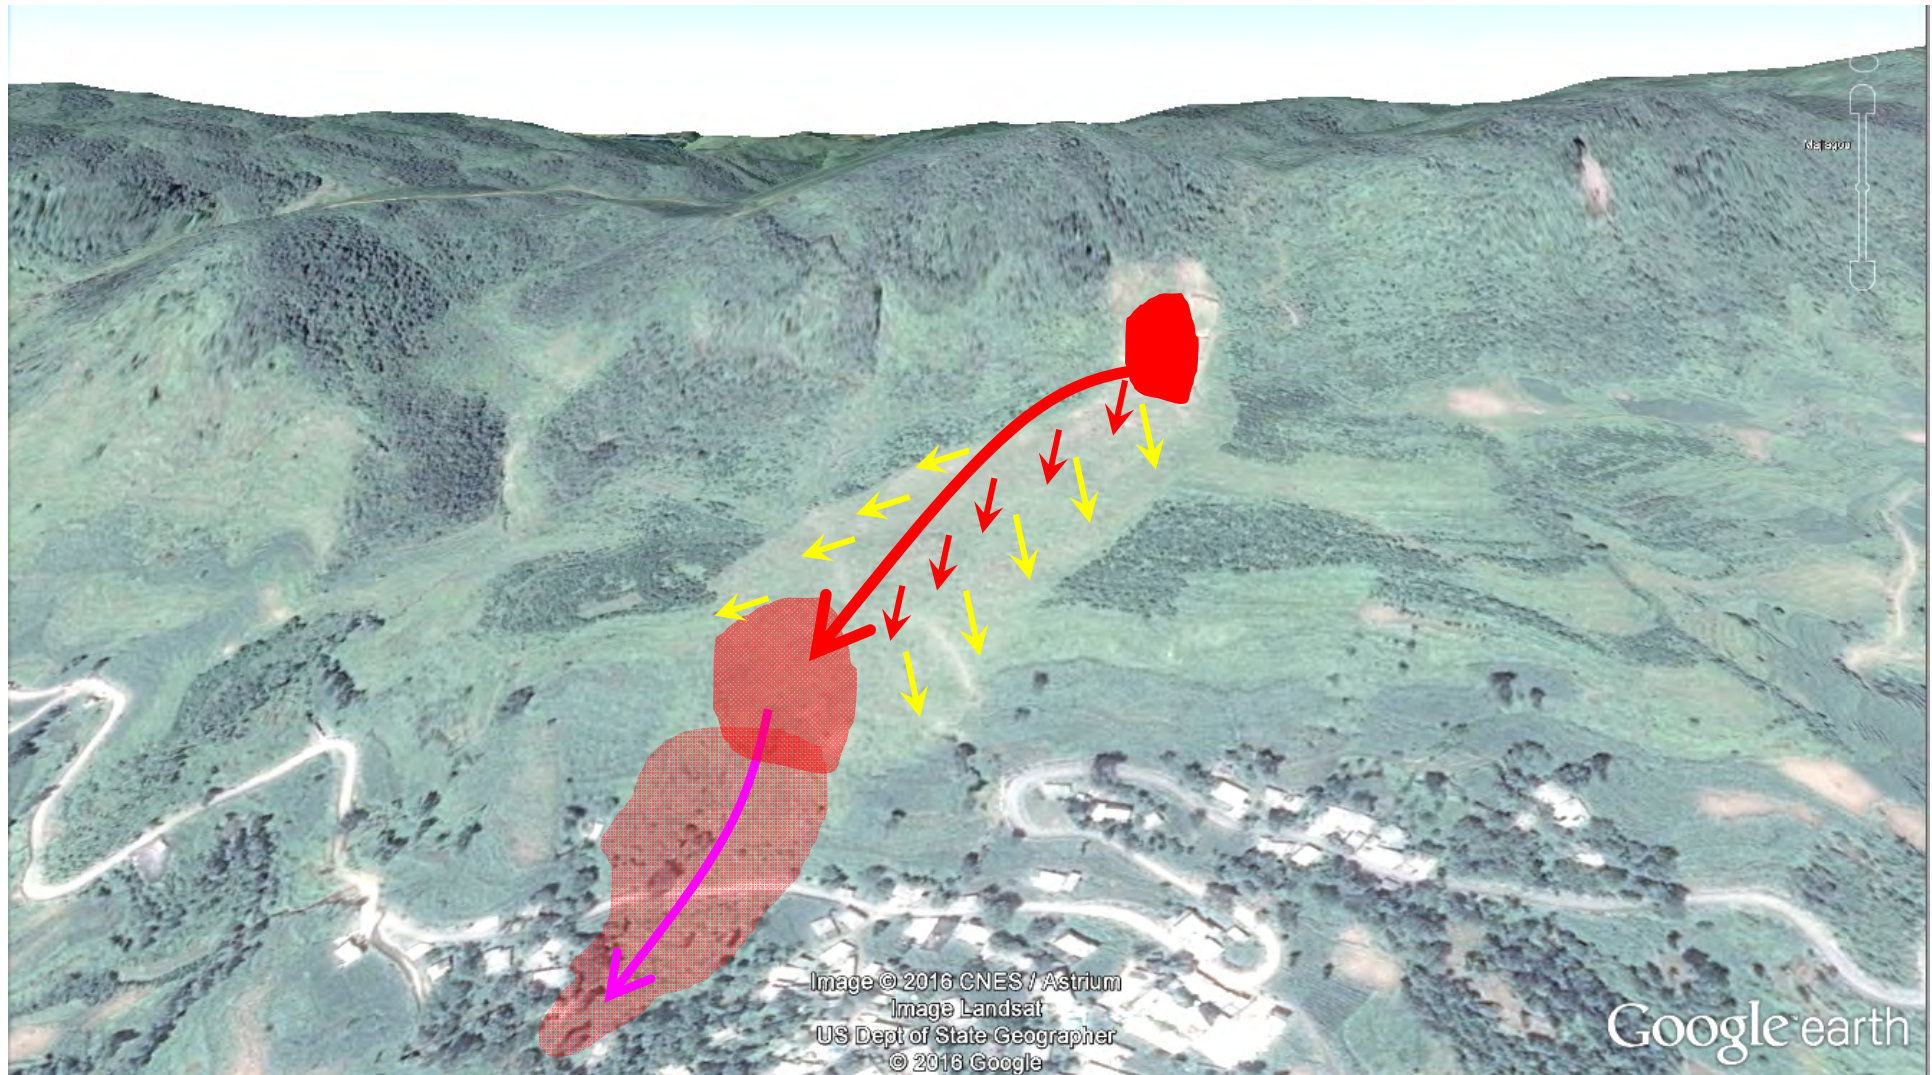
Likely mode and sequence of the fatal landslide

**Failed slope: $14^\circ \sim 30^\circ$ &
volume $\sim 0.25 \times 10^6 \text{ m}^3$**

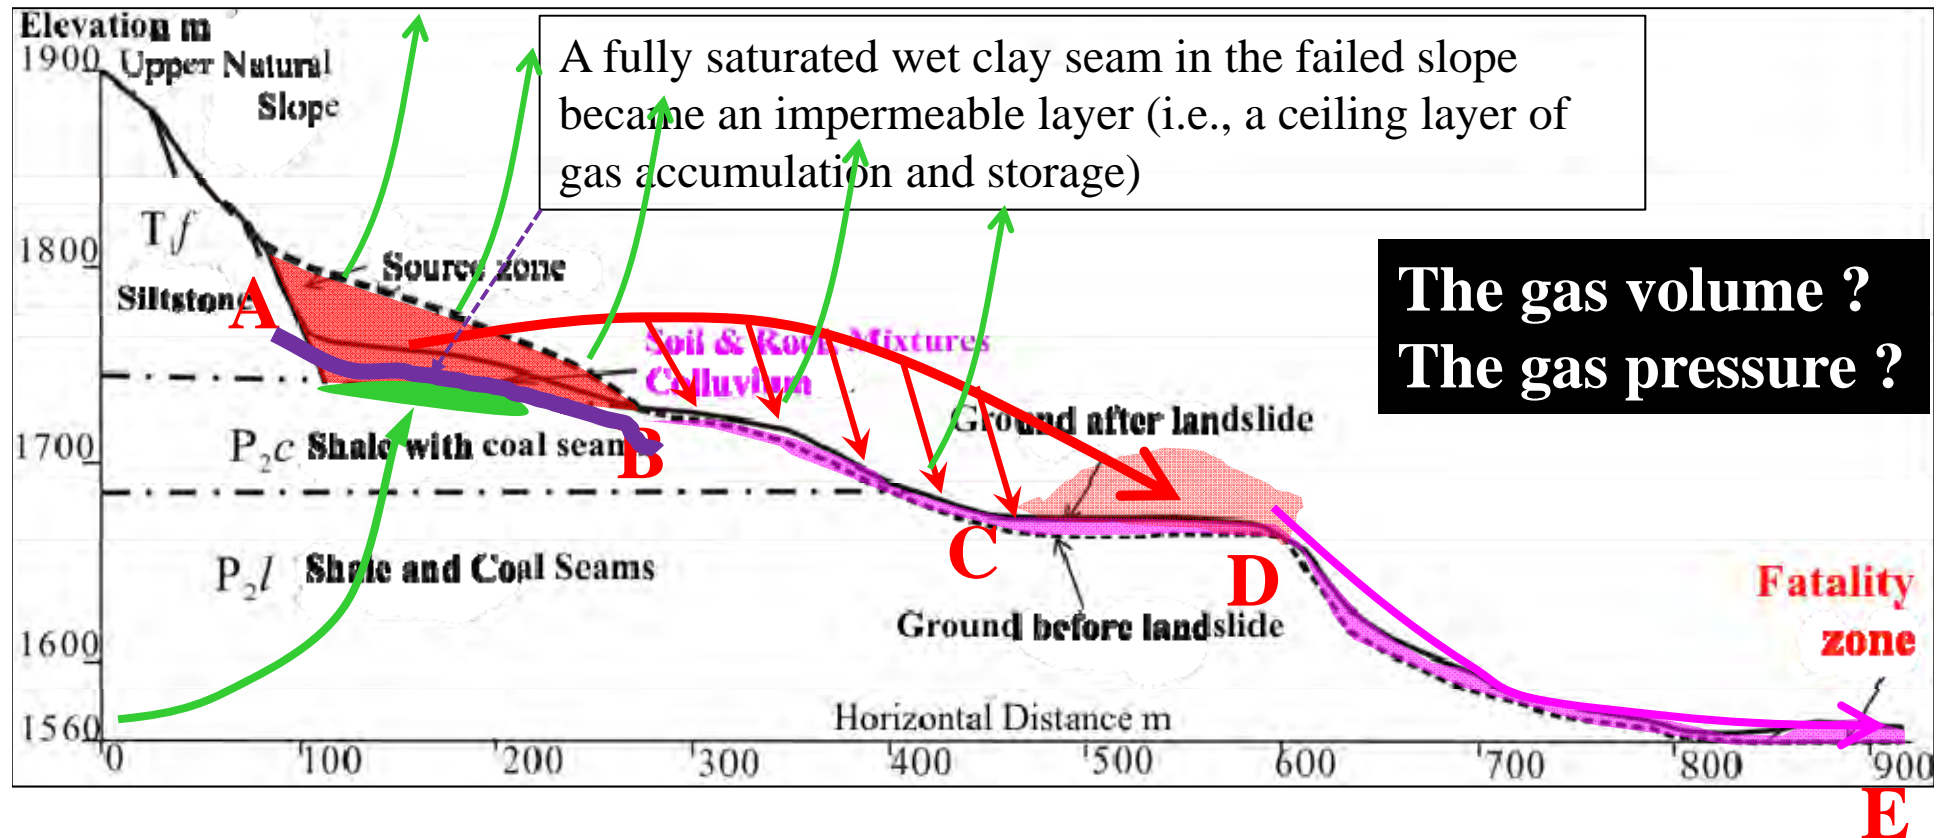
Possible scenery of migration, accumulation and eruption of highly compressed gas in the gentle natural slope to cause the fatal landslide

**Failed slope: $14^\circ \sim 30^\circ$ &
volume $\sim 0.25 \times 10^6 \text{ m}^3$**
