The Catastrophic Shenzhen Landslide of December 20, 2015

Zhong-qi Quentin Yue

Civil Engineering Department, The University of Hong Kong, Hong Kong, P.R. China

International Geotechnics Symposium cum
International Meeting of CSRME 14th Biennial National Congress
November 14-17, 2016, Hong Kong

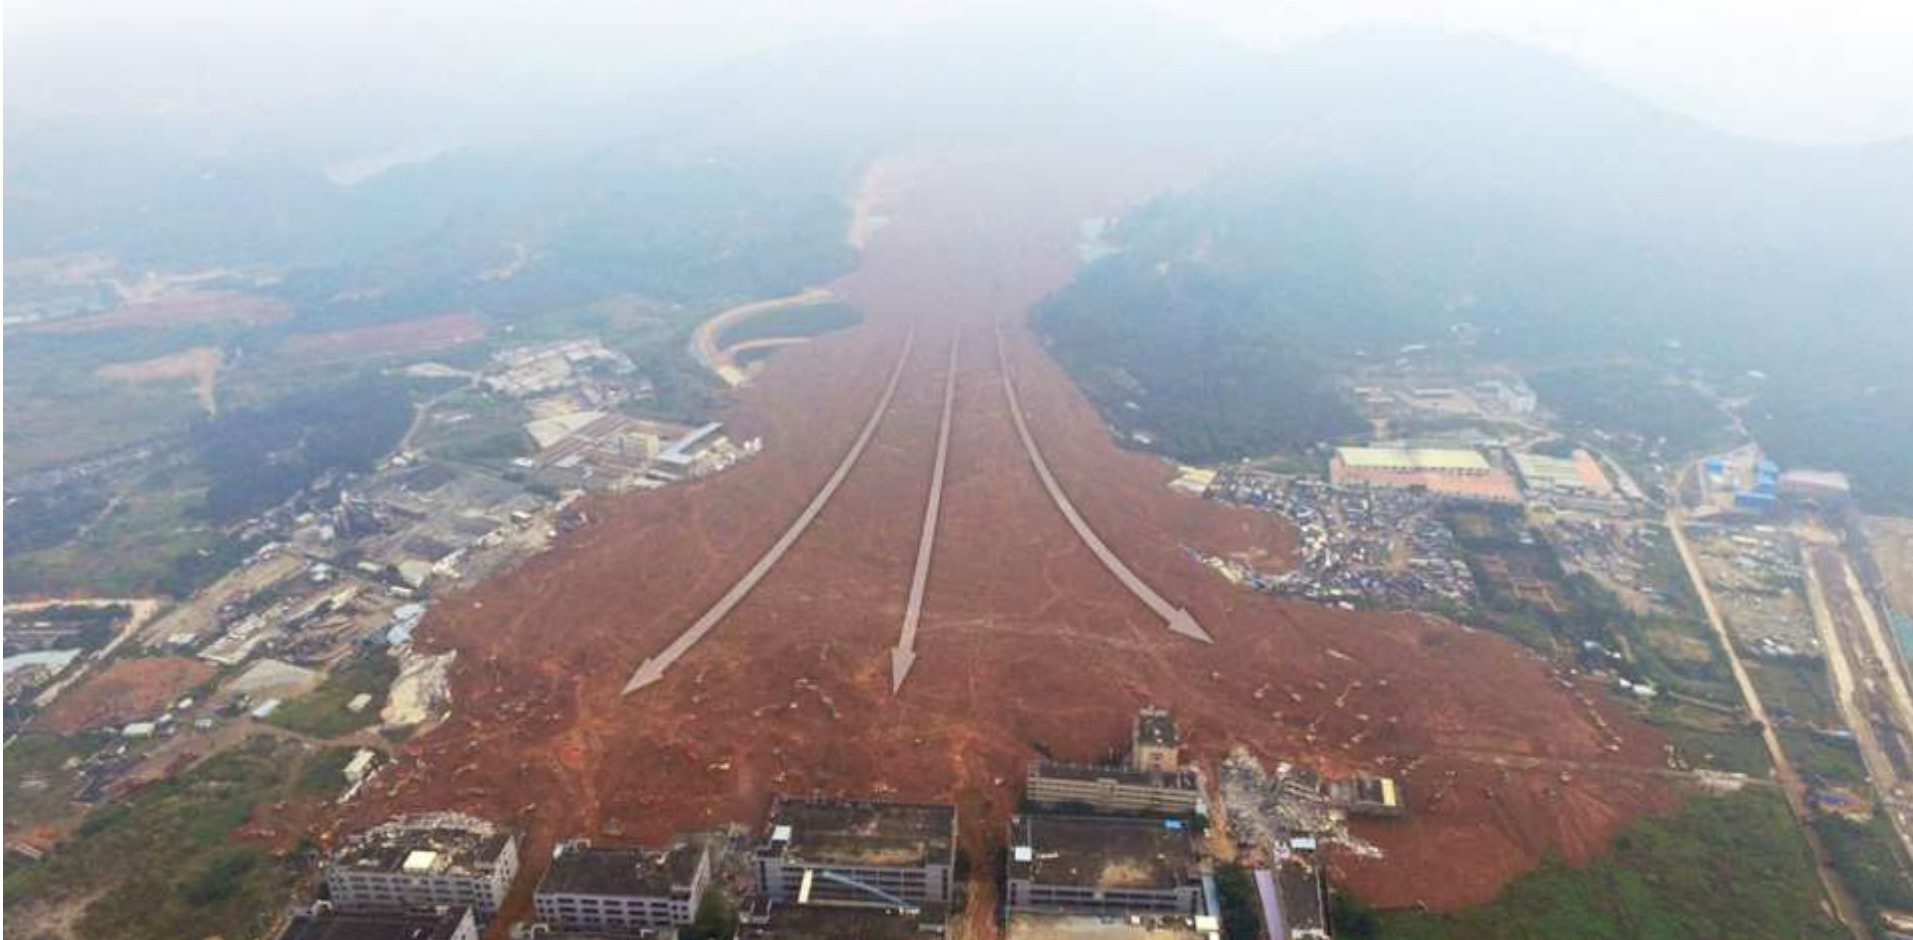
December 20, 2015, After nearly two years, the fill soil gave way, destroying several buildings as it slid down the low hillslope.

The adjacent natural hill did not slide, according to a geological report issued by the Ministry of Land and Resources on 21 December, 2015.

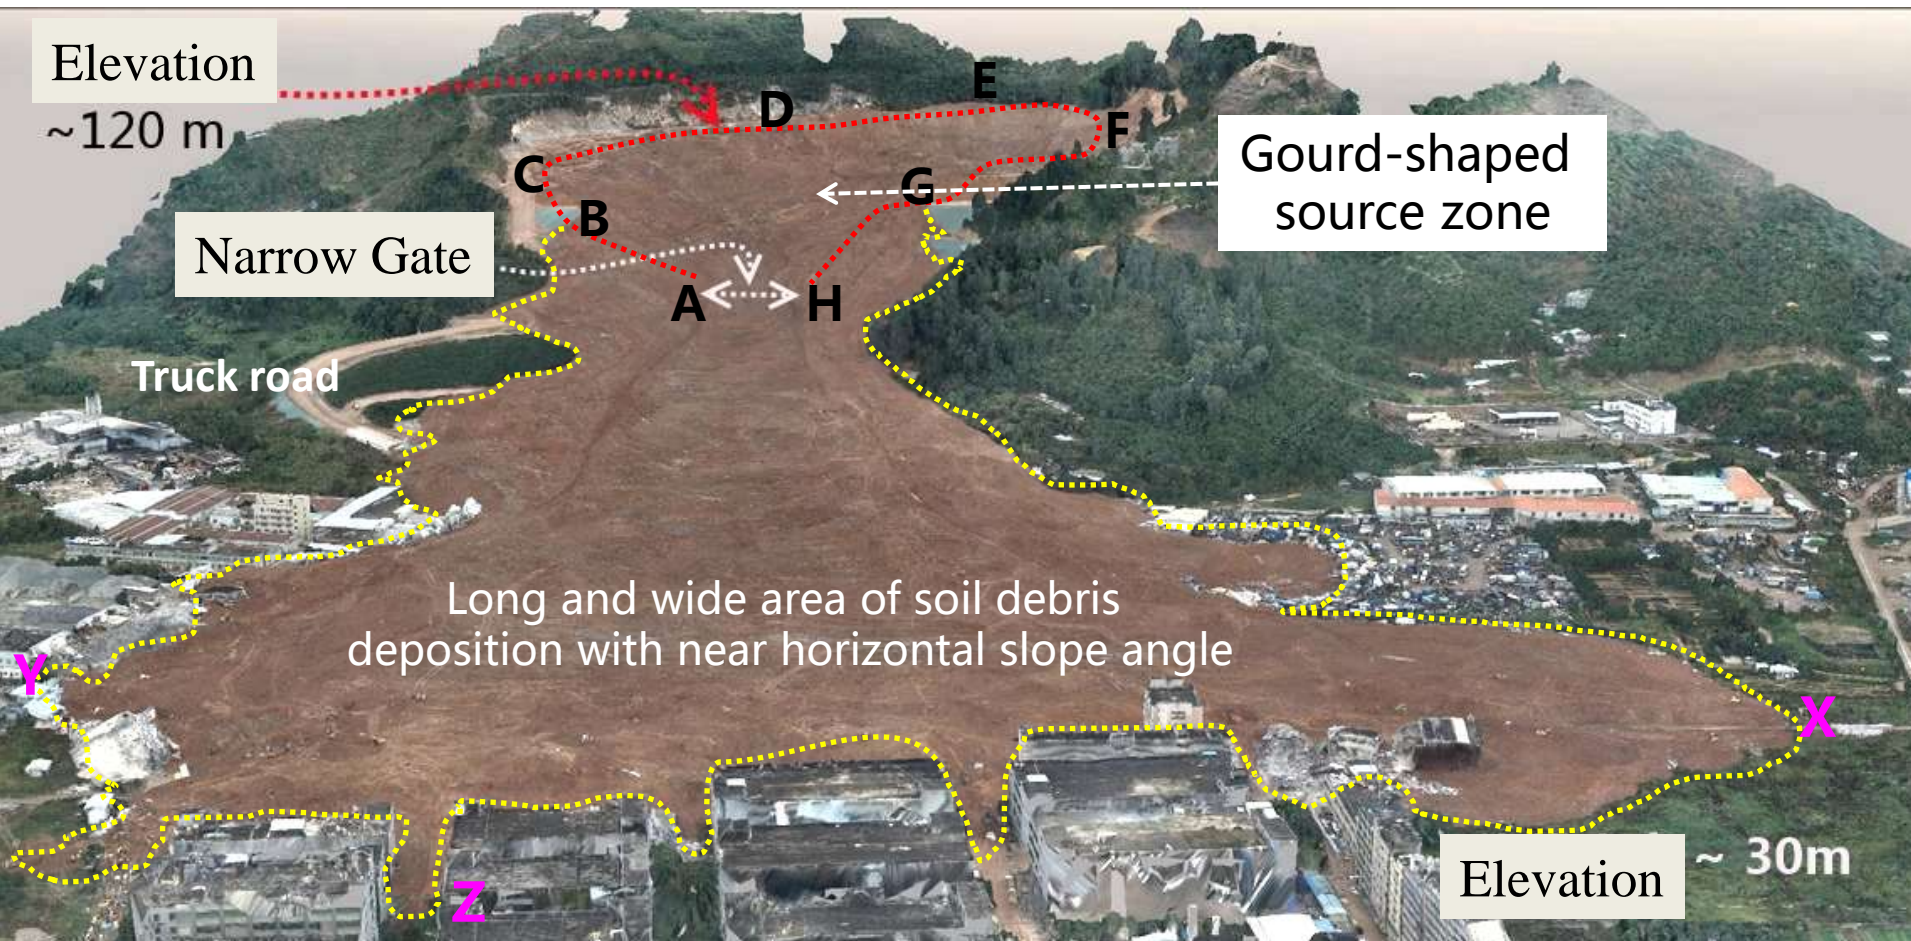
A site view from debris toe to the crest of landslide

Buildings in front of the debris flow became check-dams against impacting of rapidly moving debris of 10 m thick.

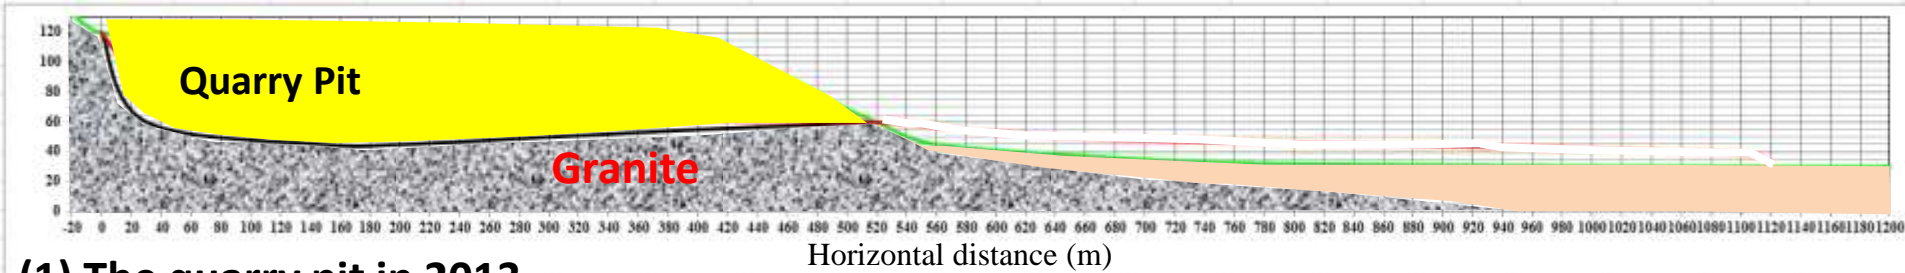
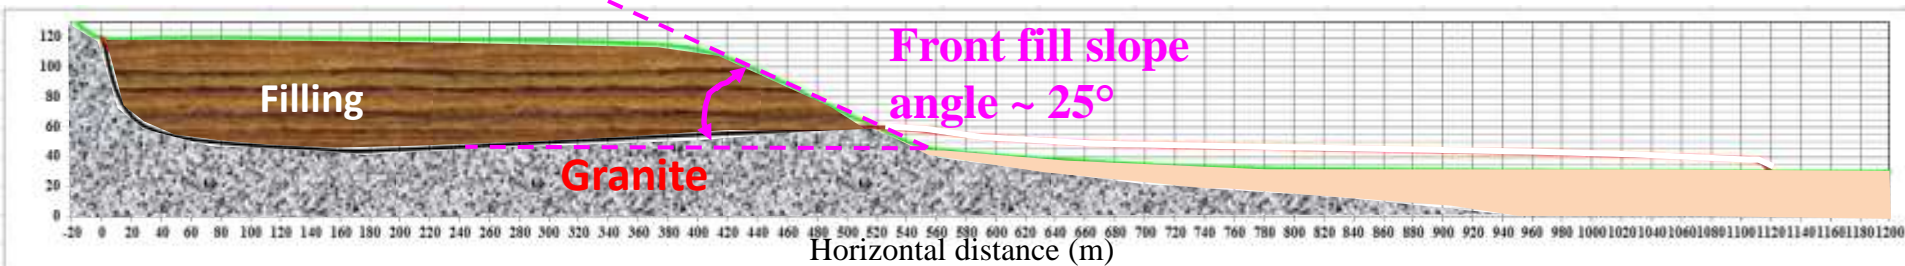
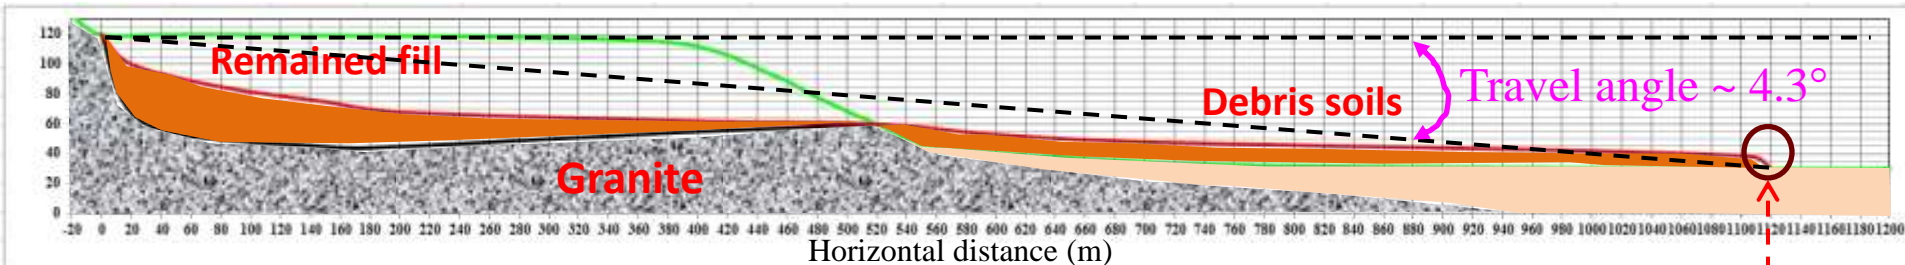
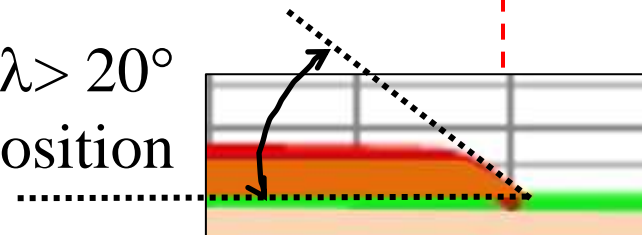
Longitudinal Section Q at Centre

(3) The failed slope after landslide on Dec. 20, 2015

Angle of repose $\lambda > 20^\circ$
of debris deposition

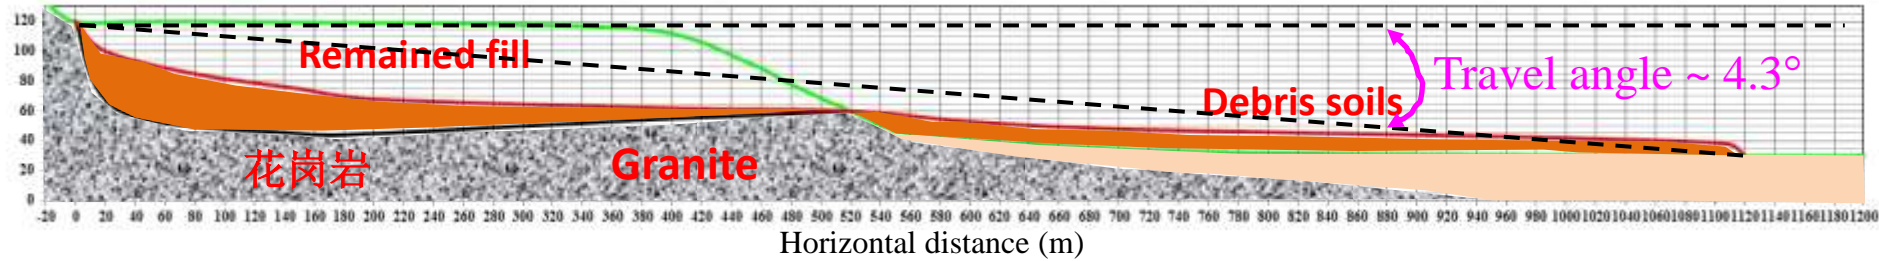
Longitudinal Section Q Versus Site Photograph

Gourd-shaped
Fill Source

Travel angle ~ 4.3°

Wide, long, rough, flat and thick debris deposition area

Angle of repose $\lambda > 20^\circ$ of the side and front toes of thick debris deposition

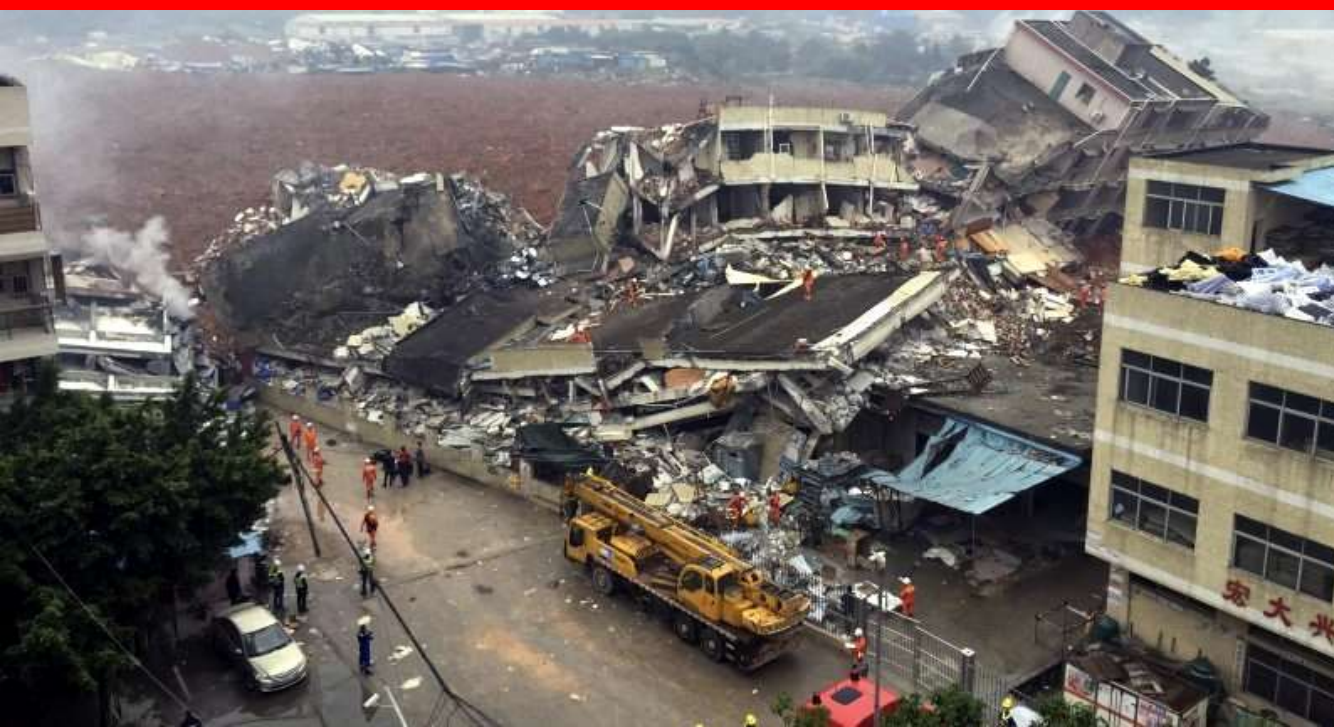
**Little free water and no mud/slurry
at front of thick debris toe**

**> 20° slope angle at
thick debris far toe**

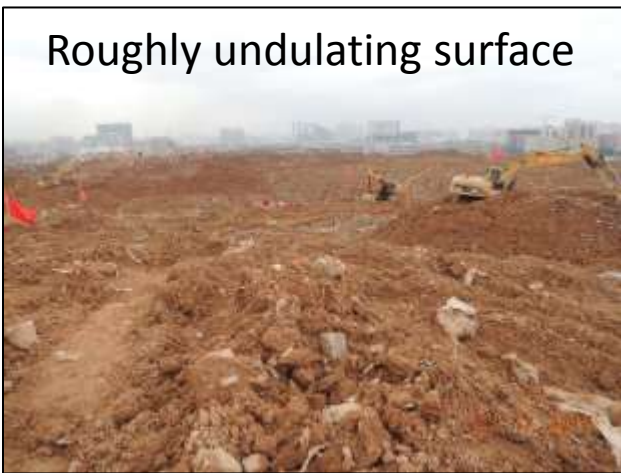
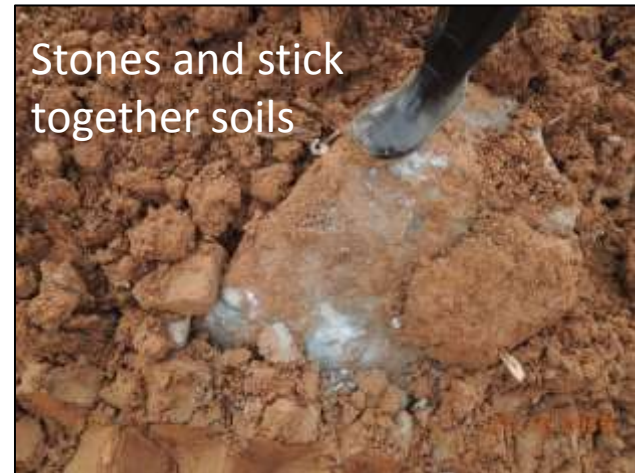
Roughly undulating surface

High & steep local slope

Stones and stick together soils

Loose and dry CDV or CDG soils with gravels on Dec. 23, 2015 in dry season

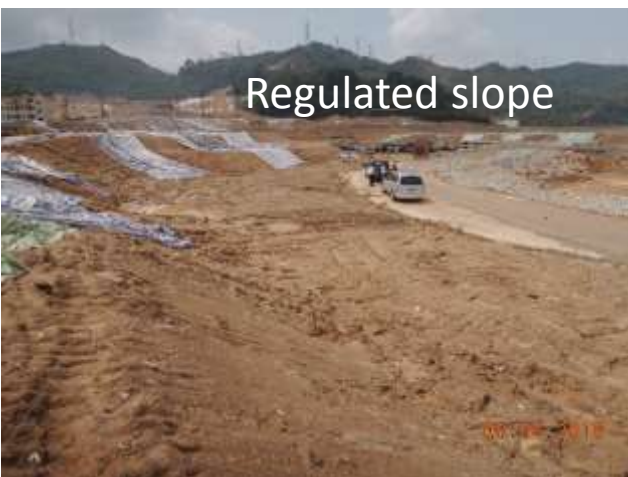
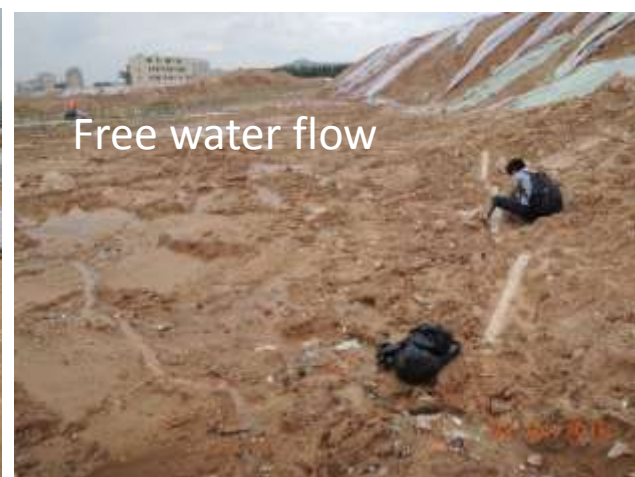
Regulated slope

Smooth surface

Free water flow

Wetted and dense CDV or CDG soils on April 8, 2015 in wet season
These soils were the landslide debris and removed to stockpiling nearby
their original deposition areas

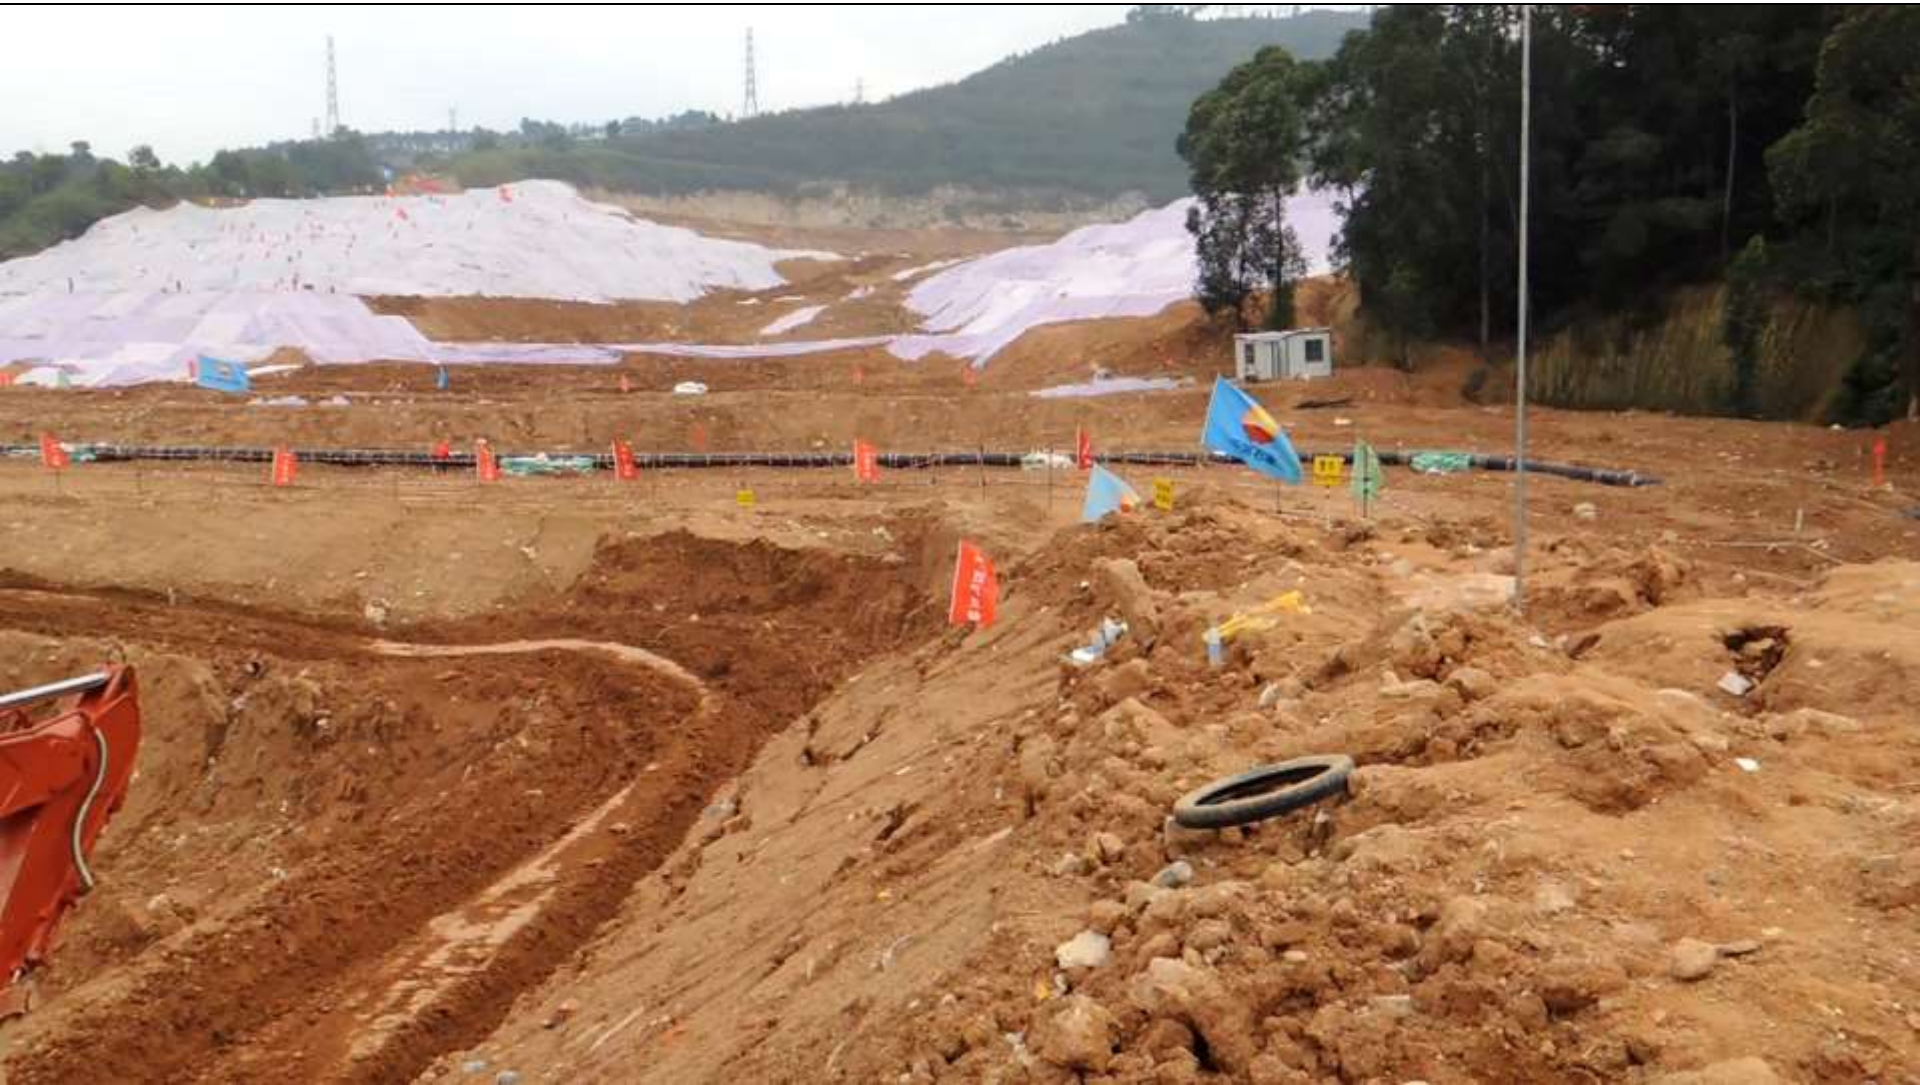
Further site video showing the conditions of landslide debris during the excavation and removal of the soils for rescuing on Jan. 9, 2016

The debris soils were not wetted and liquefied. There were almost no mud/sully or very wetted soils over the entire debris deposition areas except the former water pool area.

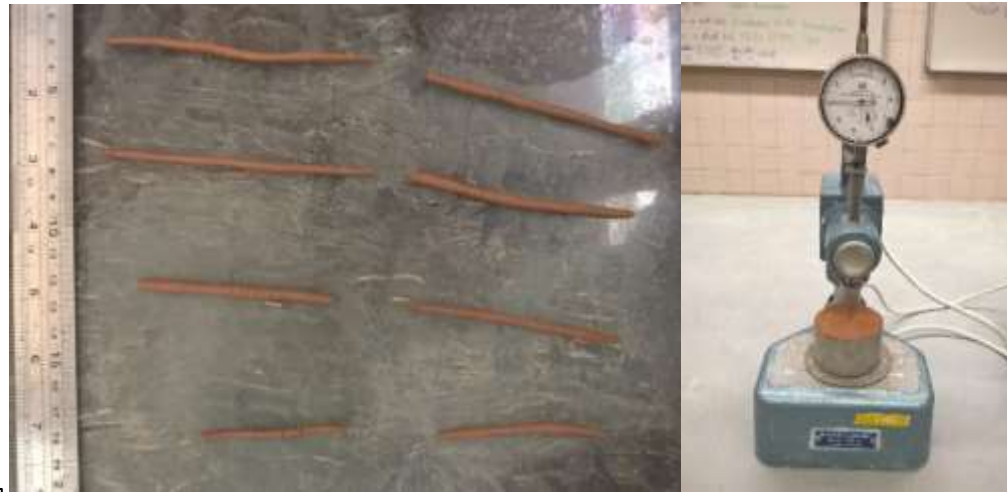
Clay contents about 7%

Well graded clayey silty sand with gravels

For particle size < 0.425 mm
 Plastic limit = 25.2% or 21.8%
 Liquid limit = 32.2% or 29.5%
 Plastic index = 7

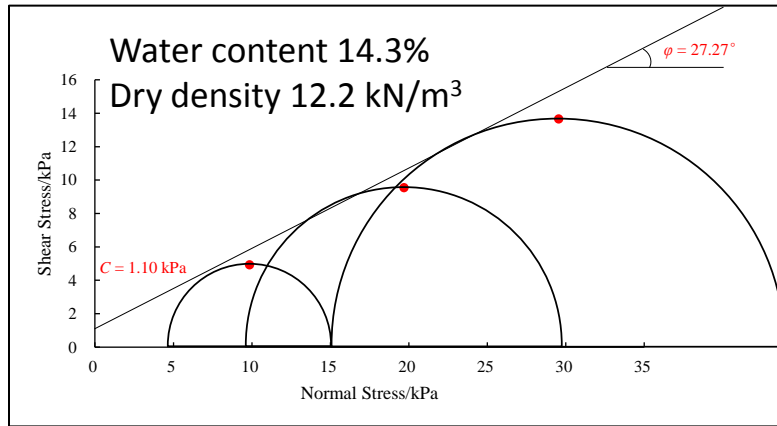
Direct shear test for soil samples at loose condition

$$c = 1 \text{ kPa}, \phi = 27^\circ$$

Initial shear modulus 2 – 10 MPa

$$c = 6 \text{ kPa}, \phi = 23^\circ$$

Initial shear modulus 1 – 2 MPa

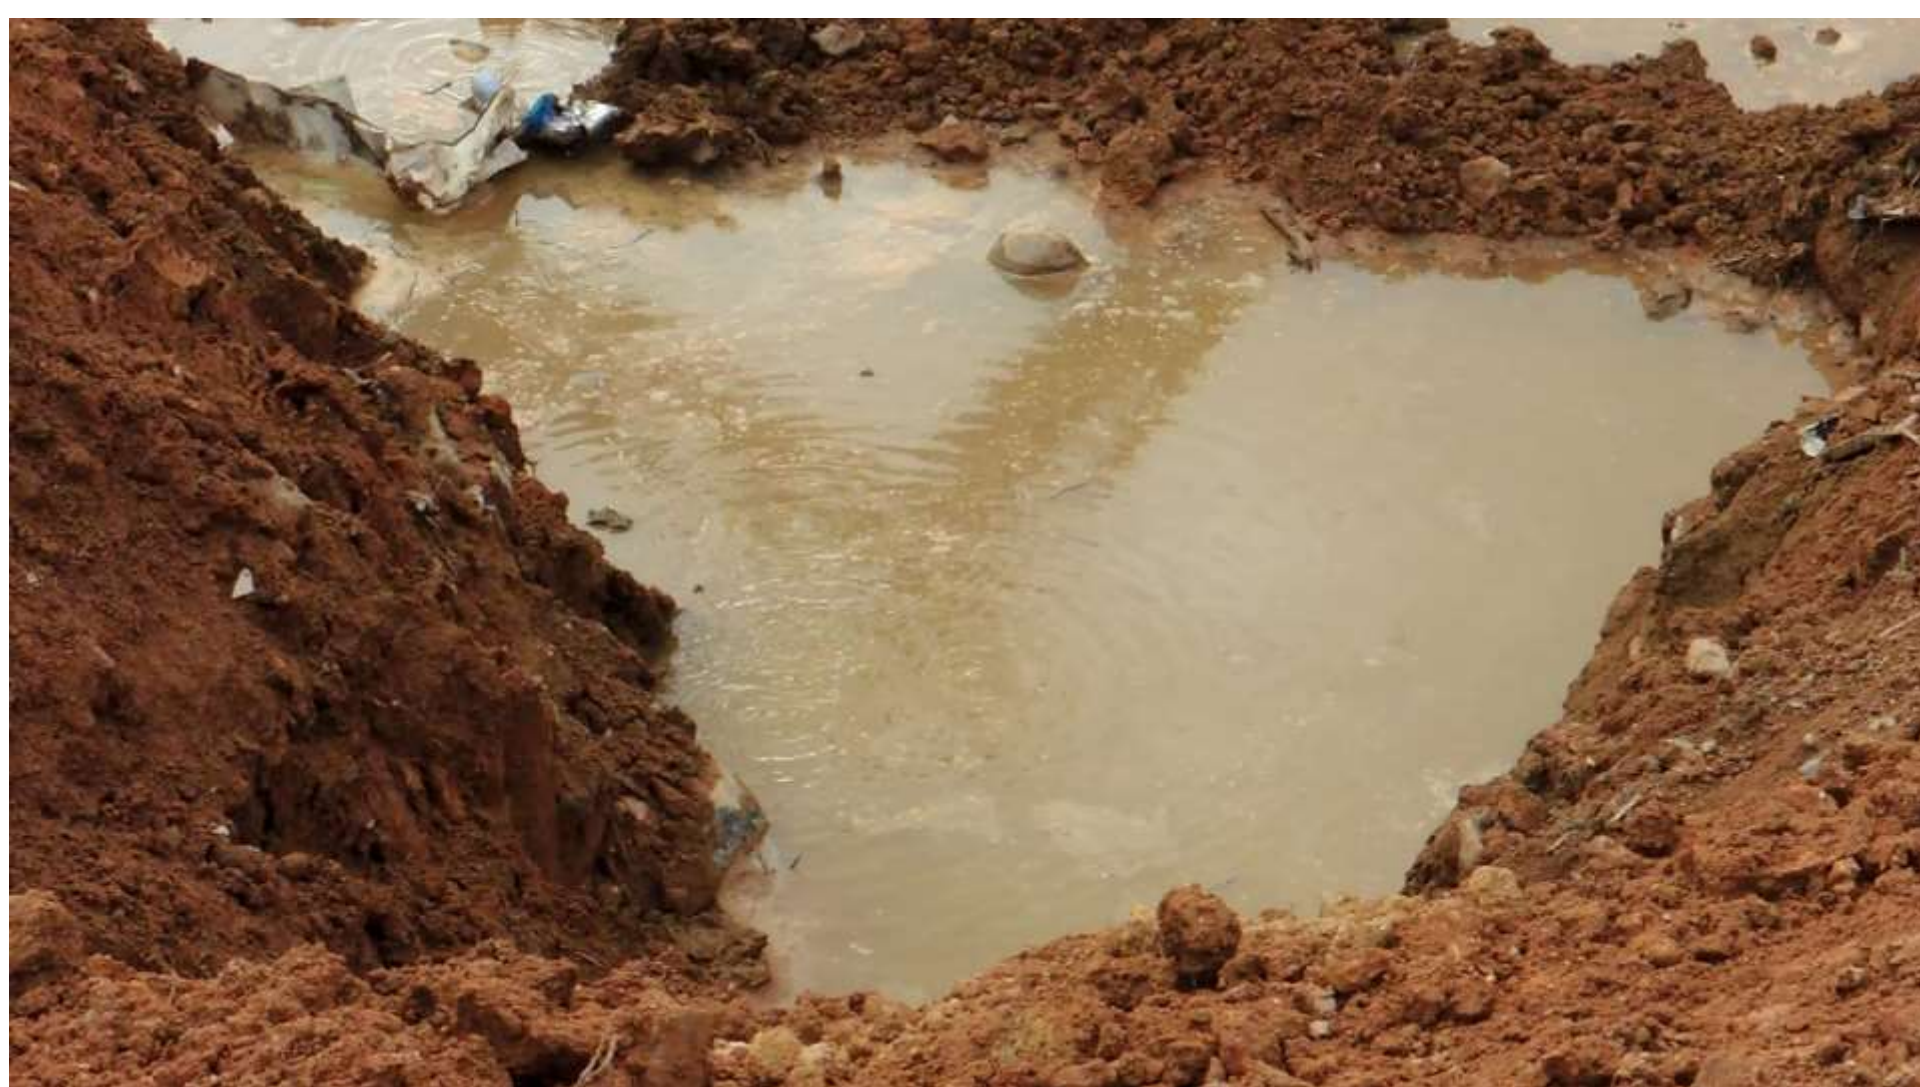
Video showing the bubbling of gas in the water pool of an deep excepted pit in the debris soils at the original water pool (video taken on Dec. 23, 2015, 3 days after the landslide)

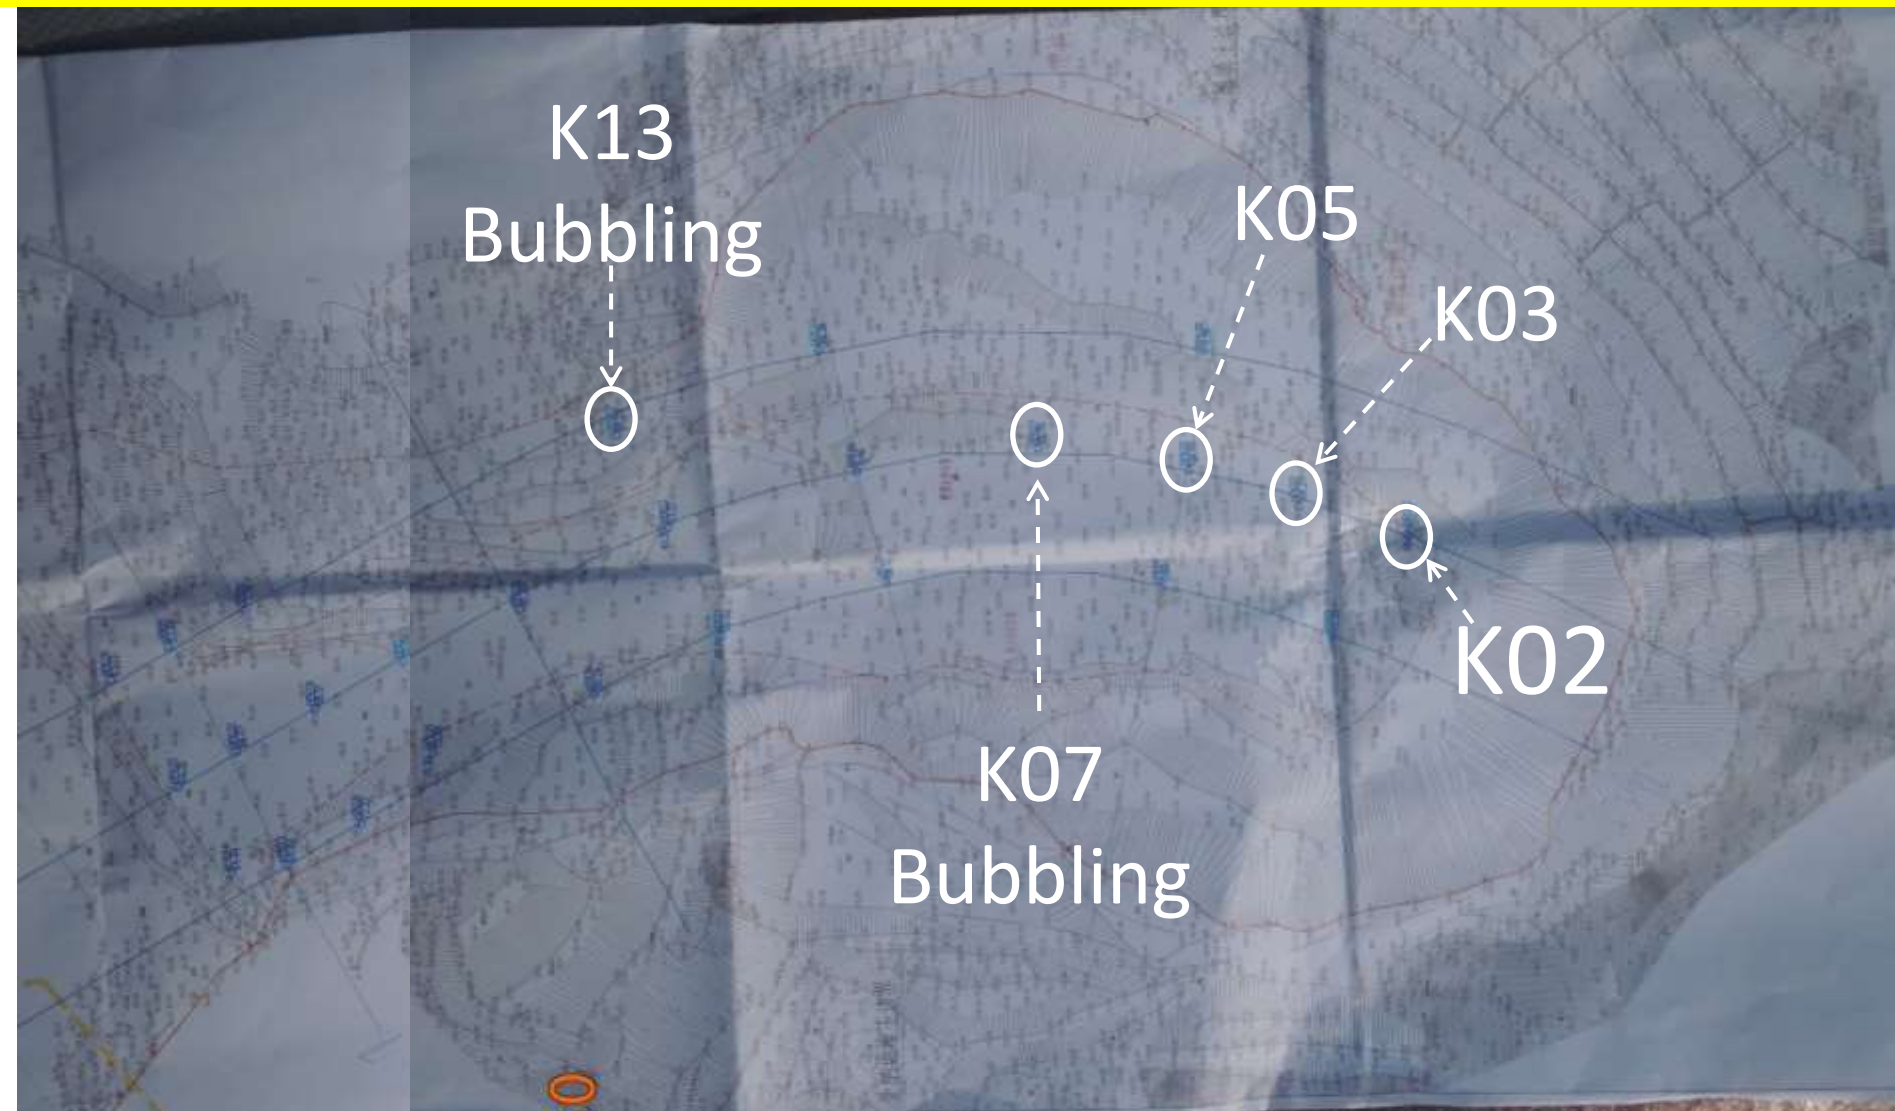
A Shenzhen geo-company made 28 drillholes in the gourd-shaped source zone. Basically, each drillhole had soil collapse cases. 8 drillholes had bubbling of gas and water. 11 drillholes had water table reaching the ground surface in the failed pit.

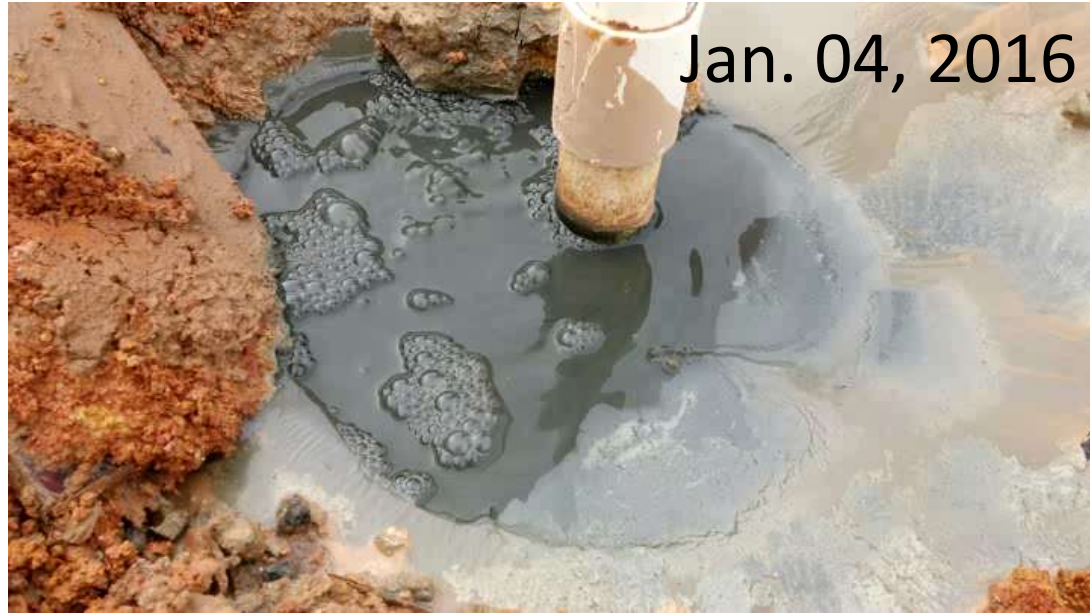
Video showing bubbling in K02

Jan. 04, 2016

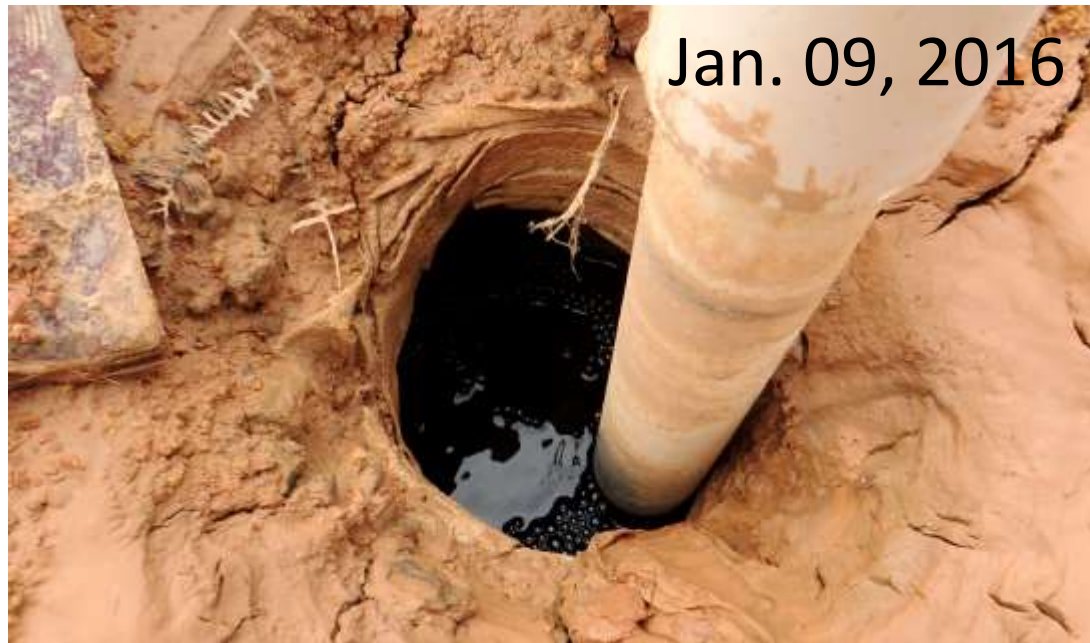
Drillhole No. K13 on Jan. 9, 2016

**The gas out of the
drillhole had strong
odour or foul smell.**

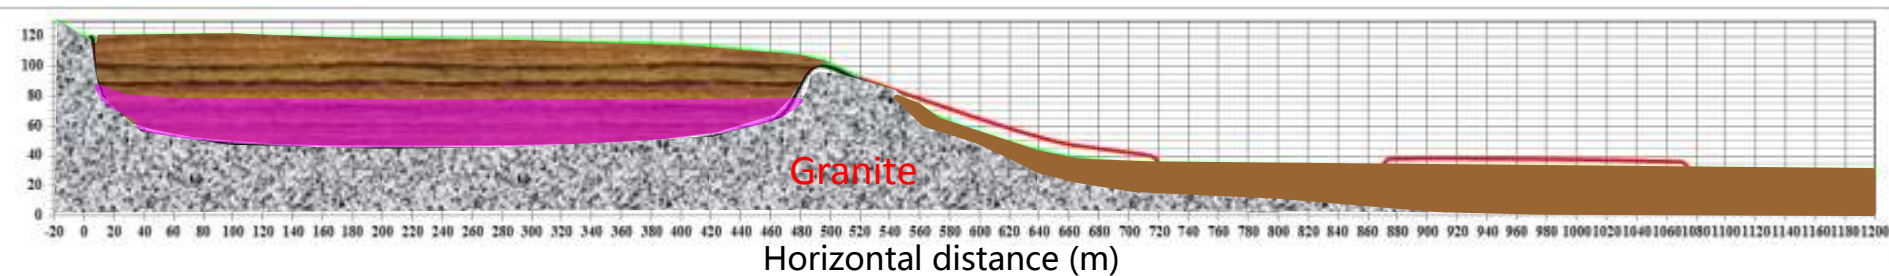
The fill soils are well graded clayey silty sand with gravels excavated from CDG or CDV sites in Shenzhen. They are loose, low permeability.

Water can be stored and accumulated in the bottom of the filled pit due to very low permeability of the granitic bedrock.

Water made the loose fill at the bottom wetted, softened and easy deformed, which gradually affected the middle part. The upper part remains loose.

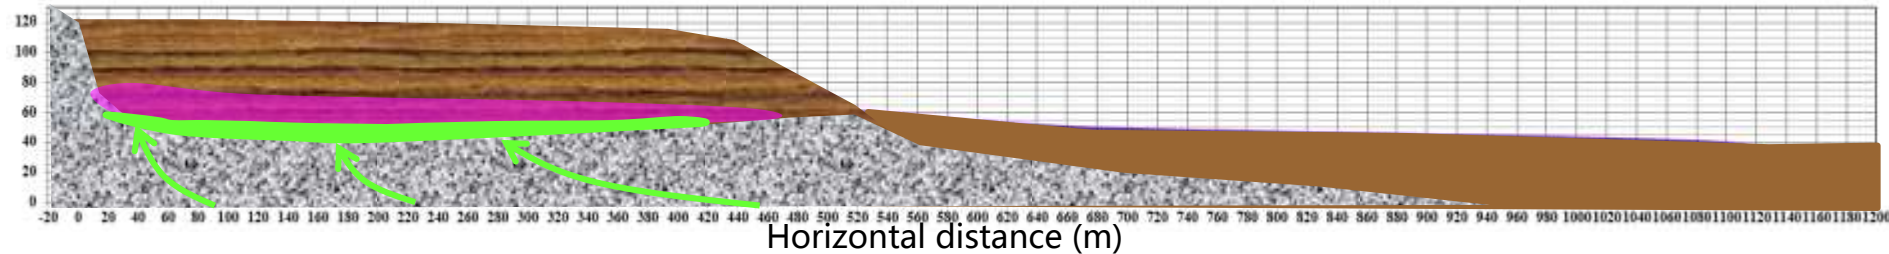
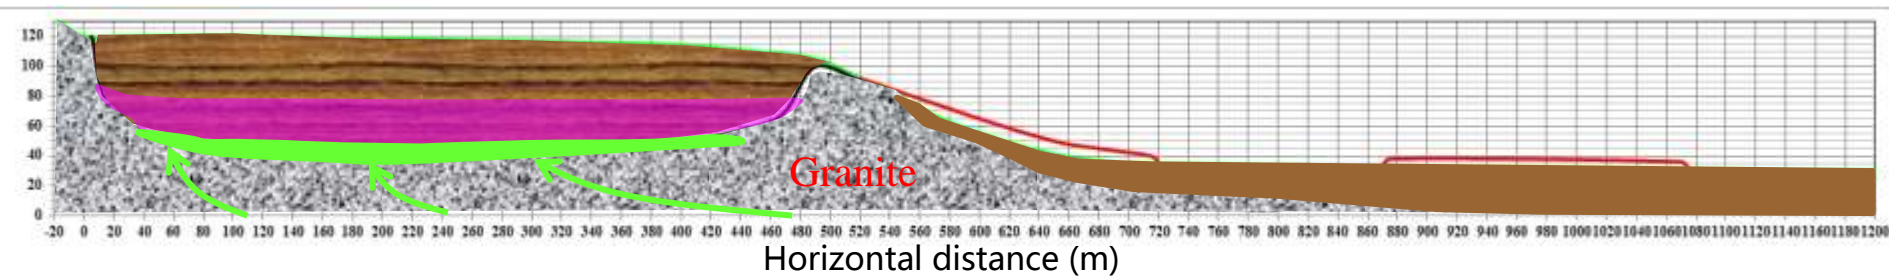
2)
The leaking and seeping of the highly compressed natural gas into the bottom part of the fill. The gas accumulated there.

The mass and pressure of the gas increased with time due to the overburden pressure of the fill weight.

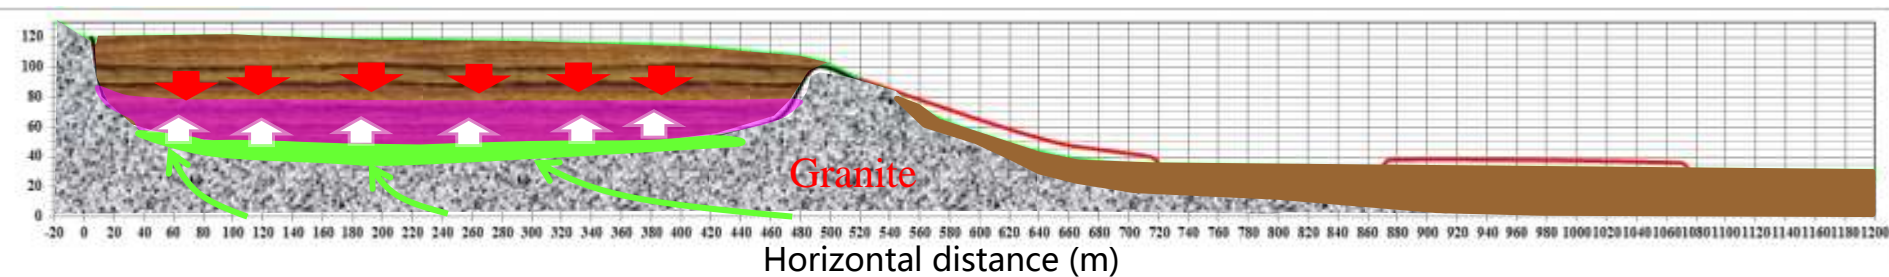
3)
The expanding of the compressed gas was uplifting the middle and upper loose fill.

The weight of the fill confined and restricted the gas uplifting.

So, the middle soil was compressed accordingly.

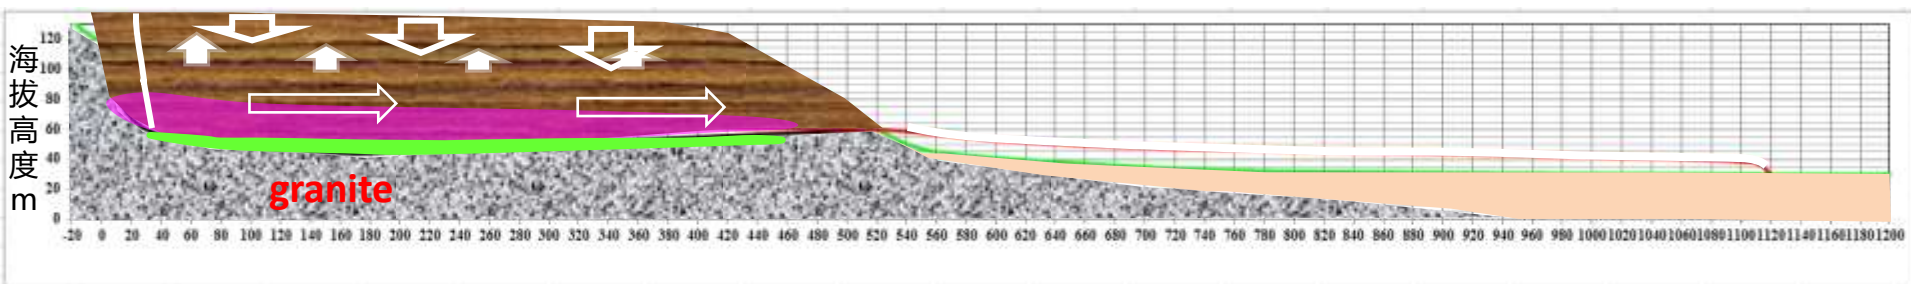
4)
Before 11:42, December 20, 2015, there was suddenly increasing in the gas pressure in the pipeline. The leaking of the gas also was increasing. Much more gas mass was accumulated and the gas pressure in the fill soils also increasing.
The force equilibrium and the deformation compatibility were broken. The expanding gas uplifted, tilted its upper soil layers and ruptured fill soils around the gourd-shaped pit.
So, the isolated above fill soil layers were moved upward significantly.

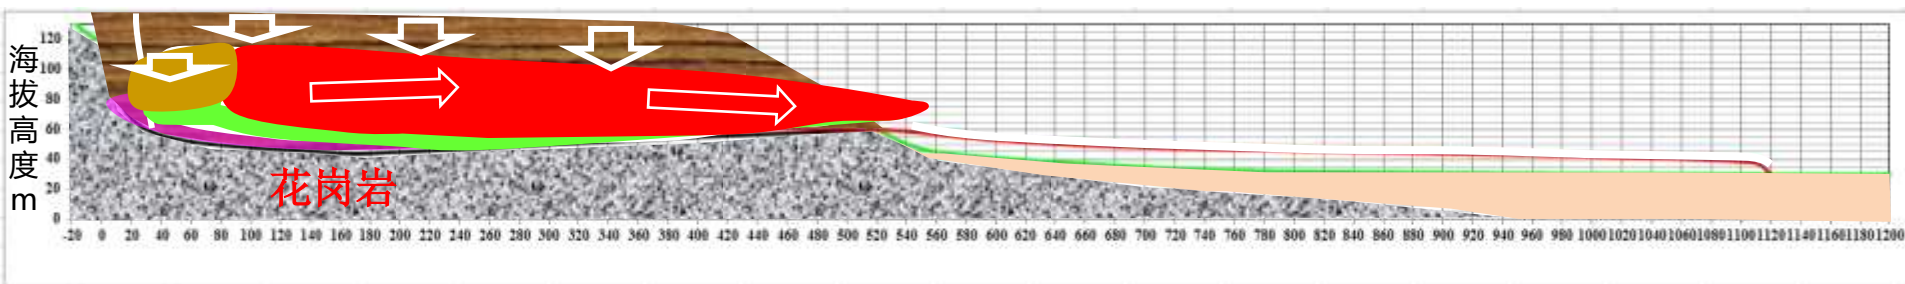
5)
The expanding gas uplifted its upper soil layers and also moved them laterally.

Due to the loose linkage between the upper loose fill layer and the middle fill layer, their interface ruptured and delinked.

Subsequently, the expanding gas, the wetted/gassed soft bottom layer and the middle layer, like water, slipped and flowed out of the narrow gate (outlet), and rapidly flew down the gentle slope.

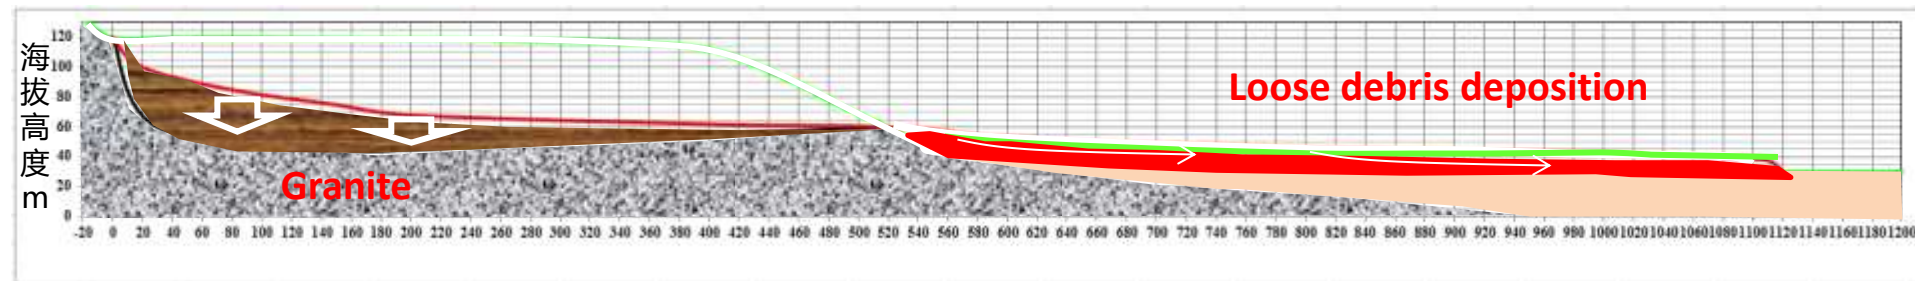
The soil debris, saturated with water and gas and uplifted by compressed gas, slipped out the outlet like water.

They rapidly flowed and spreaded over the vast flat ground.

They strongly and forcefully destroyed, impacted and buried houses and buildings on their rapid moving/flowing path.

7) In the meantime, the upper loose soil layer and the surrounding soils sunk and collapsed into the suddenly empty space due to the rapid leaving of the middle soil layers and that was originally occupied by the debris soils.
