# Nipigon River Landslide, Ontario, Canada

A. Abdelaziz, S. Besner, R. Boger, B. Fu, J. Deng, and A. Farina

Centre of Excellence for Sustainable Mining and Exploration,  
Lakehead University, Canada

# Nipigon River Landslide

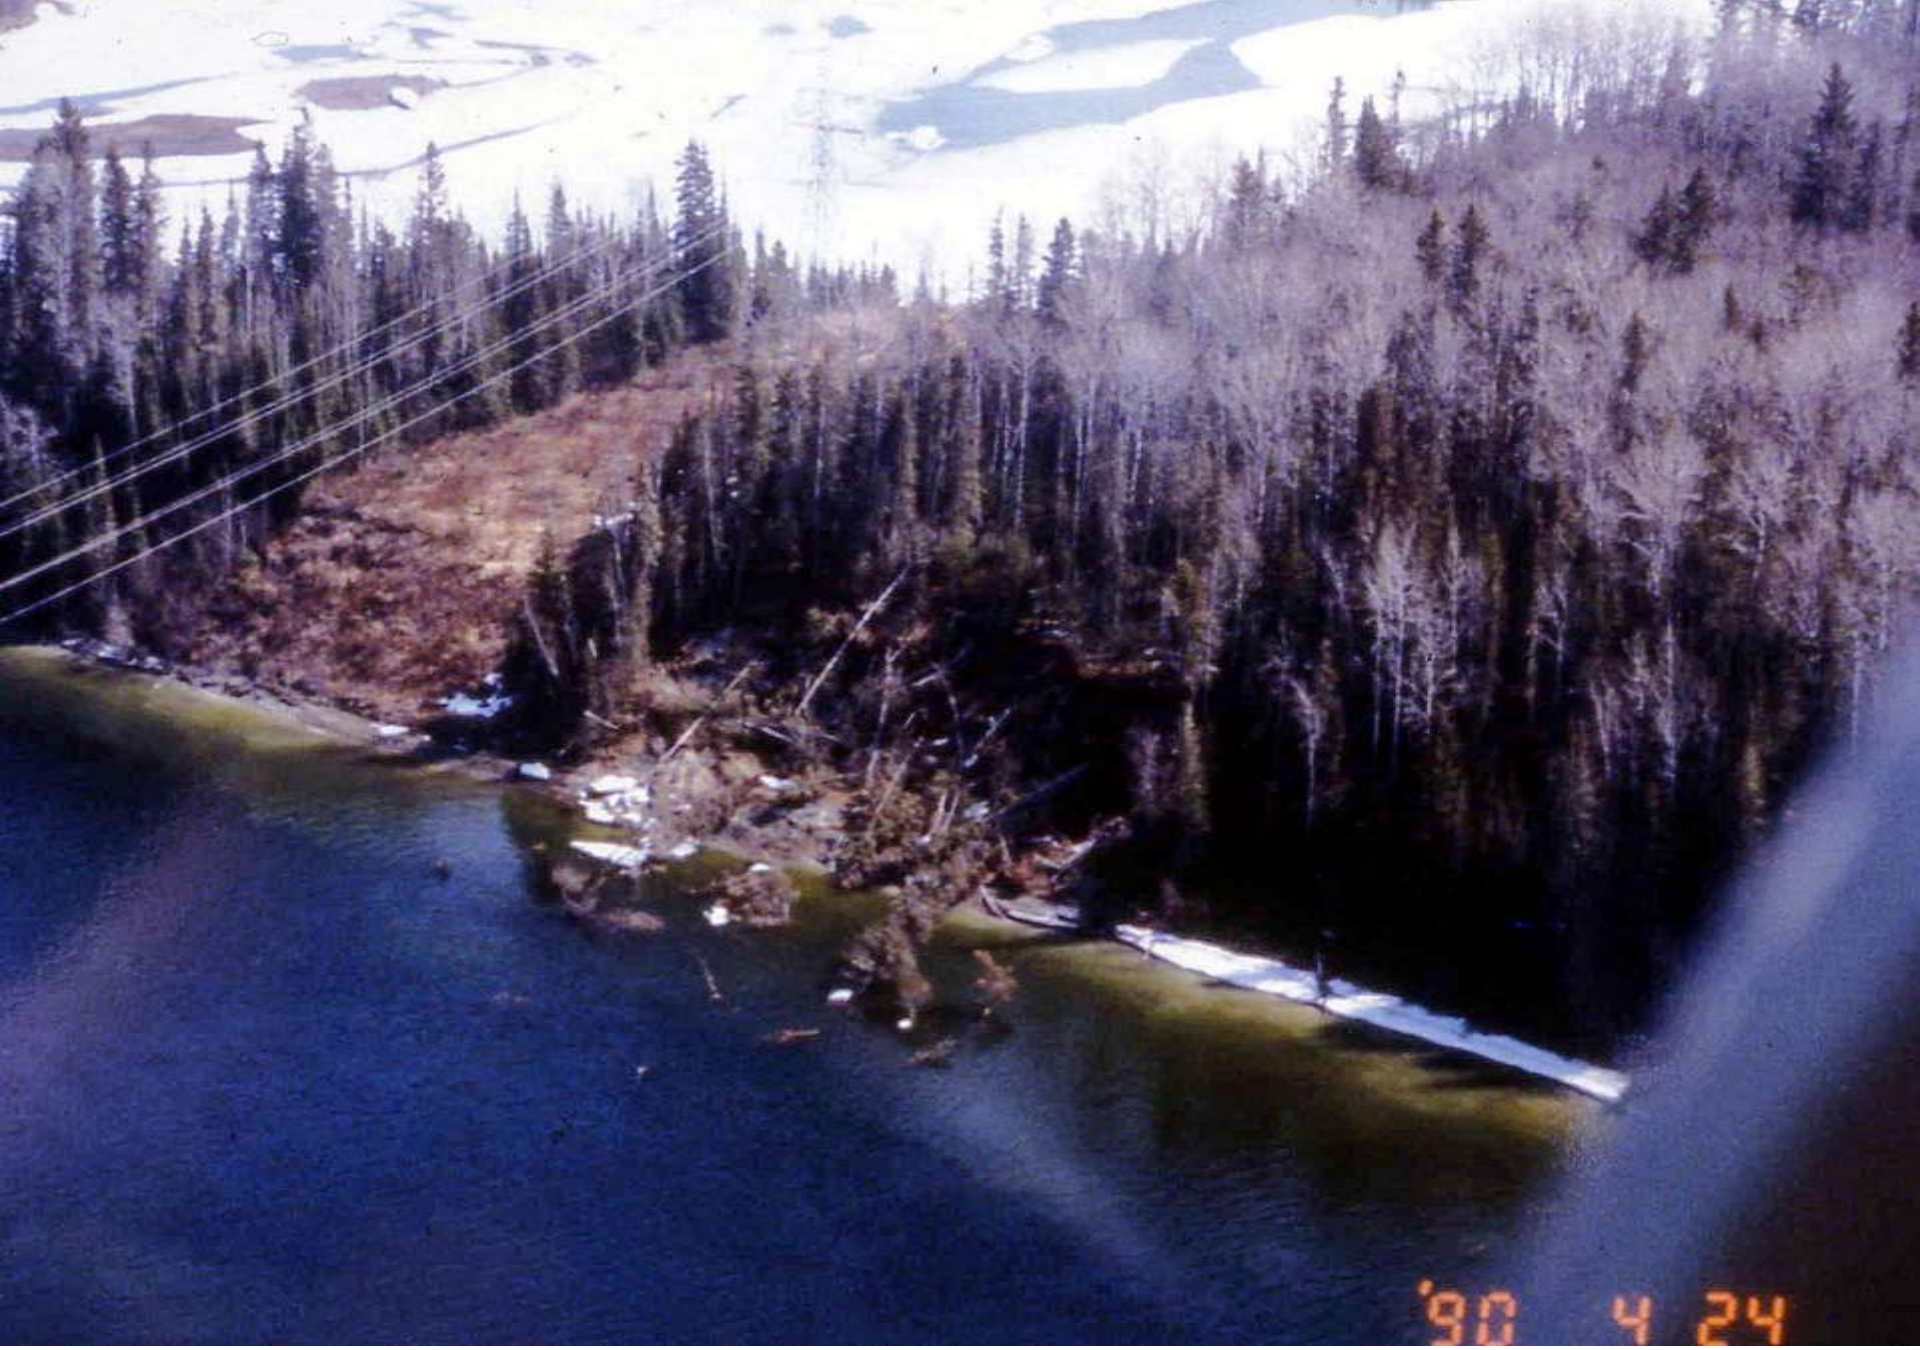
Figure 3: A day after the landslide (Adamson, 2015)

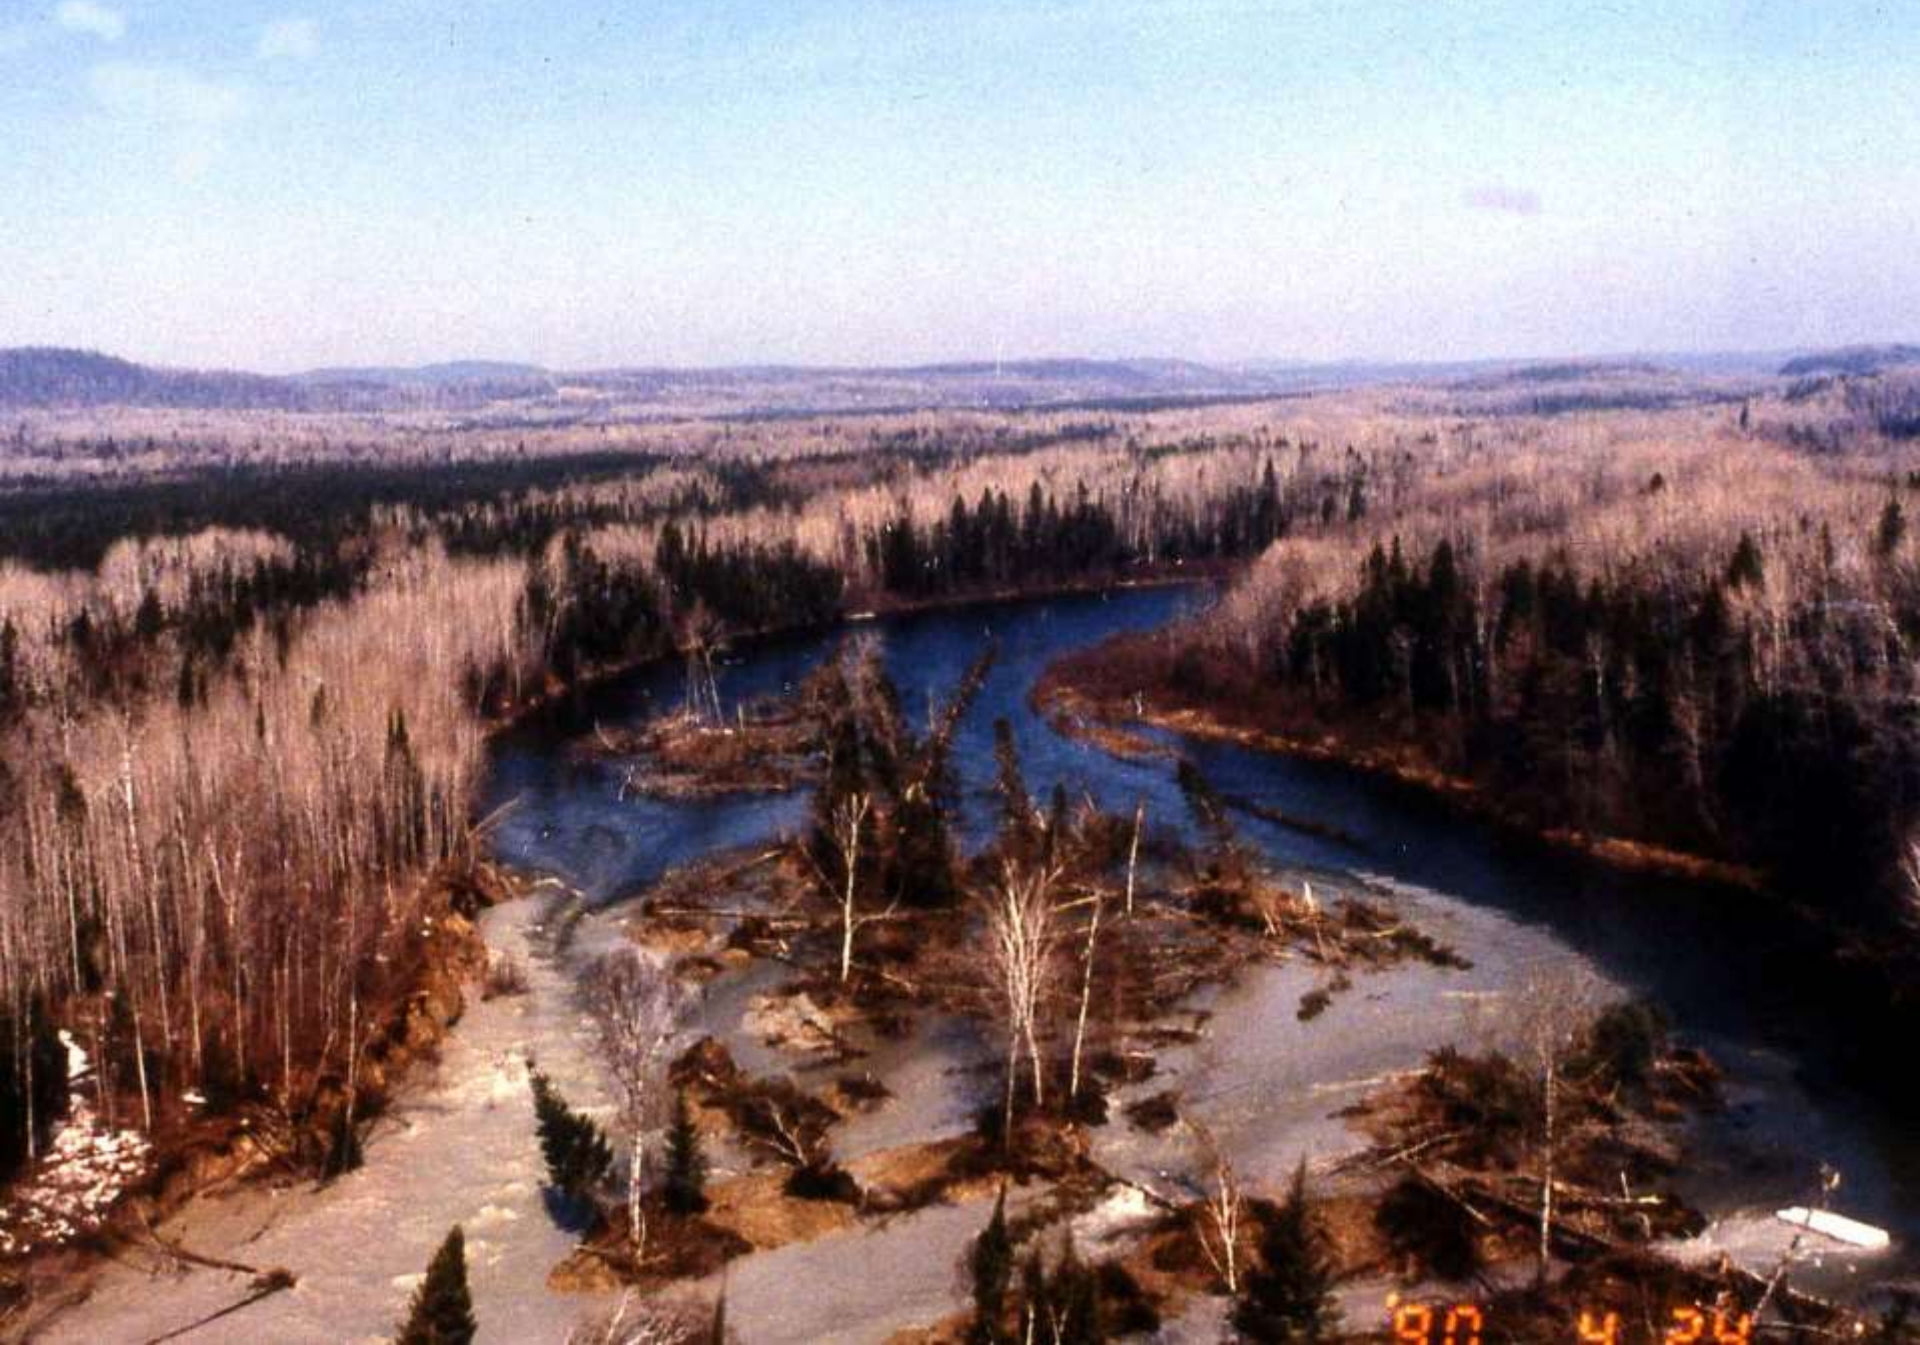
Figure 4: A day after the landslide (Adamson, 2015)

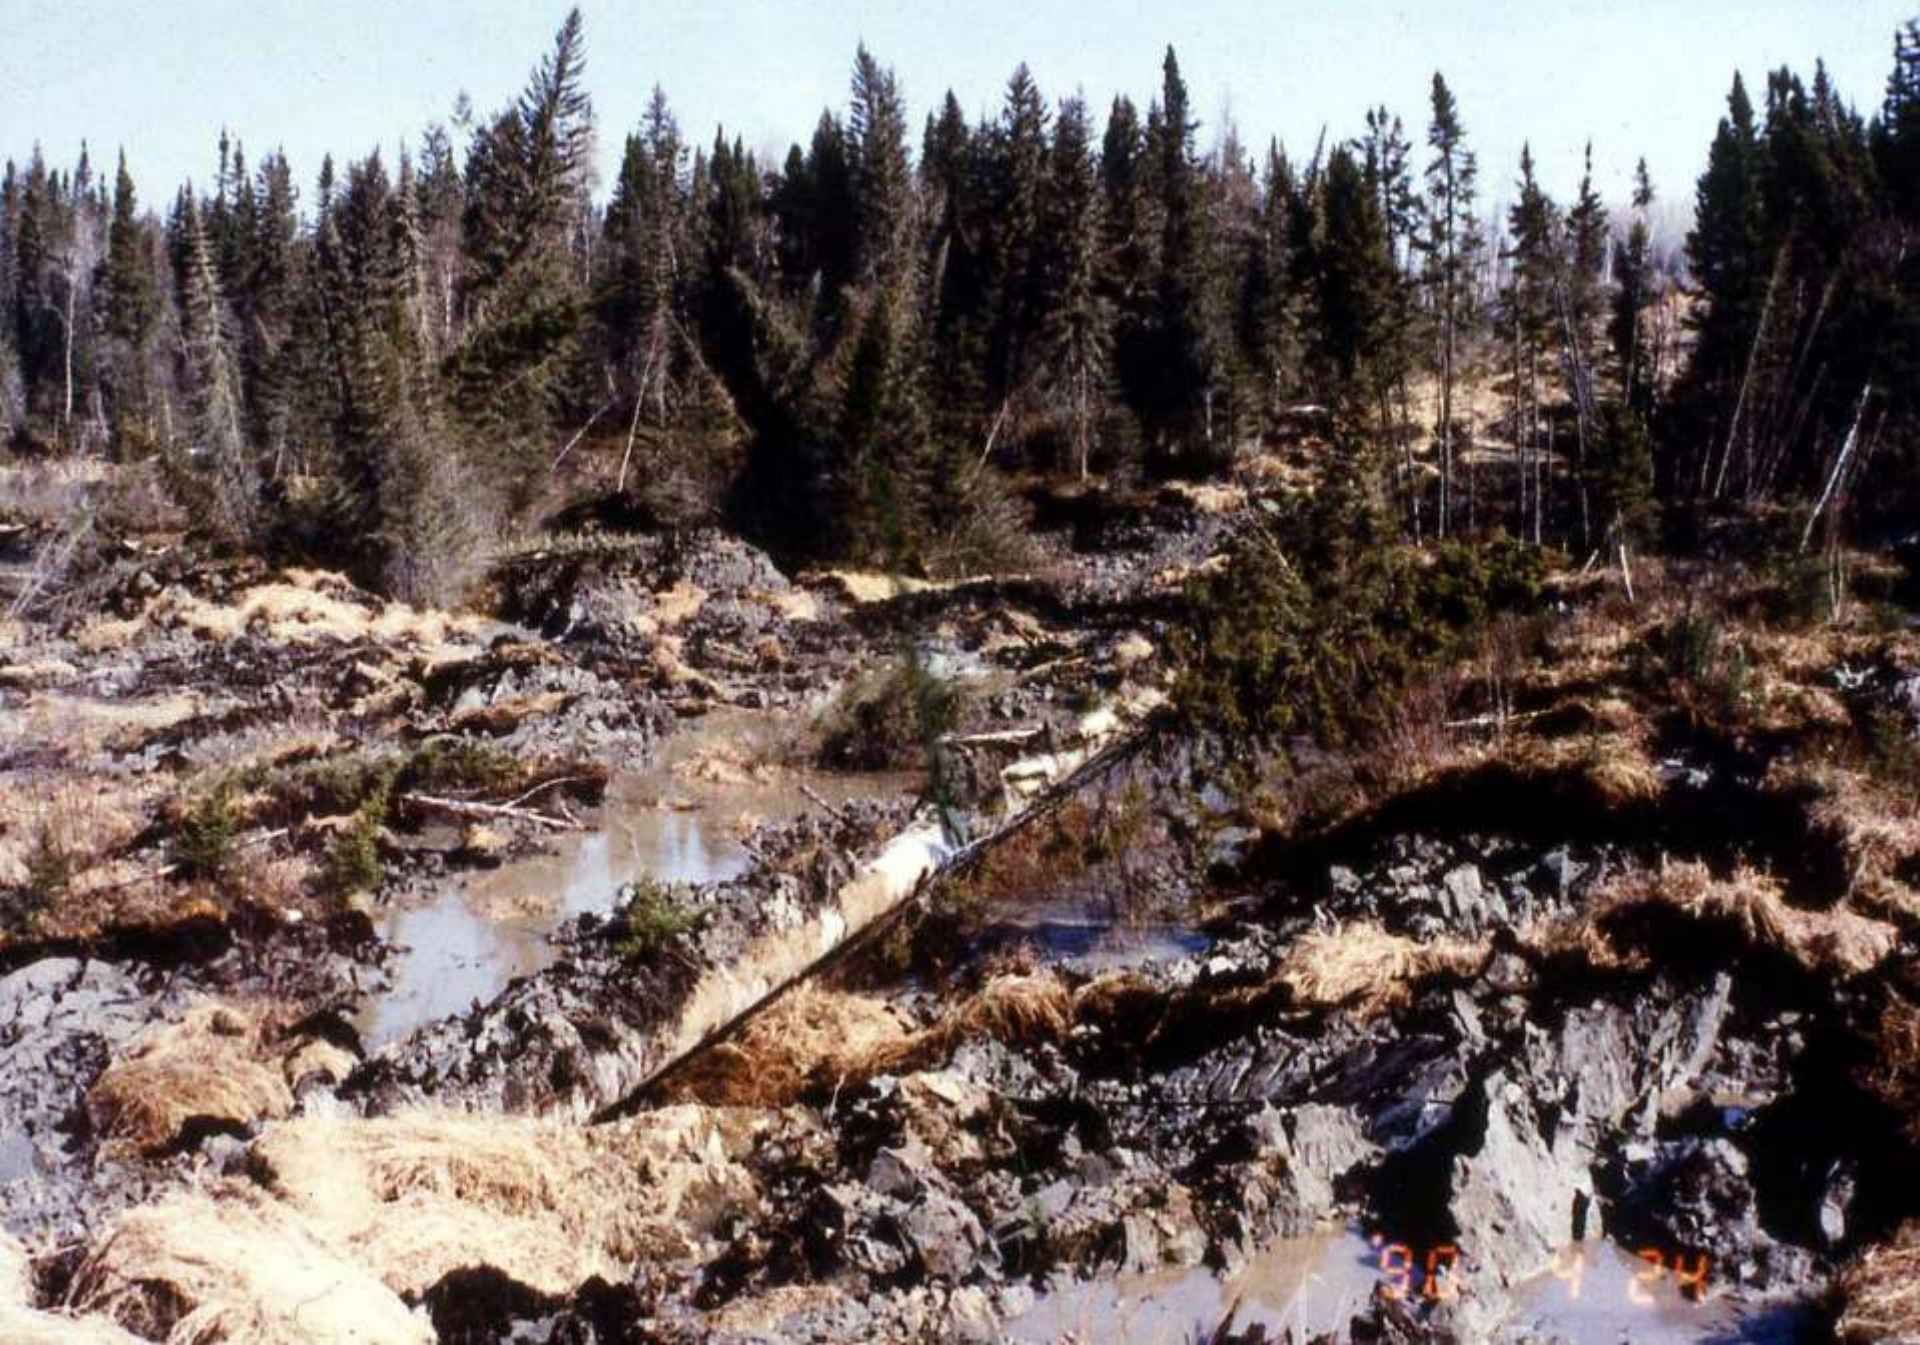
Figure 5: A day after the landslide (Adamson, 2015)

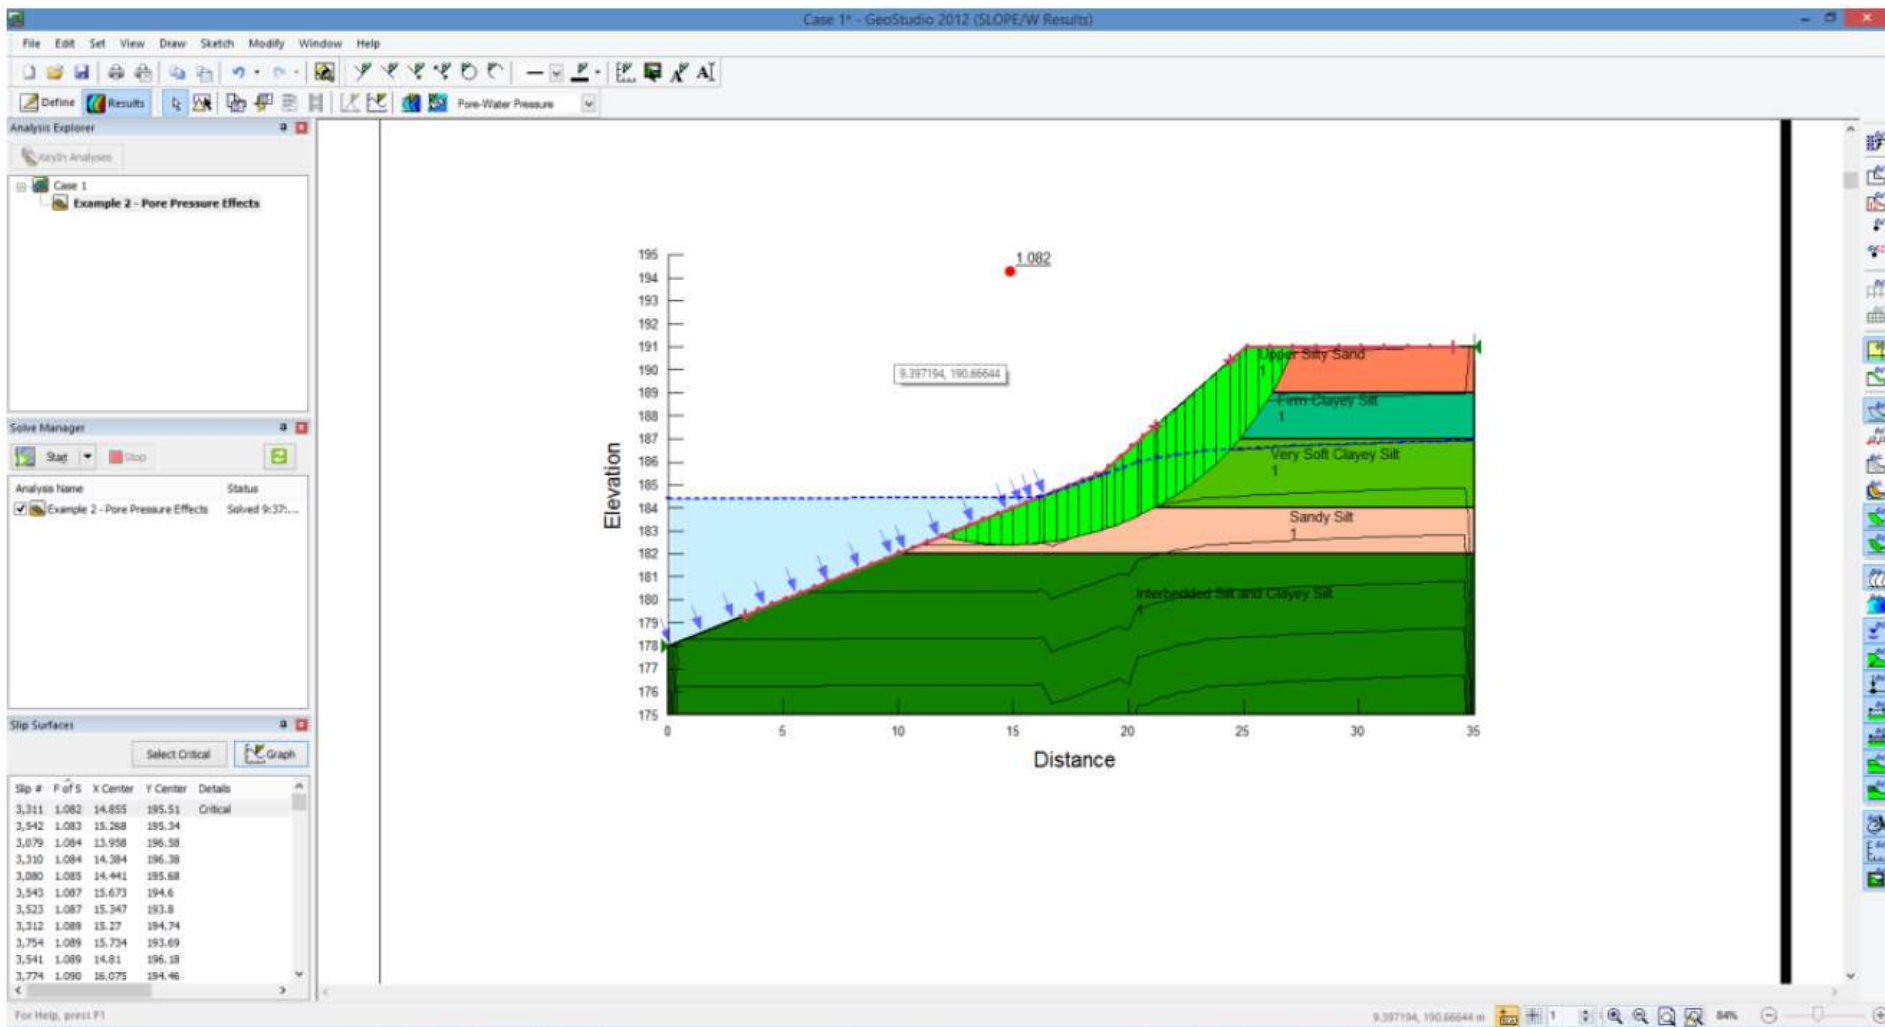
Figure A-1 : Case 1: Benchmark Case – average values, moderate ground water and river levels

| Case # | Parameter Changed | Change | Factor of Safety | Effect on FS |
|---|---|---|---|---|
| Case 1 | N/A | N/A | 1.082 | N/A |

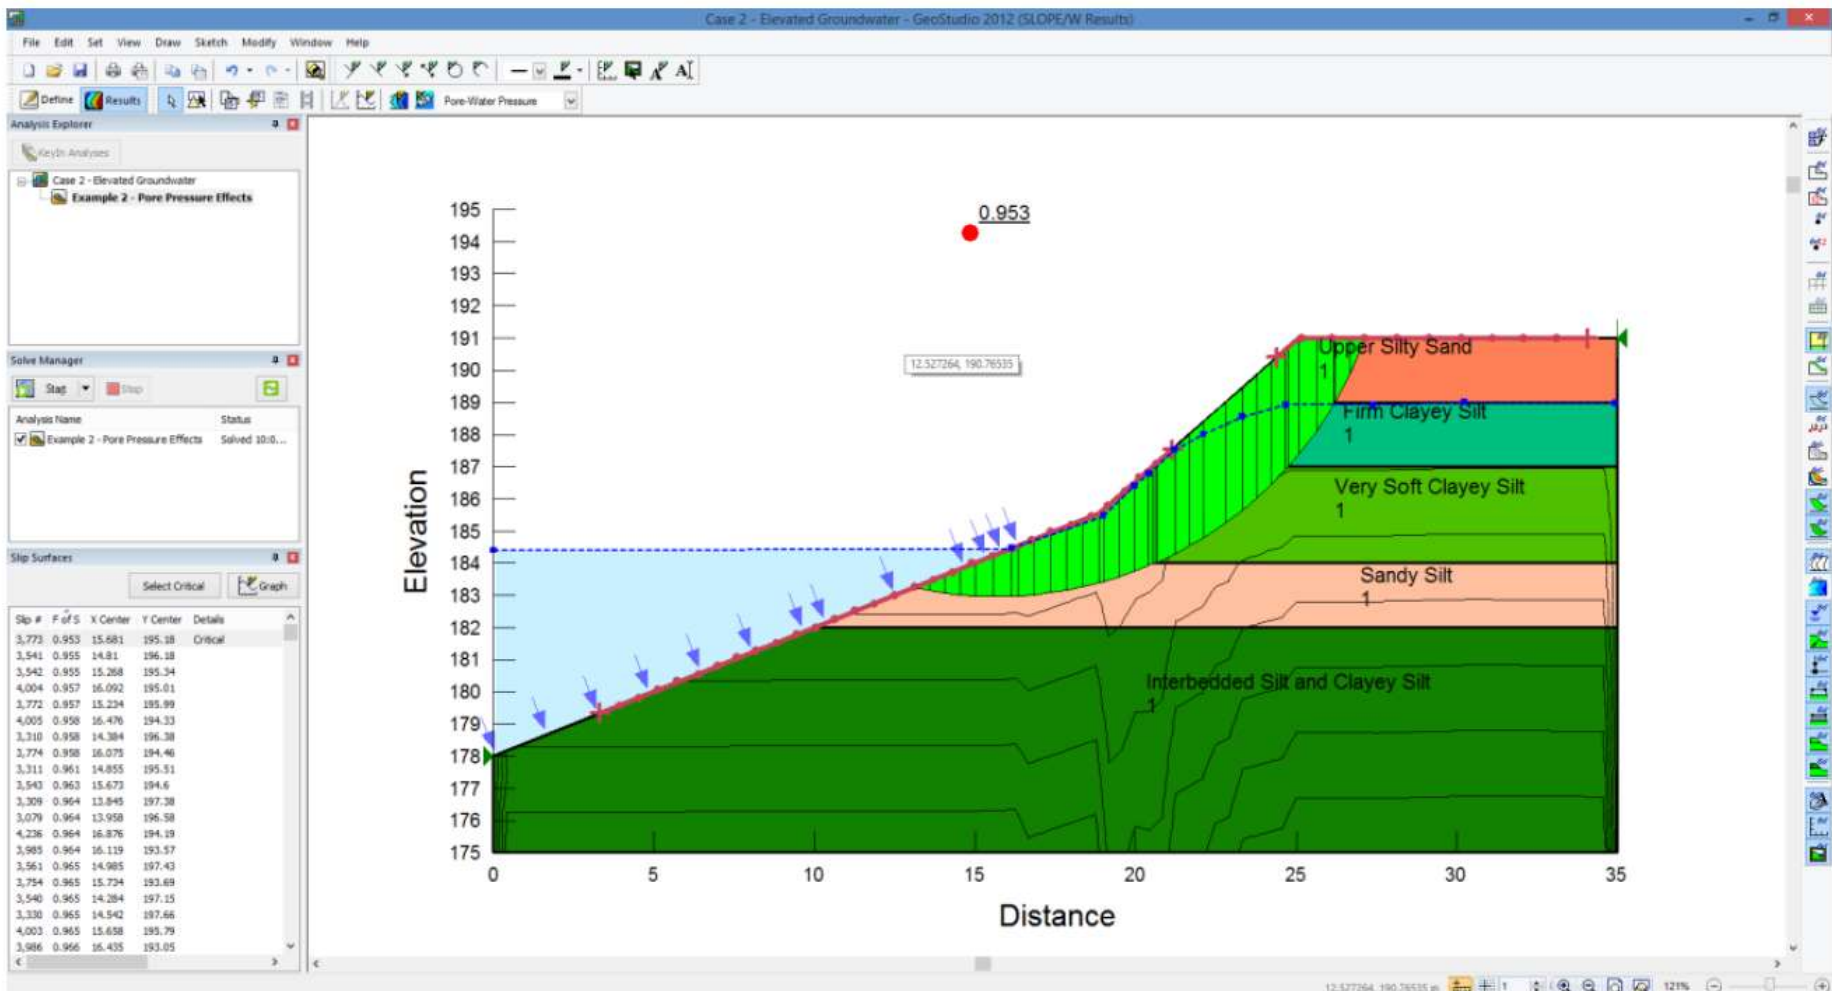
Figure A-2 : Case 2: Elevated Groundwater by 2 meters Figure

| Case # | Parameter Changed | Change | Factor of Safety | Effect on FS |
|---|---|---|---|---|
| Case 2 | Ground water | Elevated by 2 meters | 0.953 | - 0.129 |

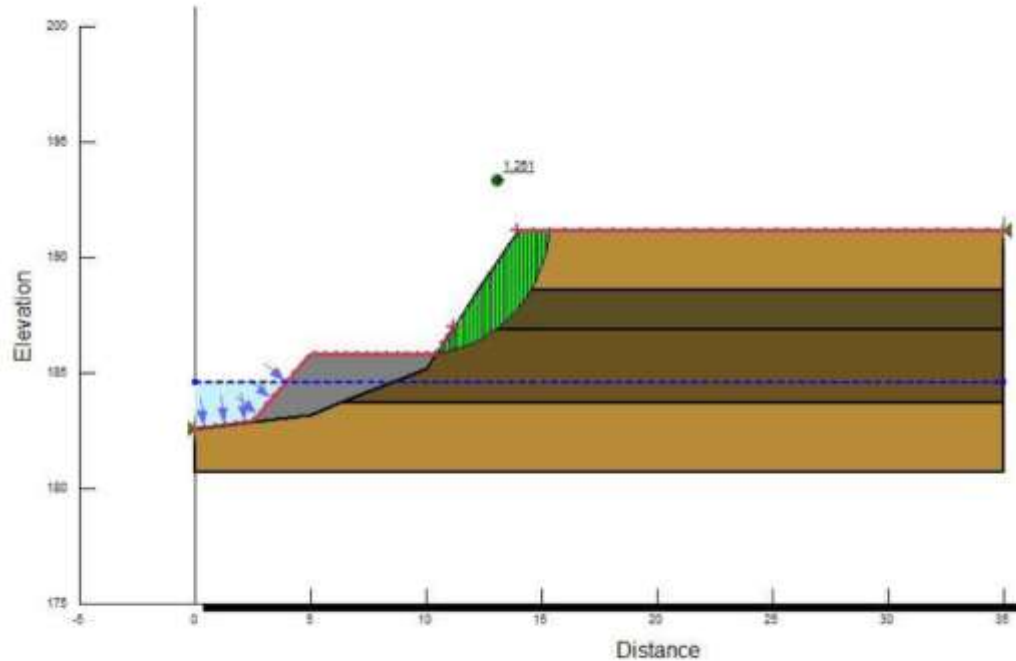
2.5m Sloped Gabion Wall, Slope Geometry 3:2

Figure A-16: Bishop's Simplified Nipigon River Slope Stability Analysis Case 16

- No tree harvesting in this landform without engineering study
- Flow reductions at the hydro dams should be timed to avoid rapid drawdown in river bank soils
- TransCanada Pipelines should drain water ponding on right of way
- A gabion baskets wall could prevent toe erosion and soil loss economically and environmentally

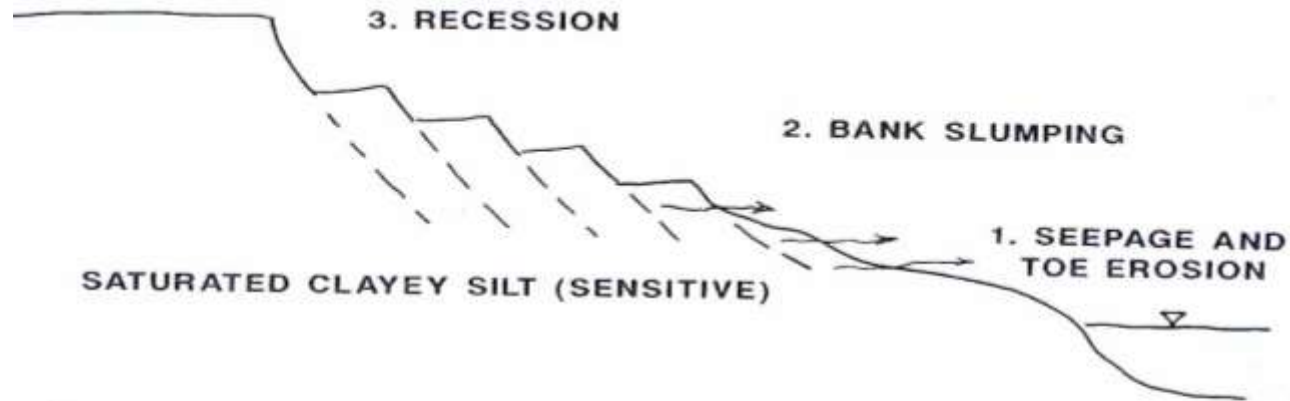
PROCESS OF FAILURE  
EROSION, LANDSLIDING AND SLOPE RECESSION  
(FROM TROW REPORT)

- The most critical slip circles are near the toe of the slope.
- The slide started as a small slip at the river bank and did not fail as a whole entity, but retrogressed uphill after initial failure occurred.
- The retrogression was due to high ground water level and sensitive soil deposits.
- The high ground water was due to warm weather, heavy rainfall, and timber harvesting operations.

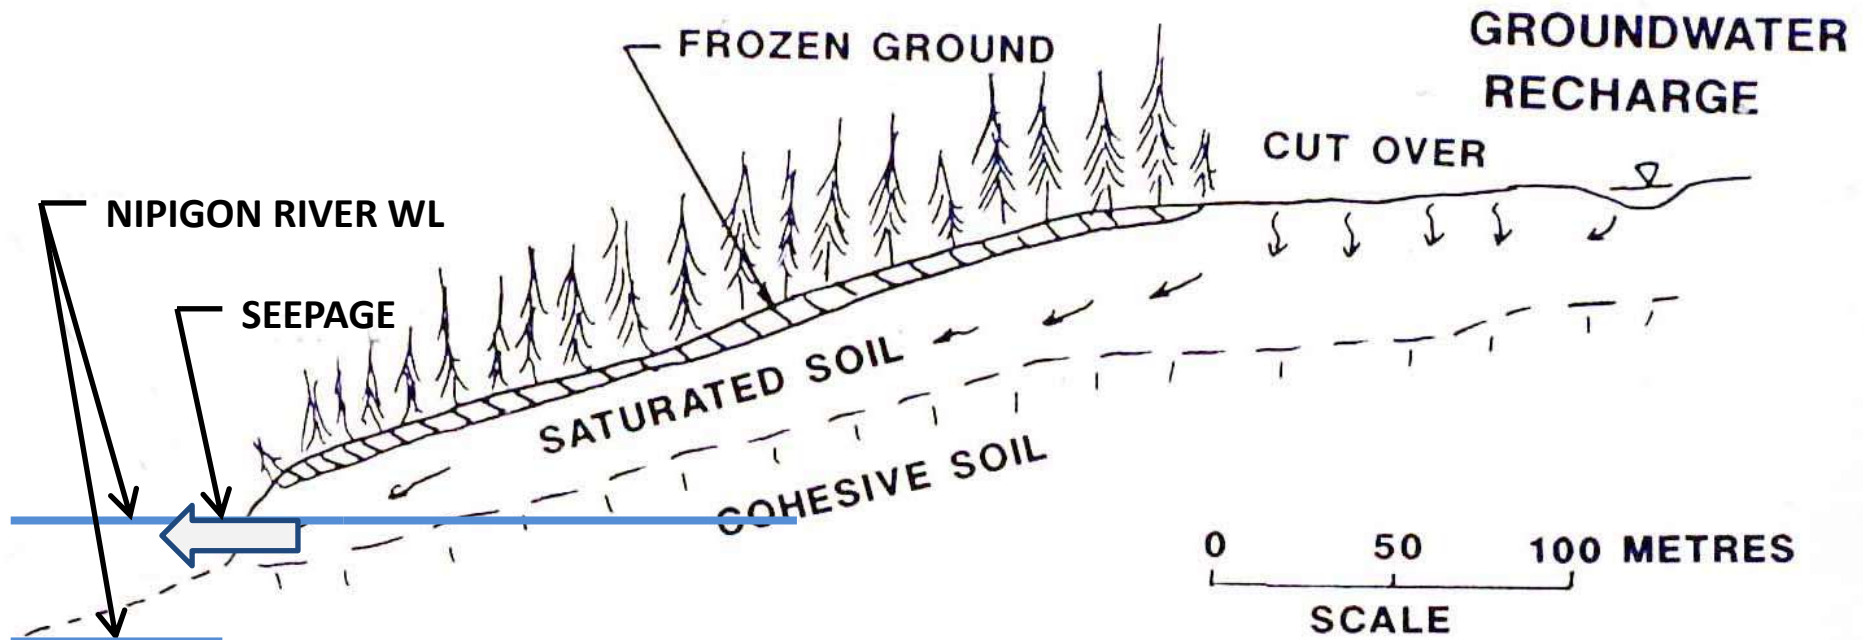
Factor of Safety with  
rapid drawdown = 0.83

POSSIBLE MODEL FOR SOIL SATURATION  
(SOURCE TROW REPORT)
