Rock Mass Behaviour during Excavation of China Jinping Underground Laboratories (CJPL-II) with Overburden of 2400 m

Xia-Ting Feng

Institute of Rock and Soil Mechanics
Chinese Academy of Sciences

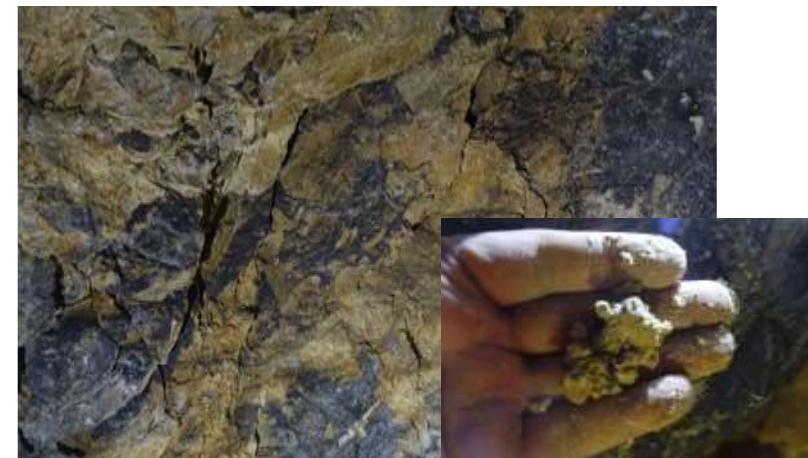
Rock altered into mud

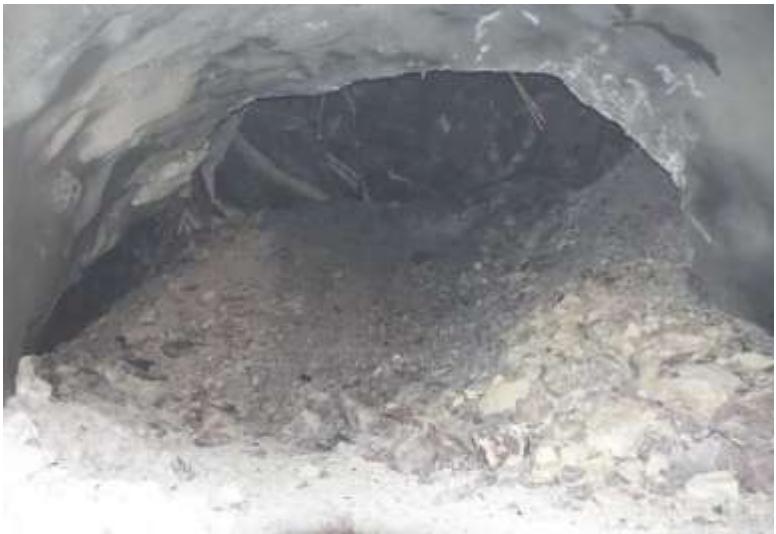
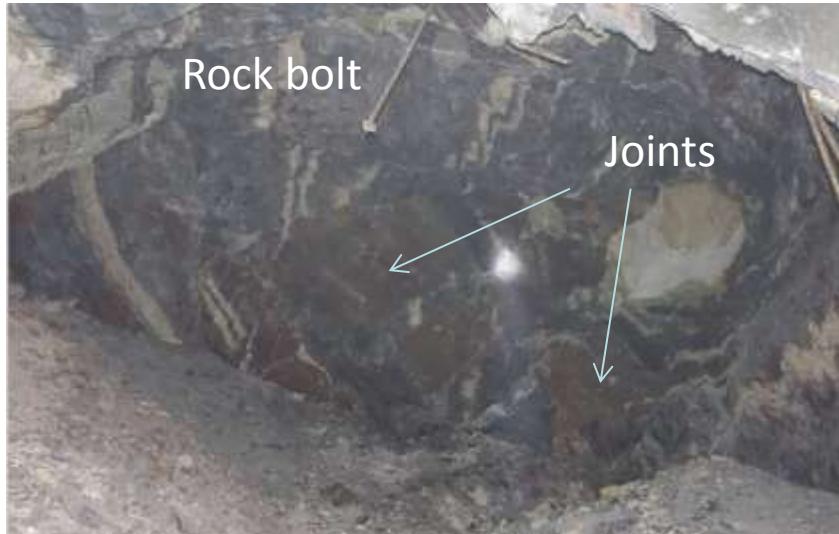
(1) Large scale collapse at roof in 3# Lab, 13 April, 2015, volume: 1000m³

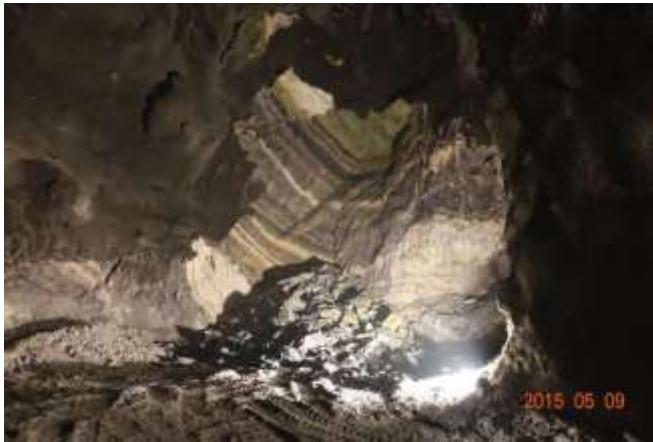
Recollapsed on 09 May, 2015 after support

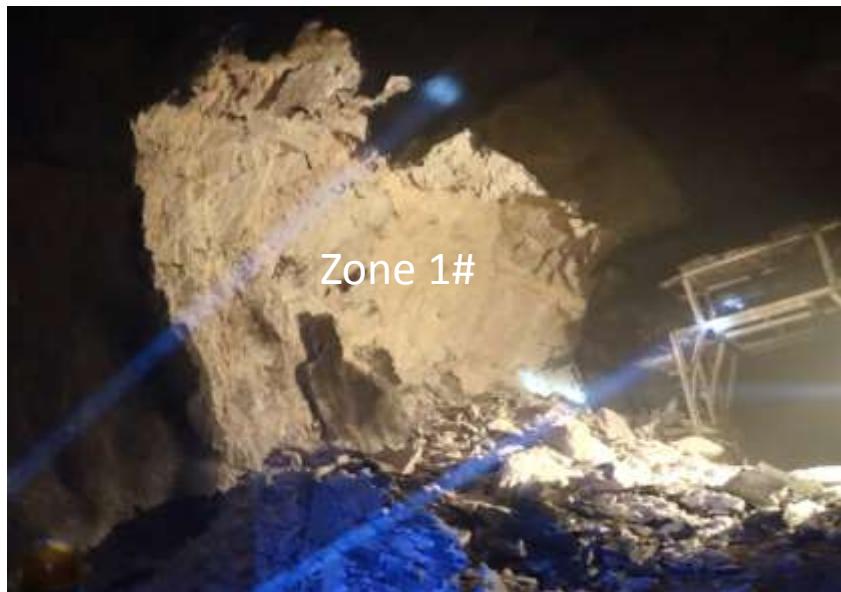
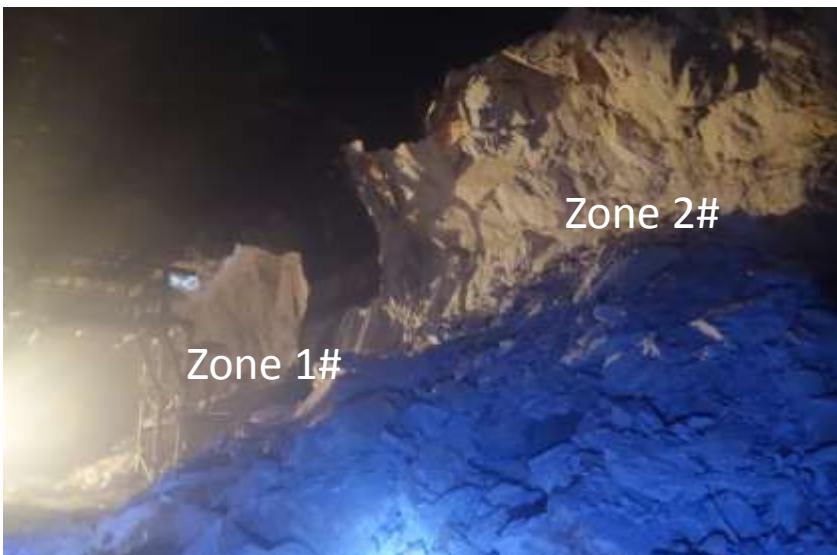
(2) Extremely intensive rockburst in 5# Lab, 23 April 2015

Micro seismic events

Two zones with length of 19 m and
10 m, depth of notch is 2-3m

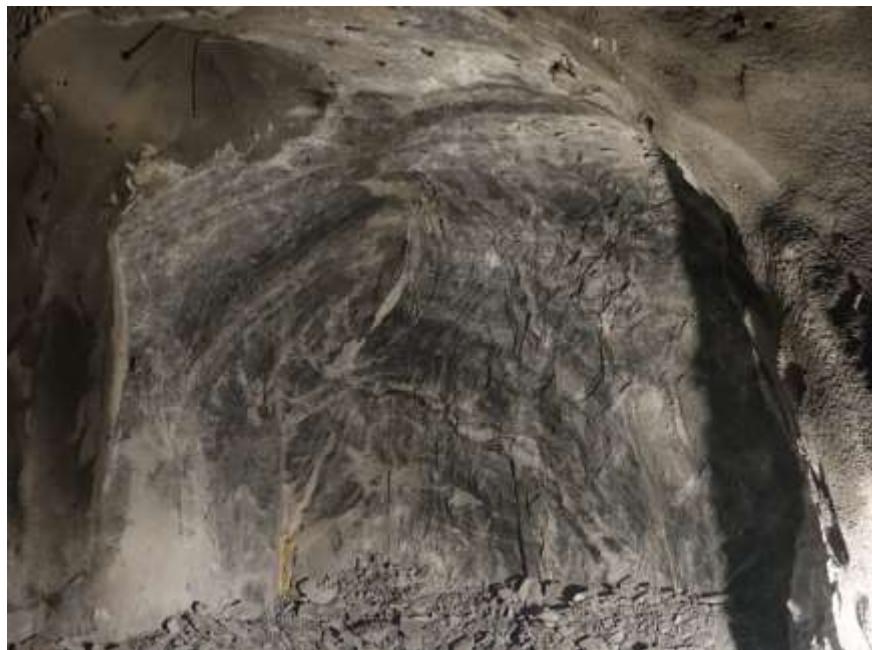
(3) Frequent rock spalling in 7# chamber

Tunnel face

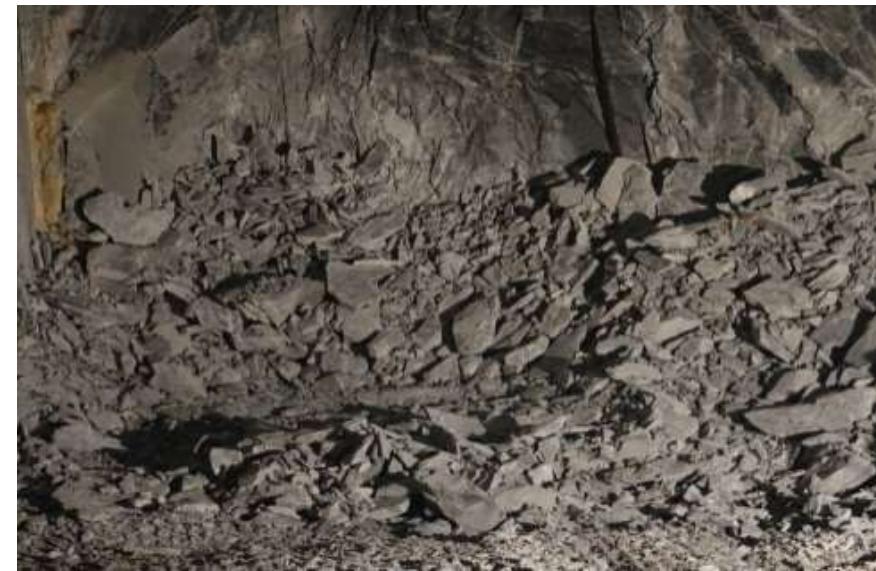
Flakelike rocks

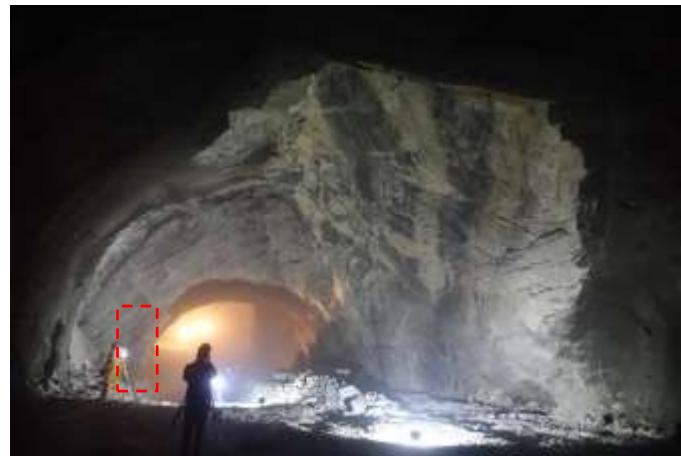
Rock slabbing after the slashing excavation of side walls of the 7# Lab

Southwest sidewall

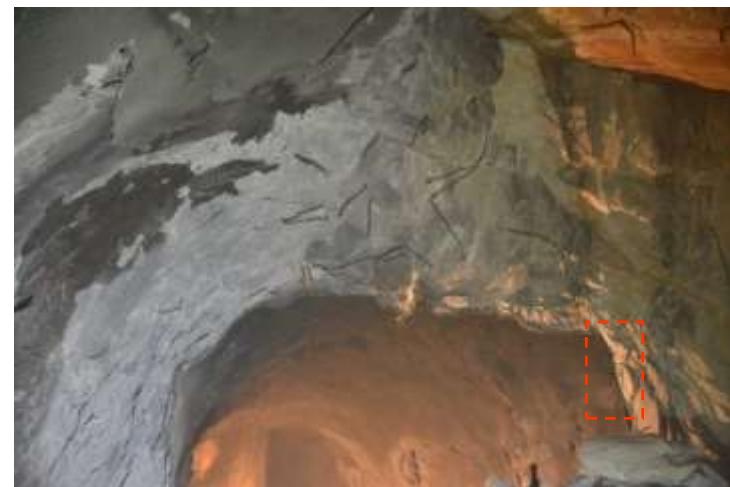
Northeast sidewall

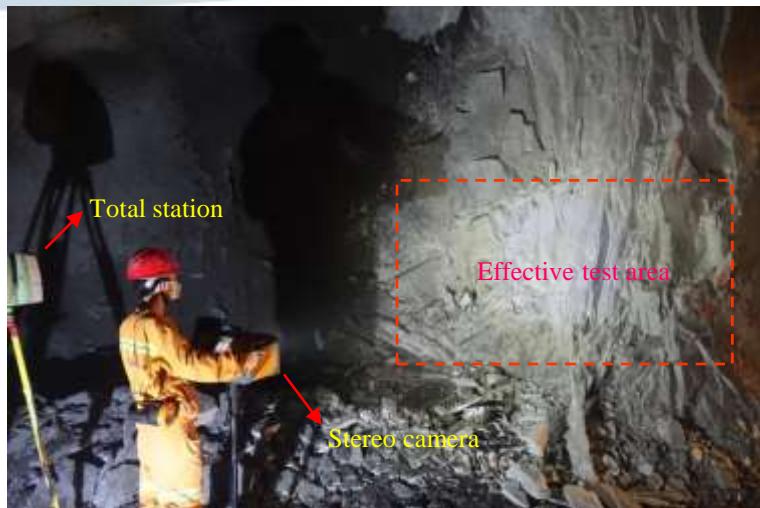
Test of non-contact measurement technology

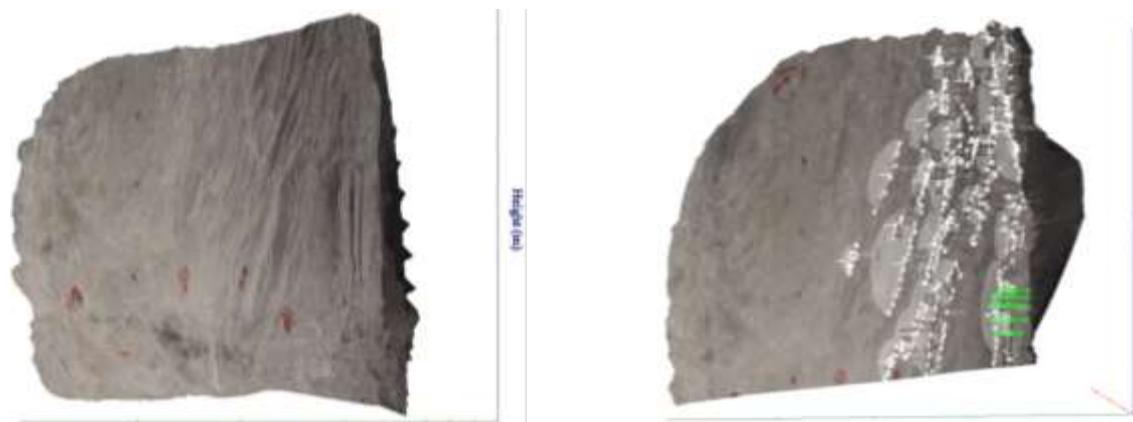
3D images of rock surfaces after identifying slabbing characteristics
