# **Cavern and Tunnel Failures due to Adverse Structural Geology and Inadequate-in-the-Circumstances Support Designs**

**N. Barton**

NB&A, Oslo, Norway

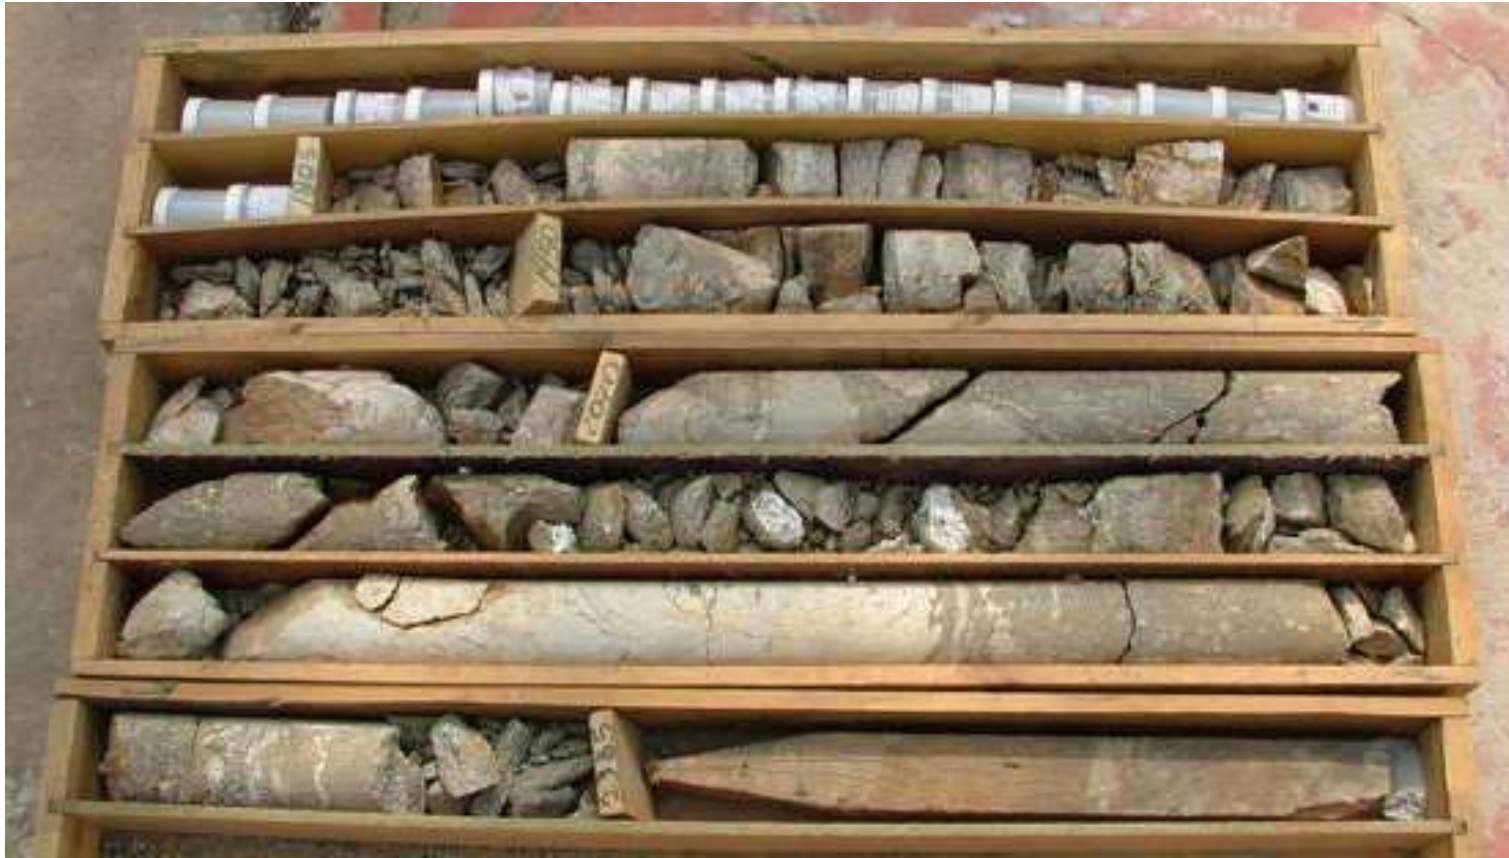
**Borehole SM-8704  
drilled near centre of  
(future) station cavern.**

**Rock was encountered at  
18 m depth, at elevation  
706m. This is 3 m above  
the cavern roof.**

**Low rock cover was  
'confirmed' – almost the  
same as the mean of the  
five nearest holes.**

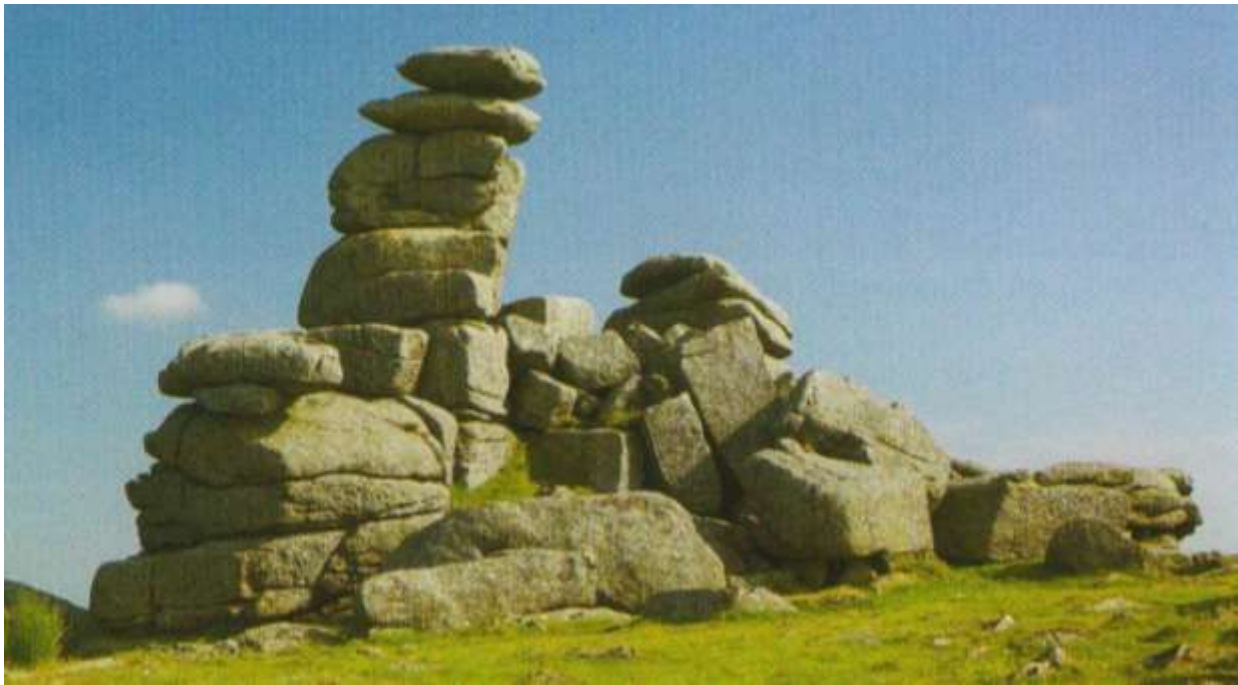
**‘Tors’ from Dartmoor, S.W.  
England. Previously  
surrounded by saprolite and  
soil and sand**

**The sub-surface in areas of  
deeply-weathered granite,  
gneiss, limestone, etc. must  
be extremely ‘rough’  
beneath the smooth soil  
cover.**

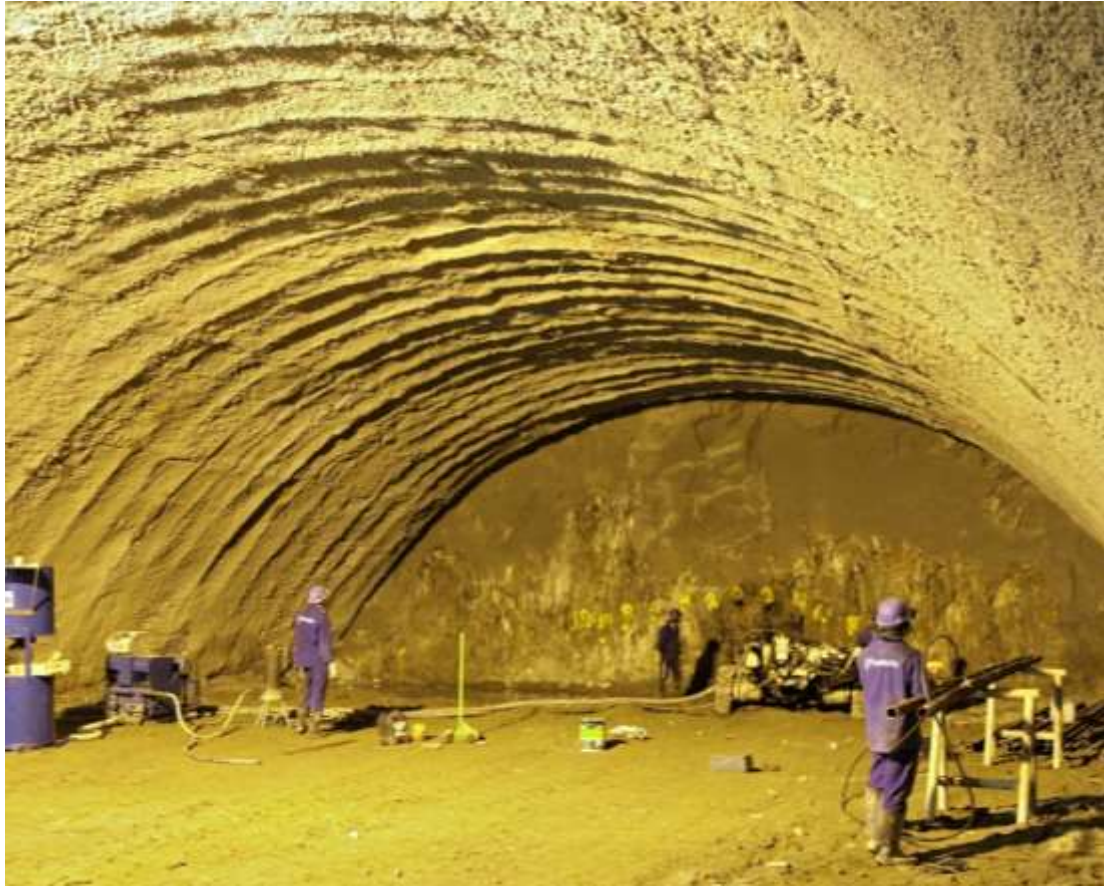
**NO BOLTS IN THIS CASE DUE TO ASSUMED LOW COVER, AND FRAGMENTED WEATHERED ROCK. BUT  $S(fr) \approx 40$  to 50 cm**

**LOOKS ROBUST – BUT WHAT IF POOR CONTACT WITH OVER-BREAK, AND NON-UNIFORM LOADING DUE TO A WEAK CONCEALED STRUCTURE?**

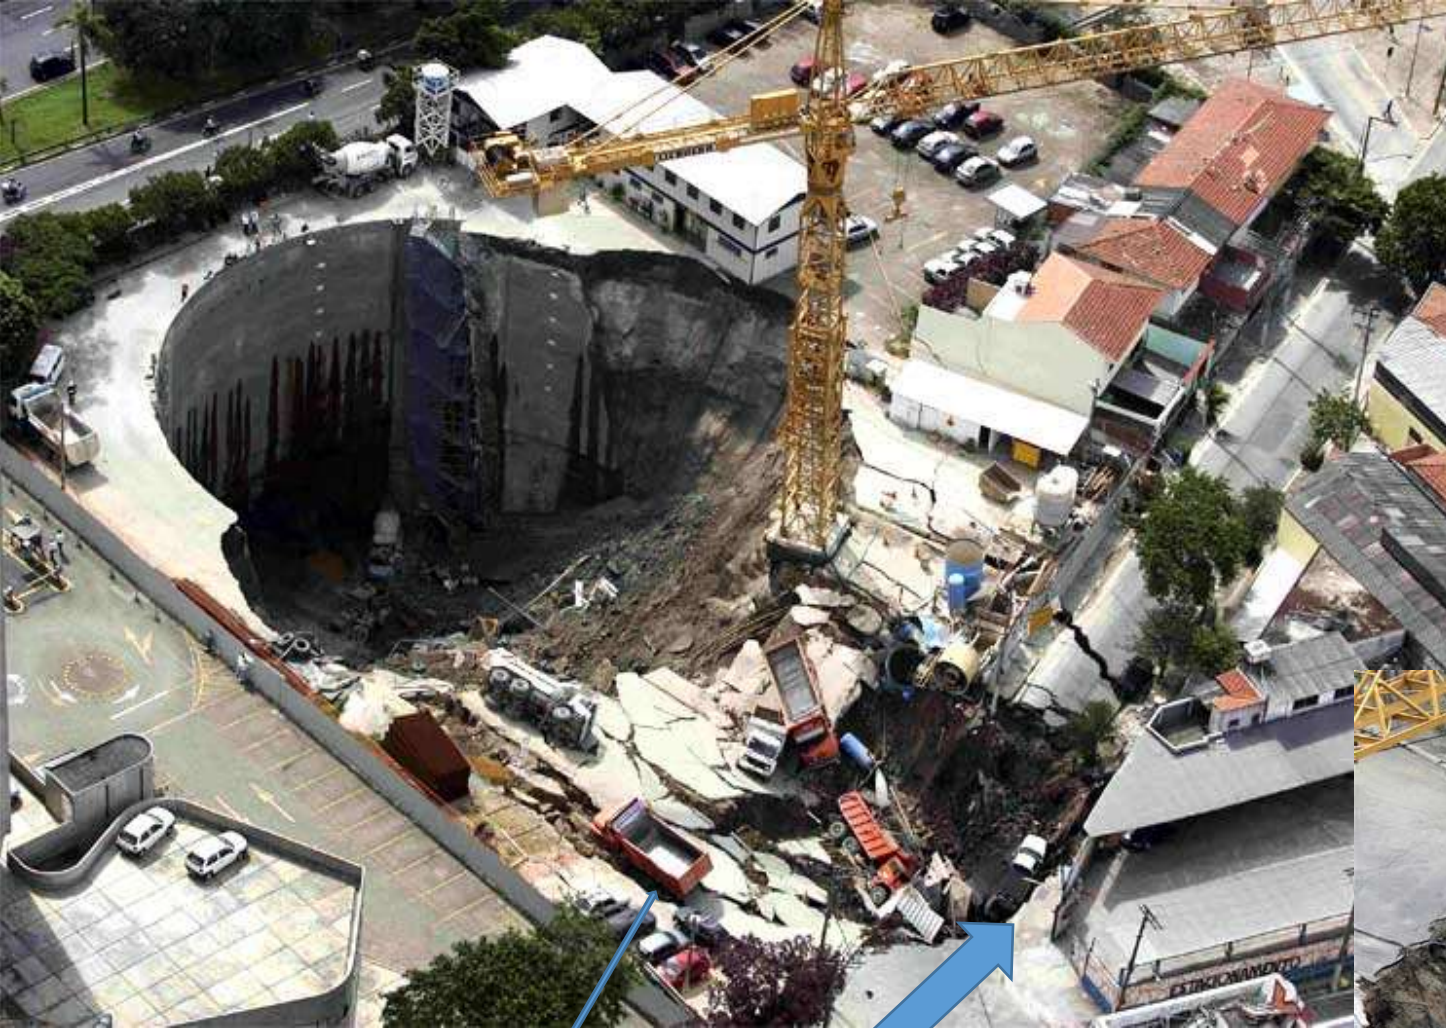
January 2007 collapse.  
Collapse so sudden that  
pedestrians and minibus  
sucked into void. (Seven die)  
Thin arrows mark same  
truck

The smooth  
discontinuity  
marking the limit  
of the collapse

Discontinuity  
marking 'end'  
of collapse:  
**Very low JRC**  
**(ALSO WATER)**

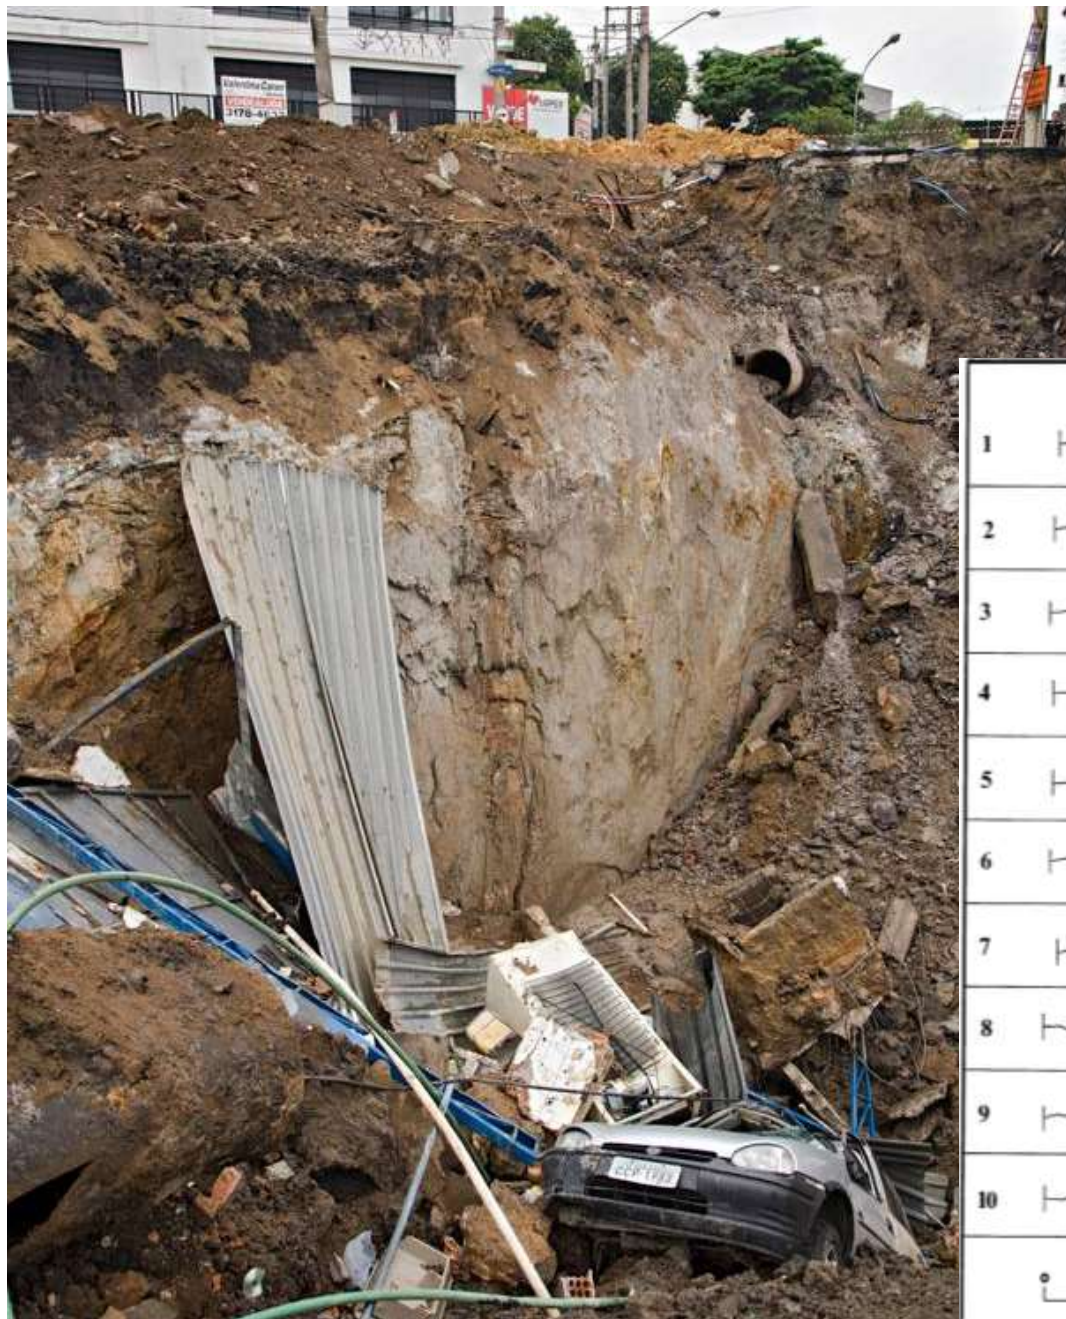
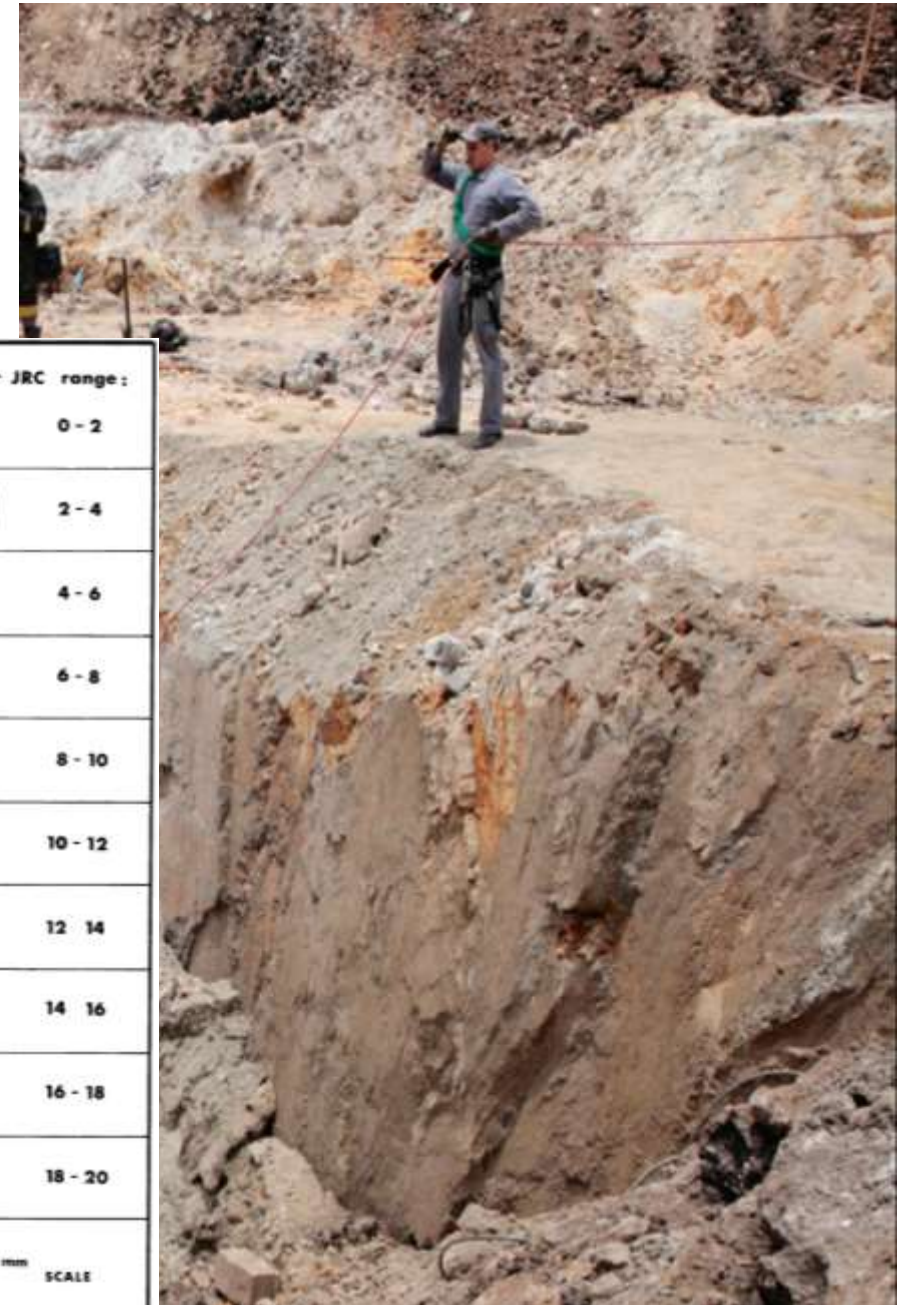
After many months of excavation – discover folded 25 x 25 x 32 mm lattice-girders (and grouting tubes).  
Note 40-50 cm of S(fr) lower-left.

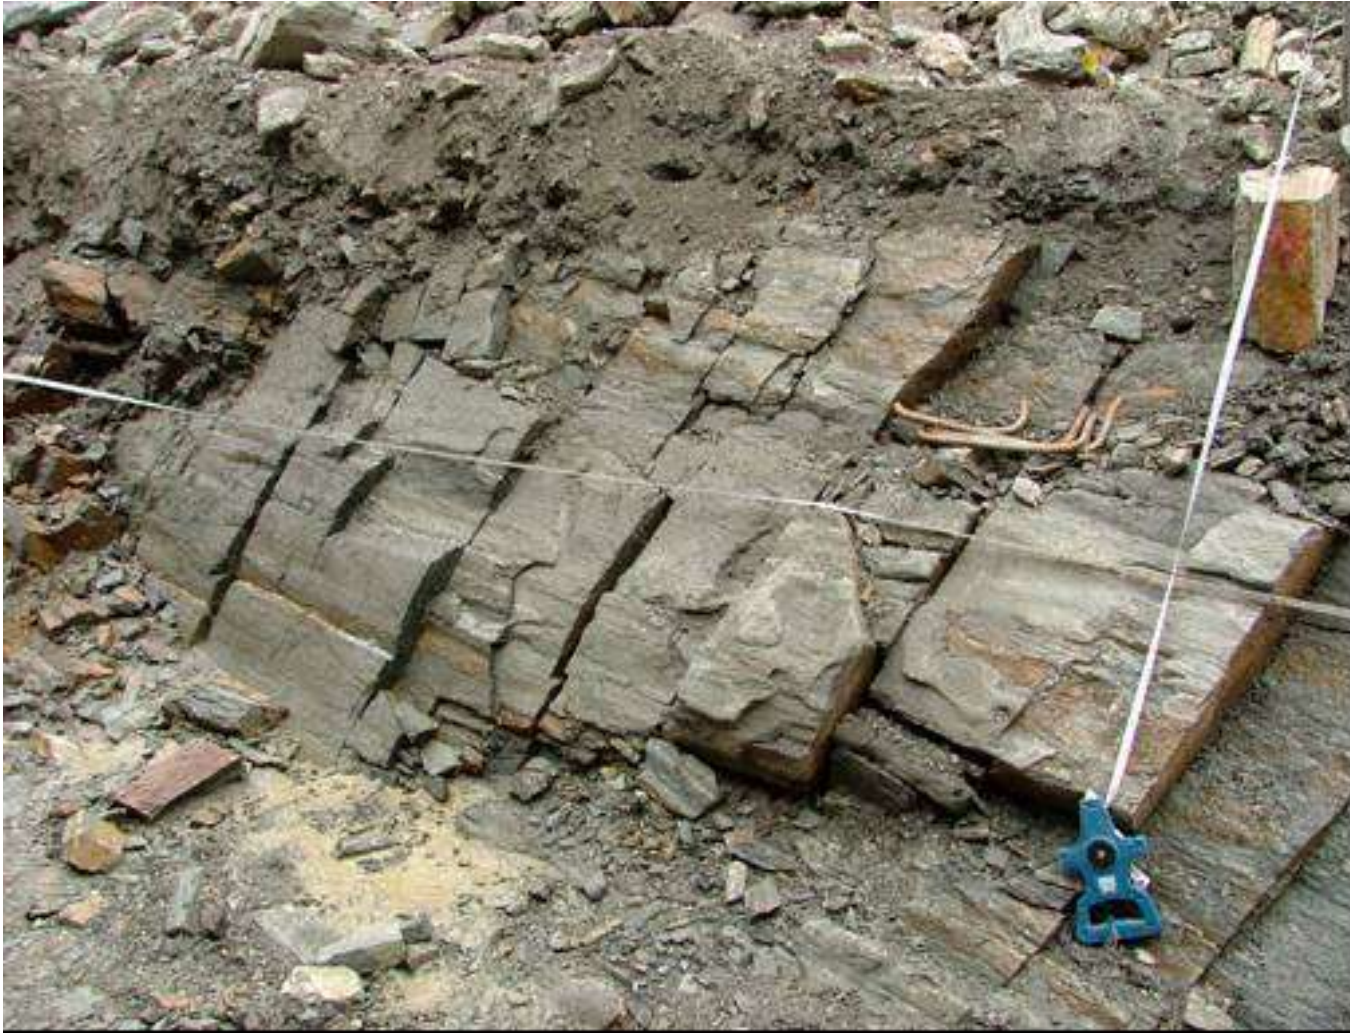
- Smooth, weathered, curved, top-of-ridge-of-rock,  $L > 30$  m.
- This jointed gneiss has fallen 8 to 10 m, but has remained like loosened 'pack-of-cards'.

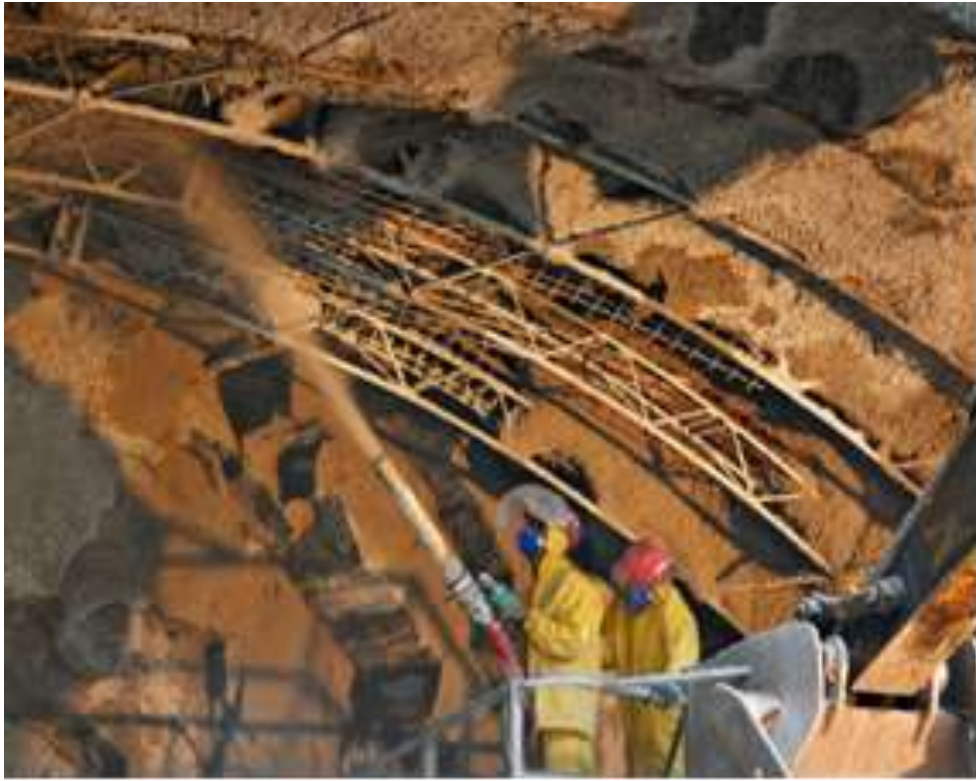
**ADEQUATE CONTACT WITH  
THE ROCK? (IT IS NOT EASY)**

**ADEQUATE FOOTING STIFFNESS?  
ADEQUATE RESISTANCE WHEN  
'POINT' LOADED? OWN  
DEFORMABILITY? ACTUALLY A  
VERY 'SOFT' SYSTEM, THEREFORE  
CAN BE UNSAFE WHEN WAITING  
FOR THE LINING.**

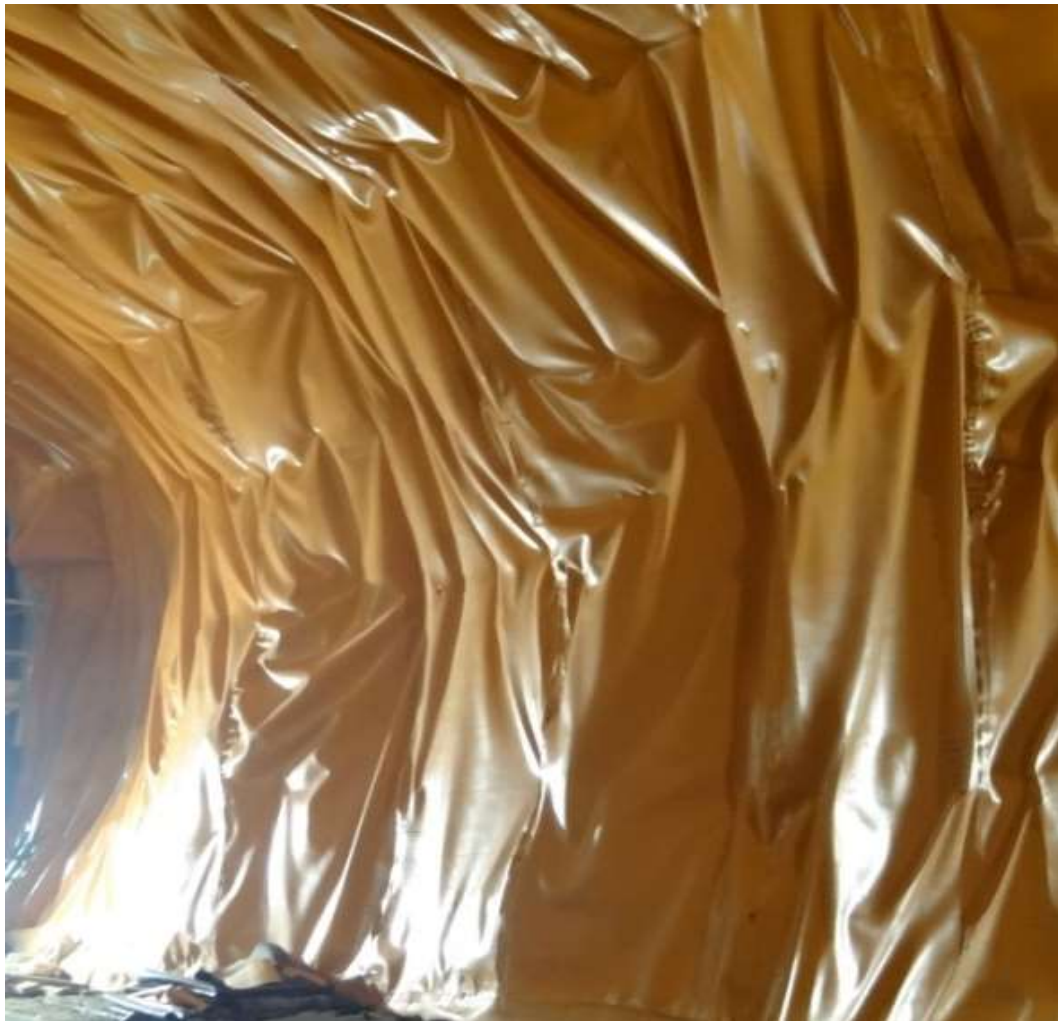
**The water-proof membrane phase. Difficult if over-break.**

**Approximately 12 to 15 km of membrane welds per 1 km of tunnel.**  
(Like garden swimming pool REPAIR).

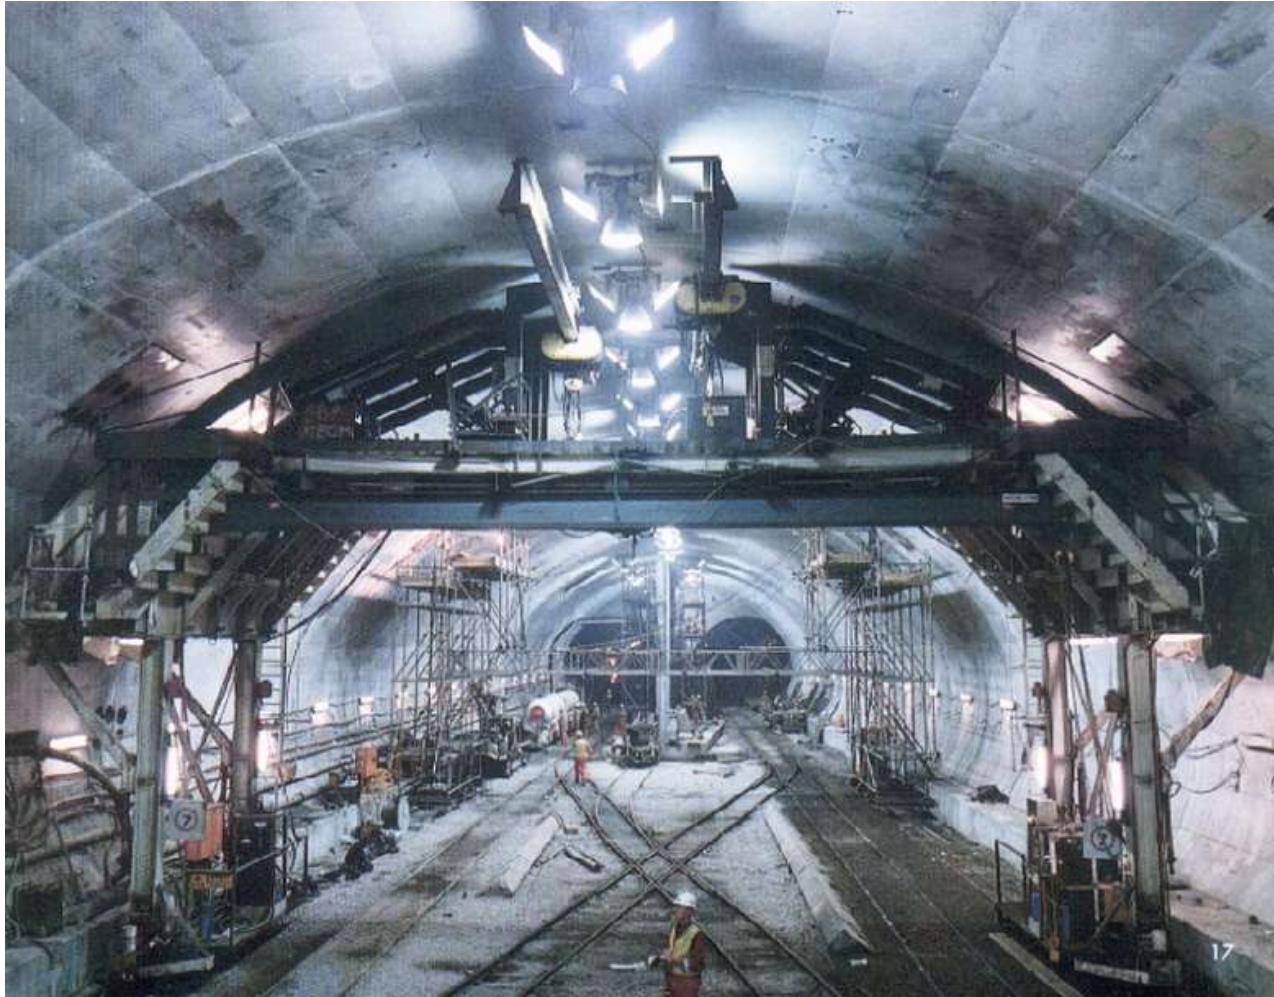
An earlier (temporary support) phase of the same project.....not very convincing level of safety. Note mesh and lattice-girder.

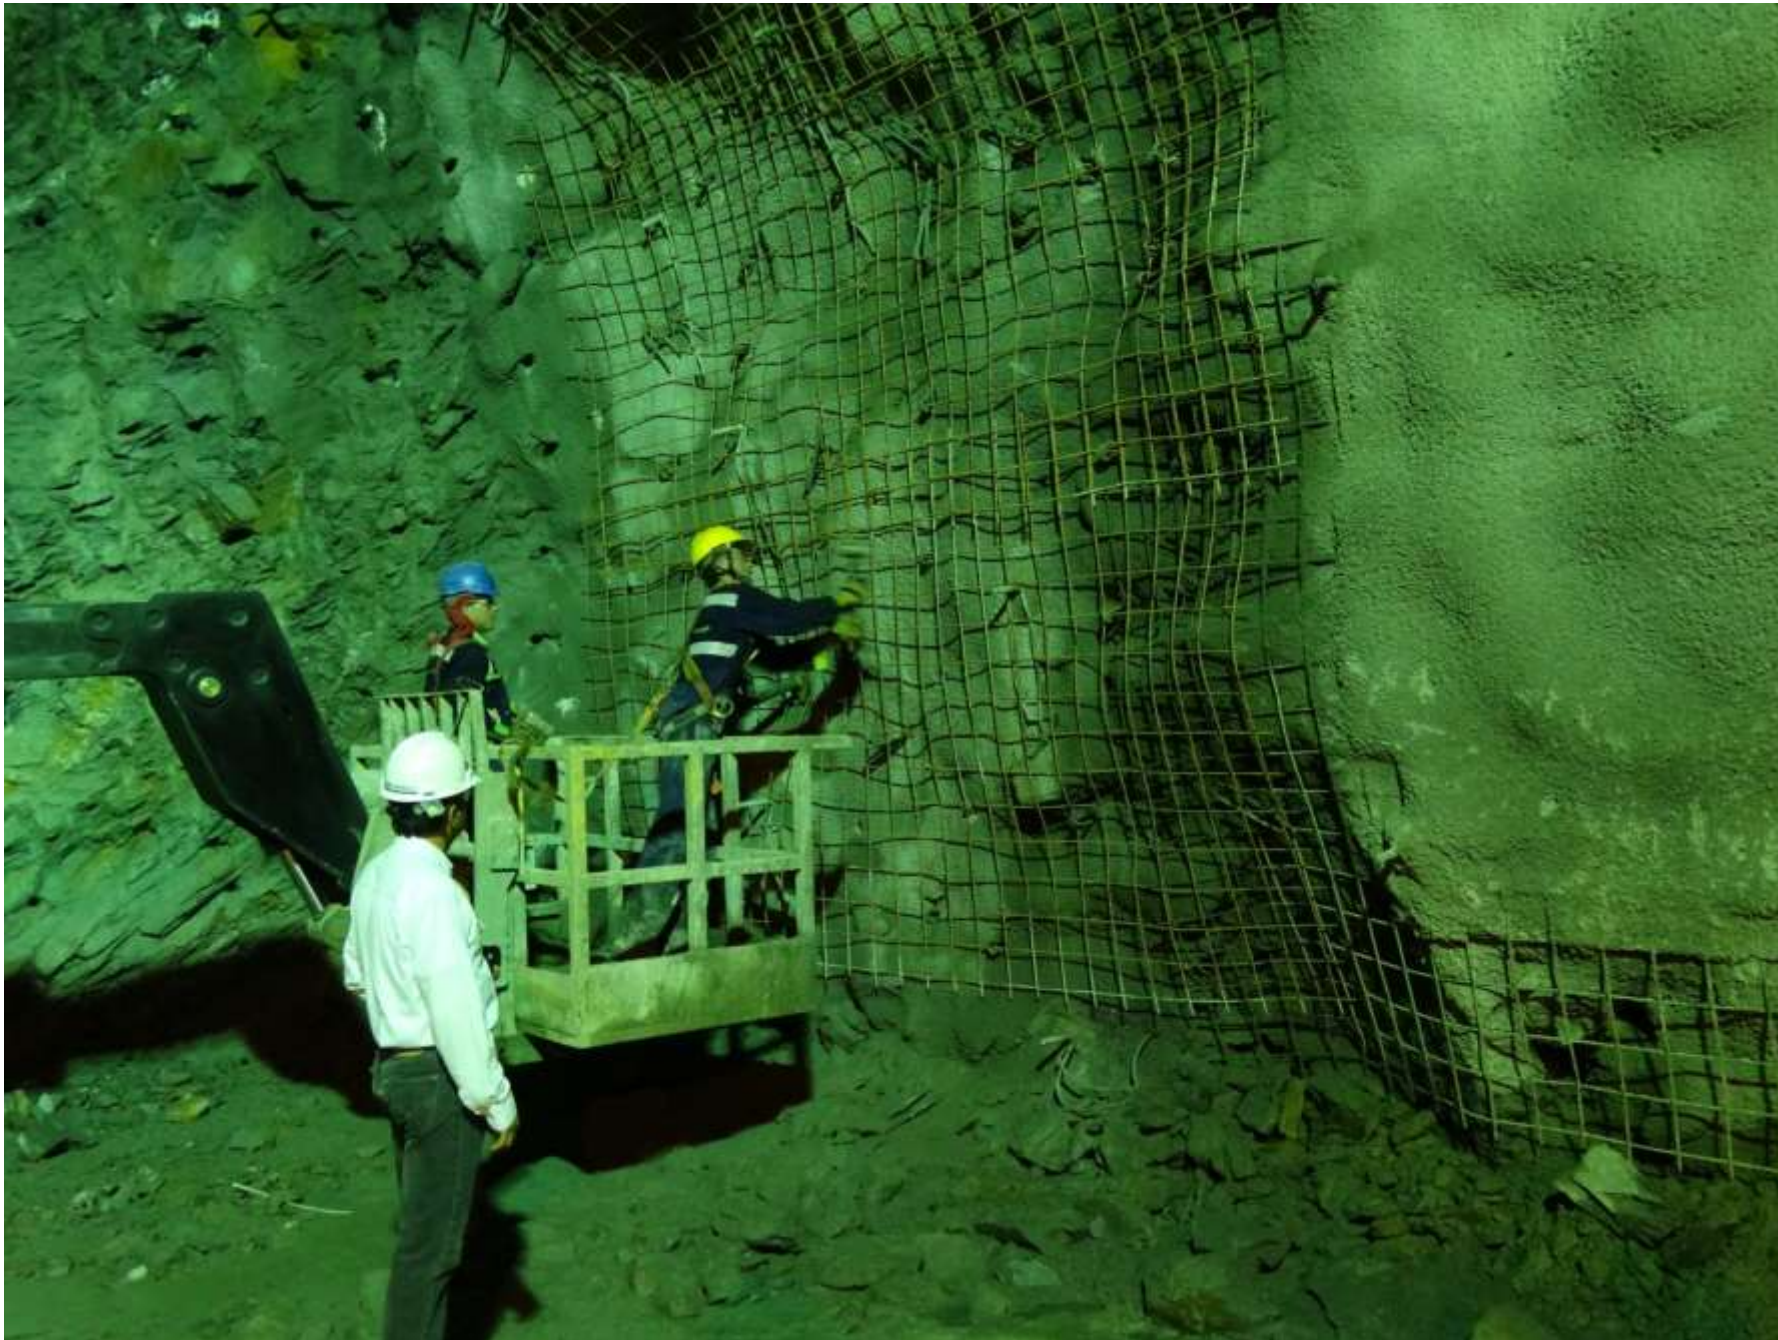
- The old-fashioned method of temporary support S(mr) which is still recommended in NATM. (A deliberately chosen example showing 'shadow' problems)

**Do not use  
S(mr), especially  
not where there  
is over-break!**

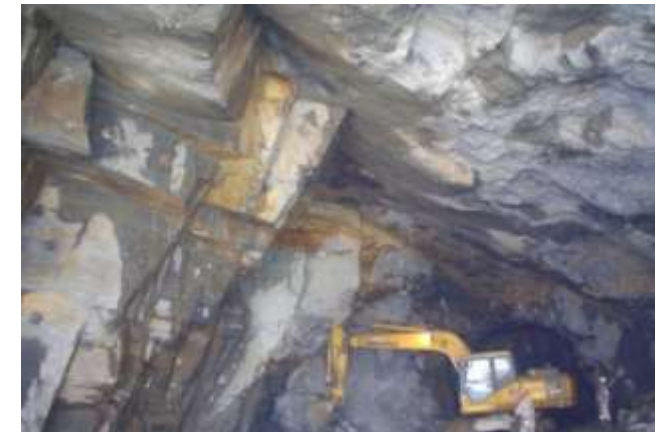
IF

$$J_n/J_r \geq 6$$

(DESPITE FOUR JOINT SETS, TOO MUCH ROUGHNESS AND DILATION)

In photos:

$$J_n/J_r = 9/1.5$$

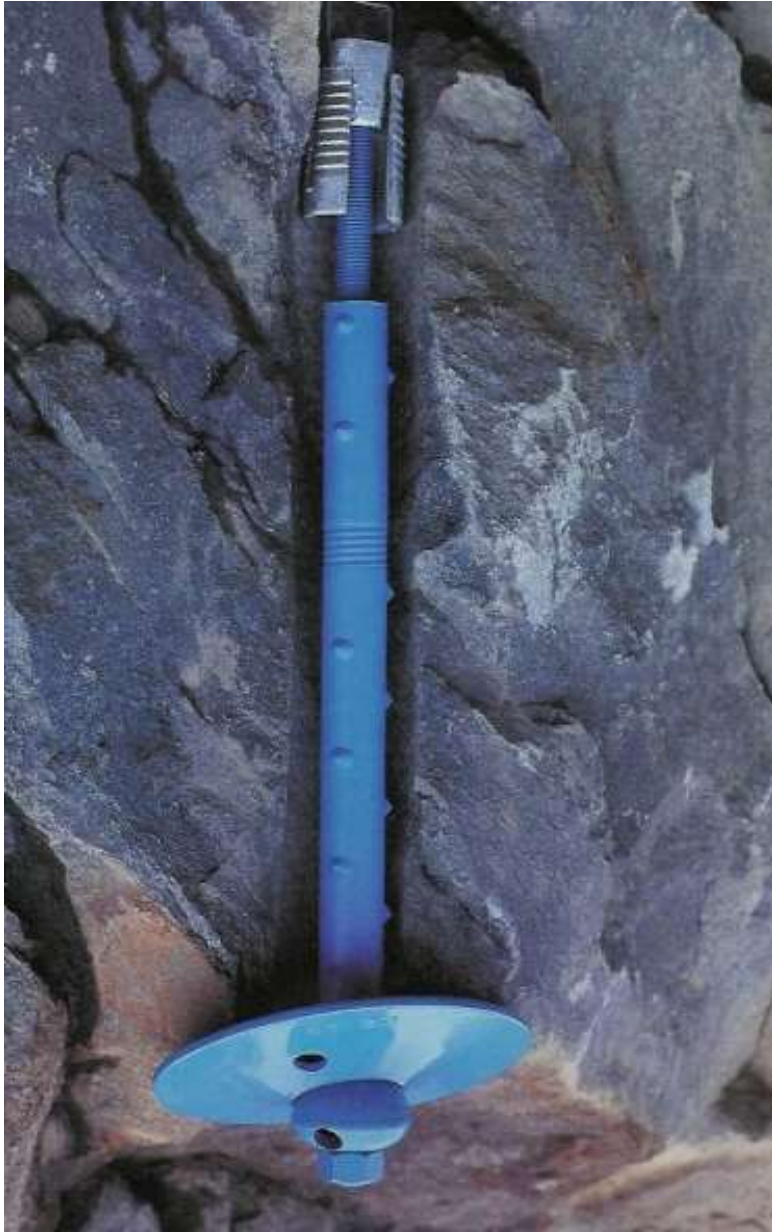
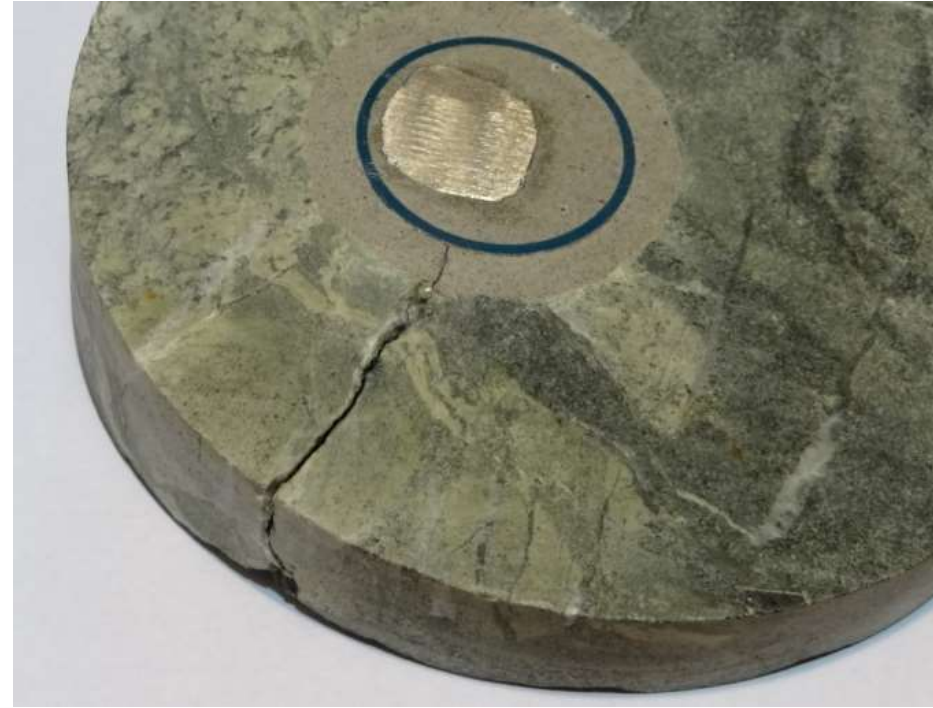
**Principles of CT bolt: Right: Joint/crack deformation next to the bolt *does not initiate* a potential process of corrosion, which it might in the case of a conventional bolt without the PVC sleeve. 4-layers of protection remain.**

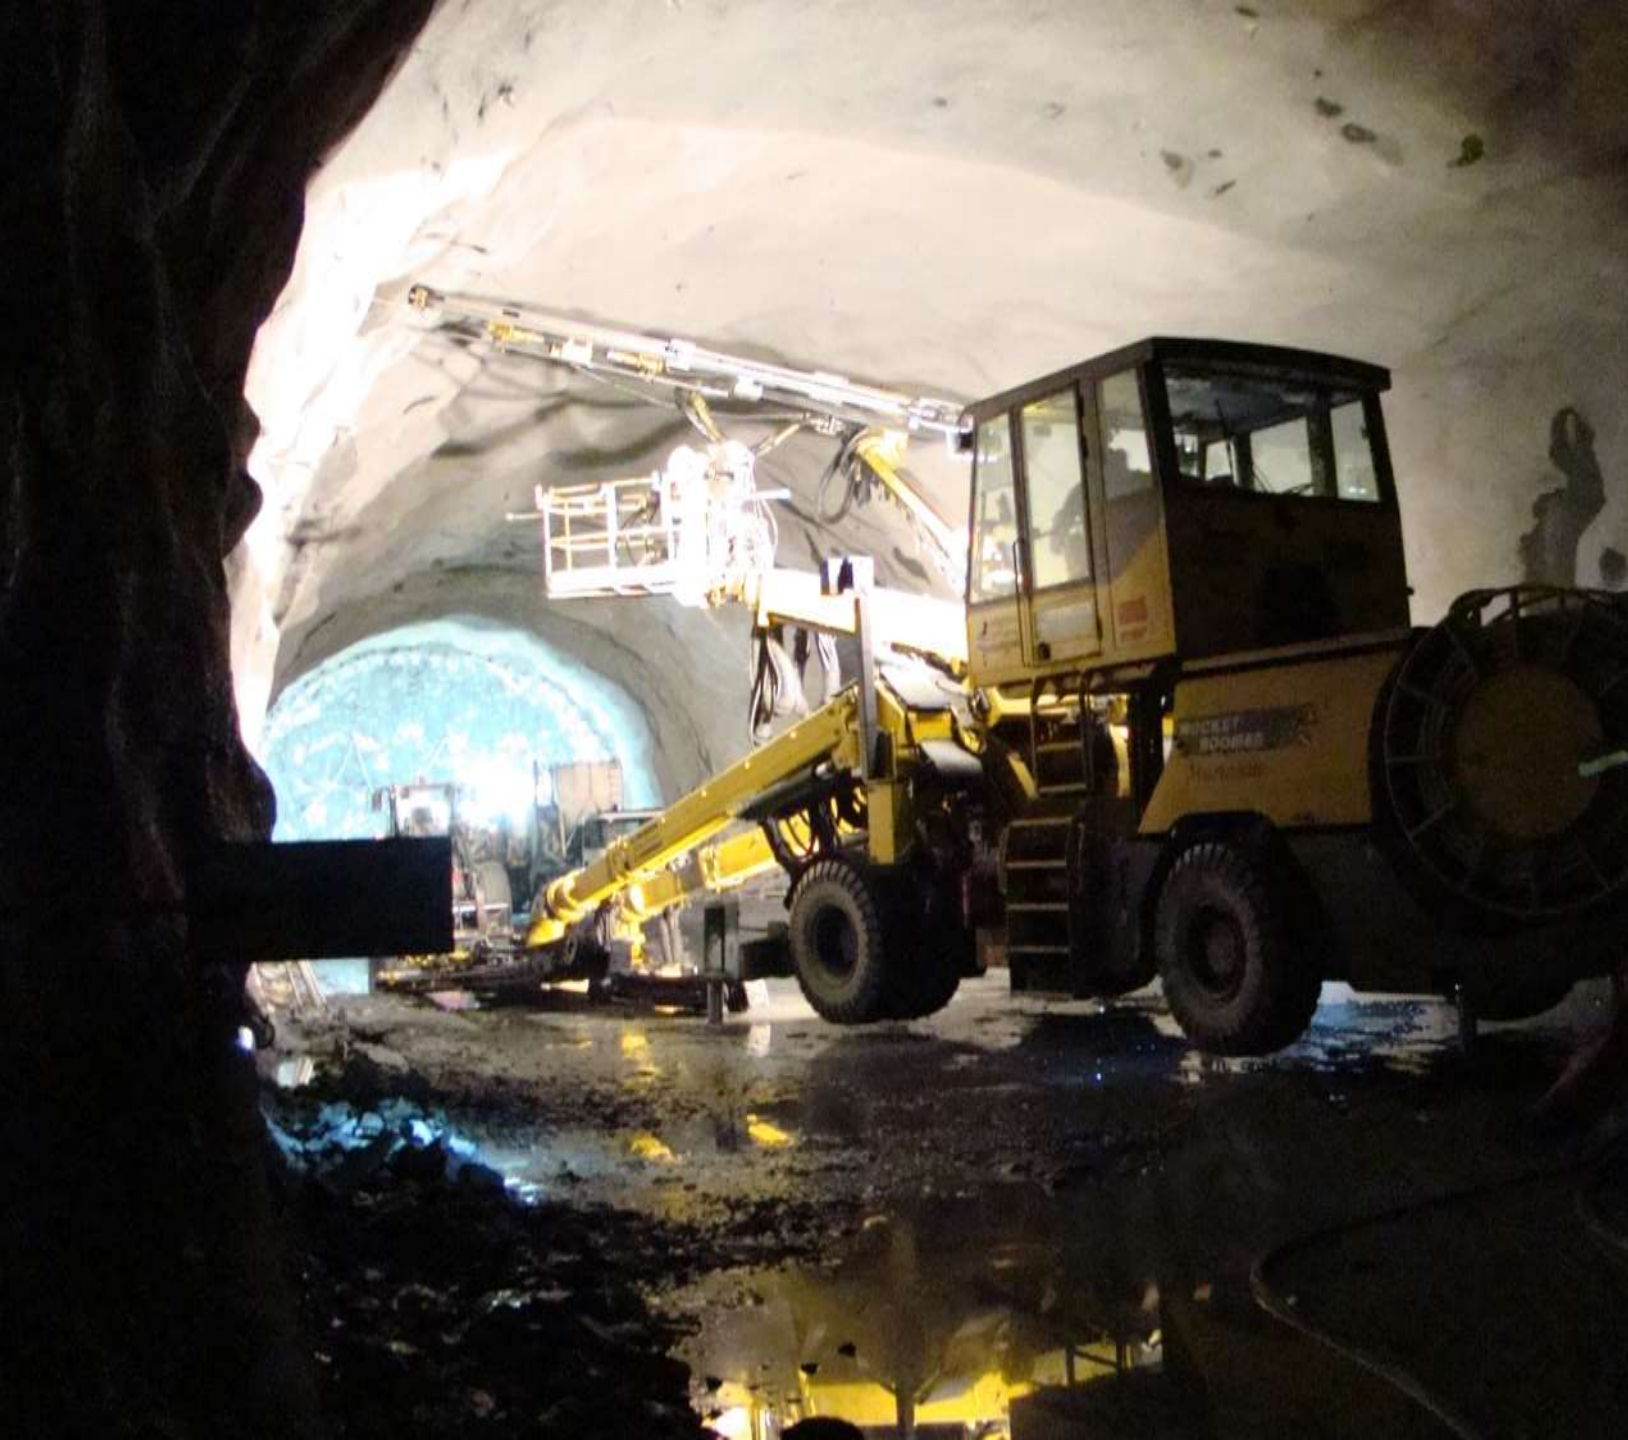
**EXAMPLE OF PRE-INJECTED SHALES:  
110 m<sup>2</sup> TWIN-TRACK HIGH SPEED  
RAIL TUNNEL**

**IF THE CHOICE IS *SINGLE-SHELL*  
NMT: **ECONOMY AND  
PERFORMANCE ARE ENHANCED  
WITH PRE-INJECTION****

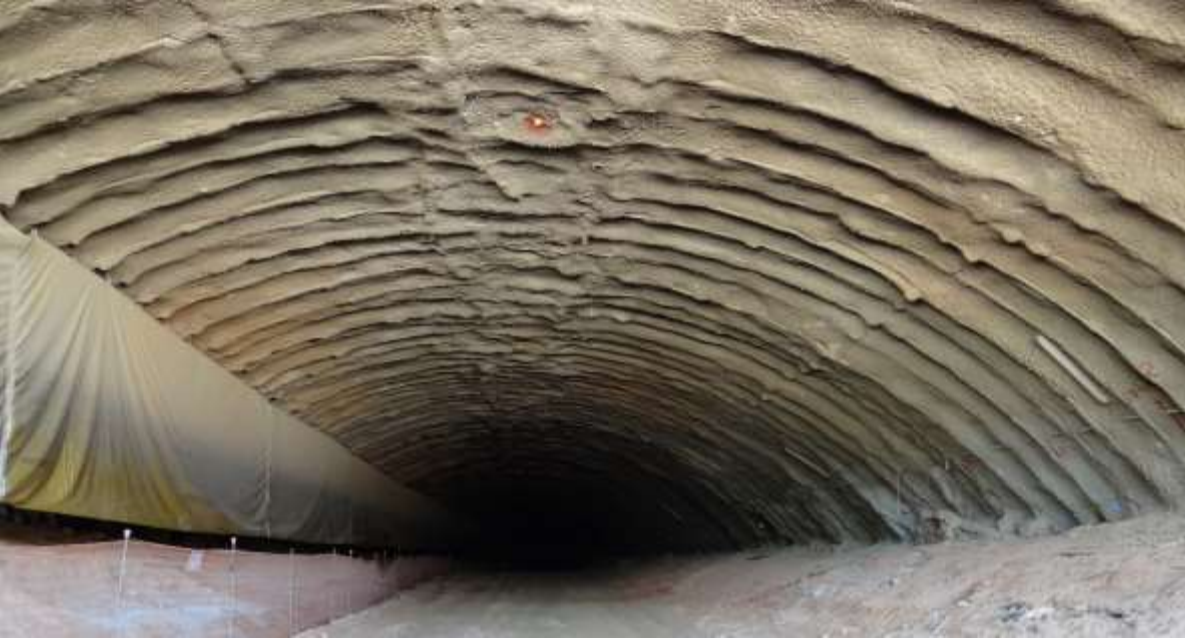
OPTIMISTIC 'LIGHT' LATTICE-GIRDERS and UNREINFORCED SHOTCRETE. NO ROCK BOLTS.

- **OPTIMISTIC AXISYMMETRIC UNIFORM LOADING ASSUMED.**
- **WHAT HAPPENS WITH VERTICALLY JOINTED PHYLLITE?**
- **WHAT HAPPENS WITH OVER-BREAK AND A WEATHERED DIKE?**

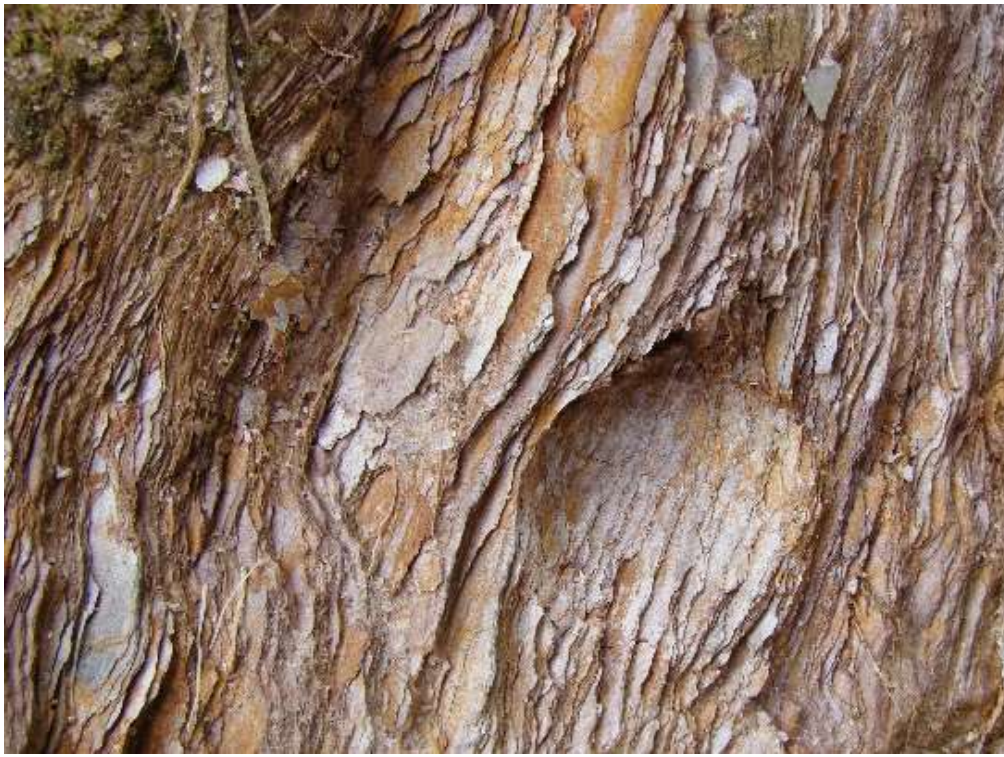
WEATHERED PHYLLITE (WITH  
STEEP DIP) AS SEEN IN THE  
NEIGHBOURHOOD OF THE  
TWIN TUNNELS

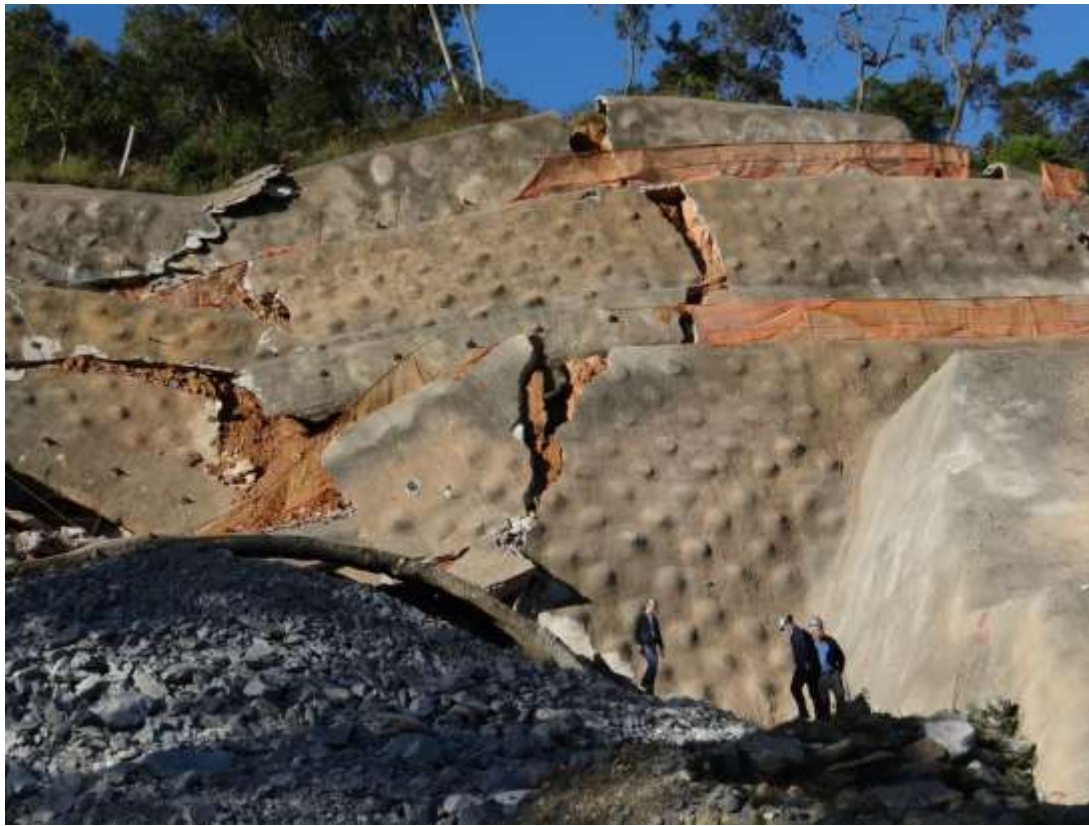
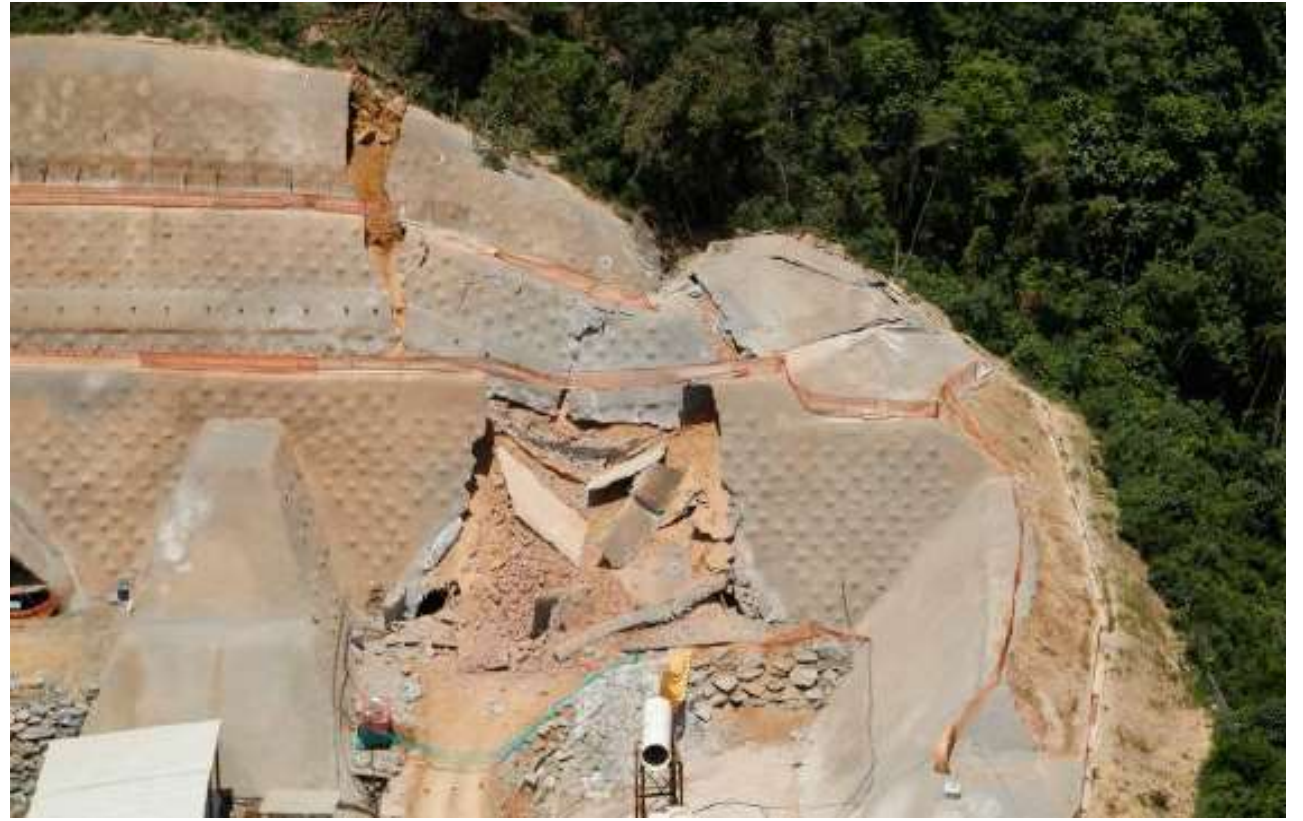
3DEC modelling by  
Dr. Stavros Bandis

THEN THE LEFT-SIDE.....FIRST THE RIGHT-SIDE  
( $\approx$  140 m COLLAPSE) .....( $\approx$  140 m COLLAPSE)

SOIL, THEN SAPROLITE, THEN WEATHERED PHILLITE, DIKE
