# **Cavern and Tunnel Failures due to Adverse Structural Geology and Inadequate-in-the-Circumstances Support Designs**

**N. Barton**

NB&A, Oslo, Norway

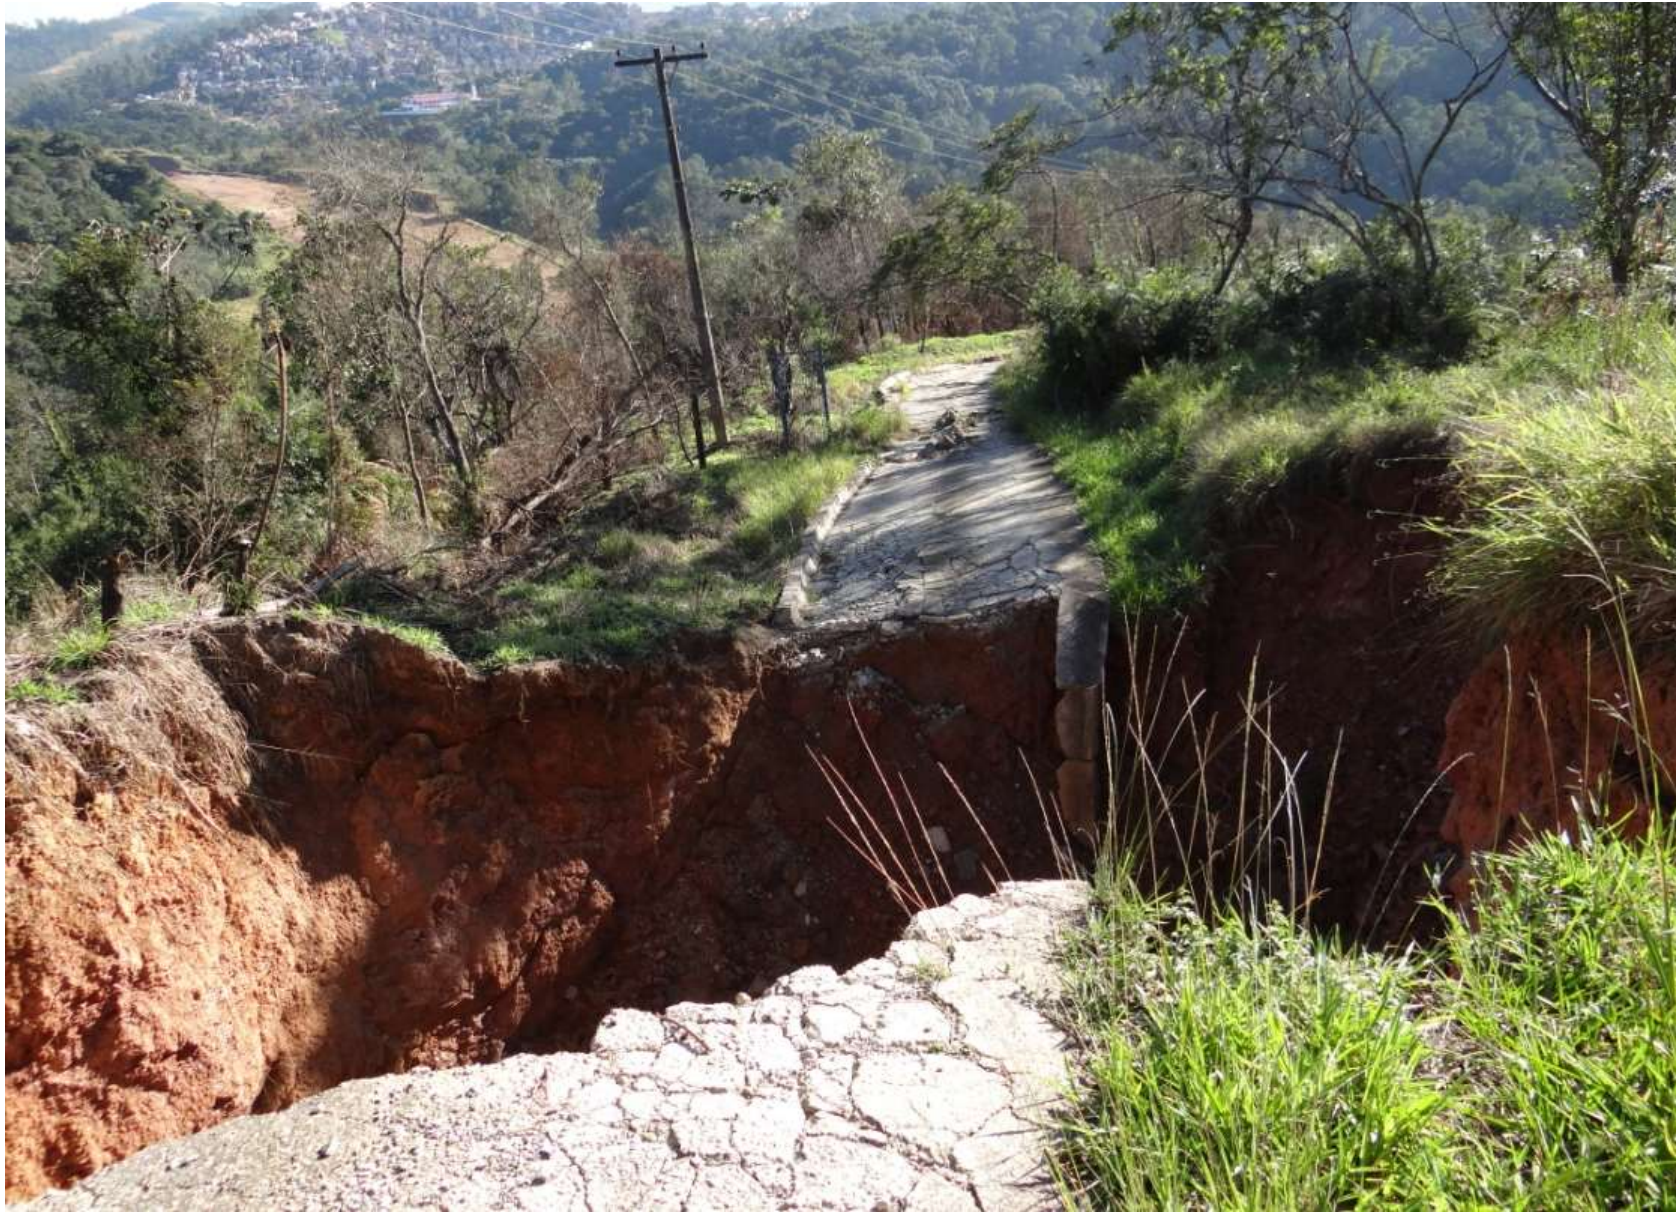
ROTATED  
ROAD,  
TREES  
AND  
TELEGRAPH  
POLE (after  
failure of  
second tube)

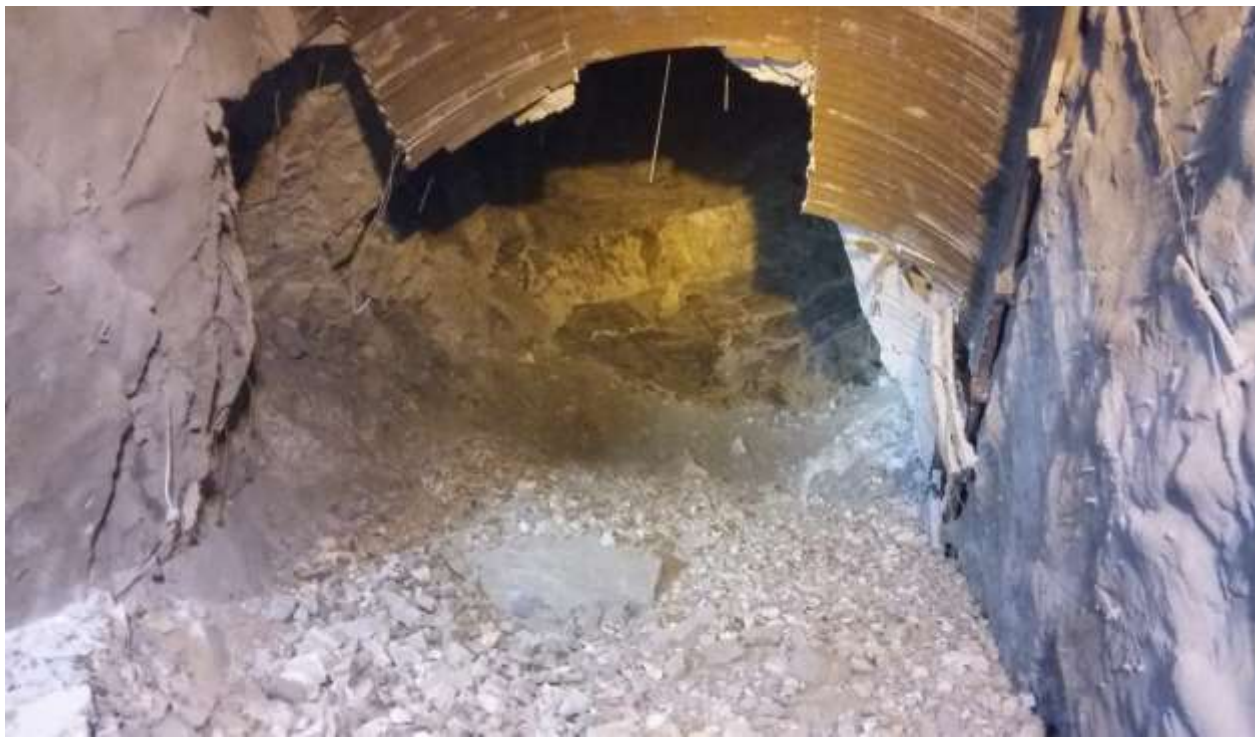
The attempt to remove some 15,000 m<sup>3</sup> of the fallen rock, revealed the destruction of the 'heavy' steel sets in the arch.

**(It was too dangerous to continue)**

A total of 70,000 m<sup>3</sup> may now have fallen. A cavity with approximate dimensions L x H x W of (50-60) m x (40-50) m x (30-35) m has to be stabilized, then victims recovered.

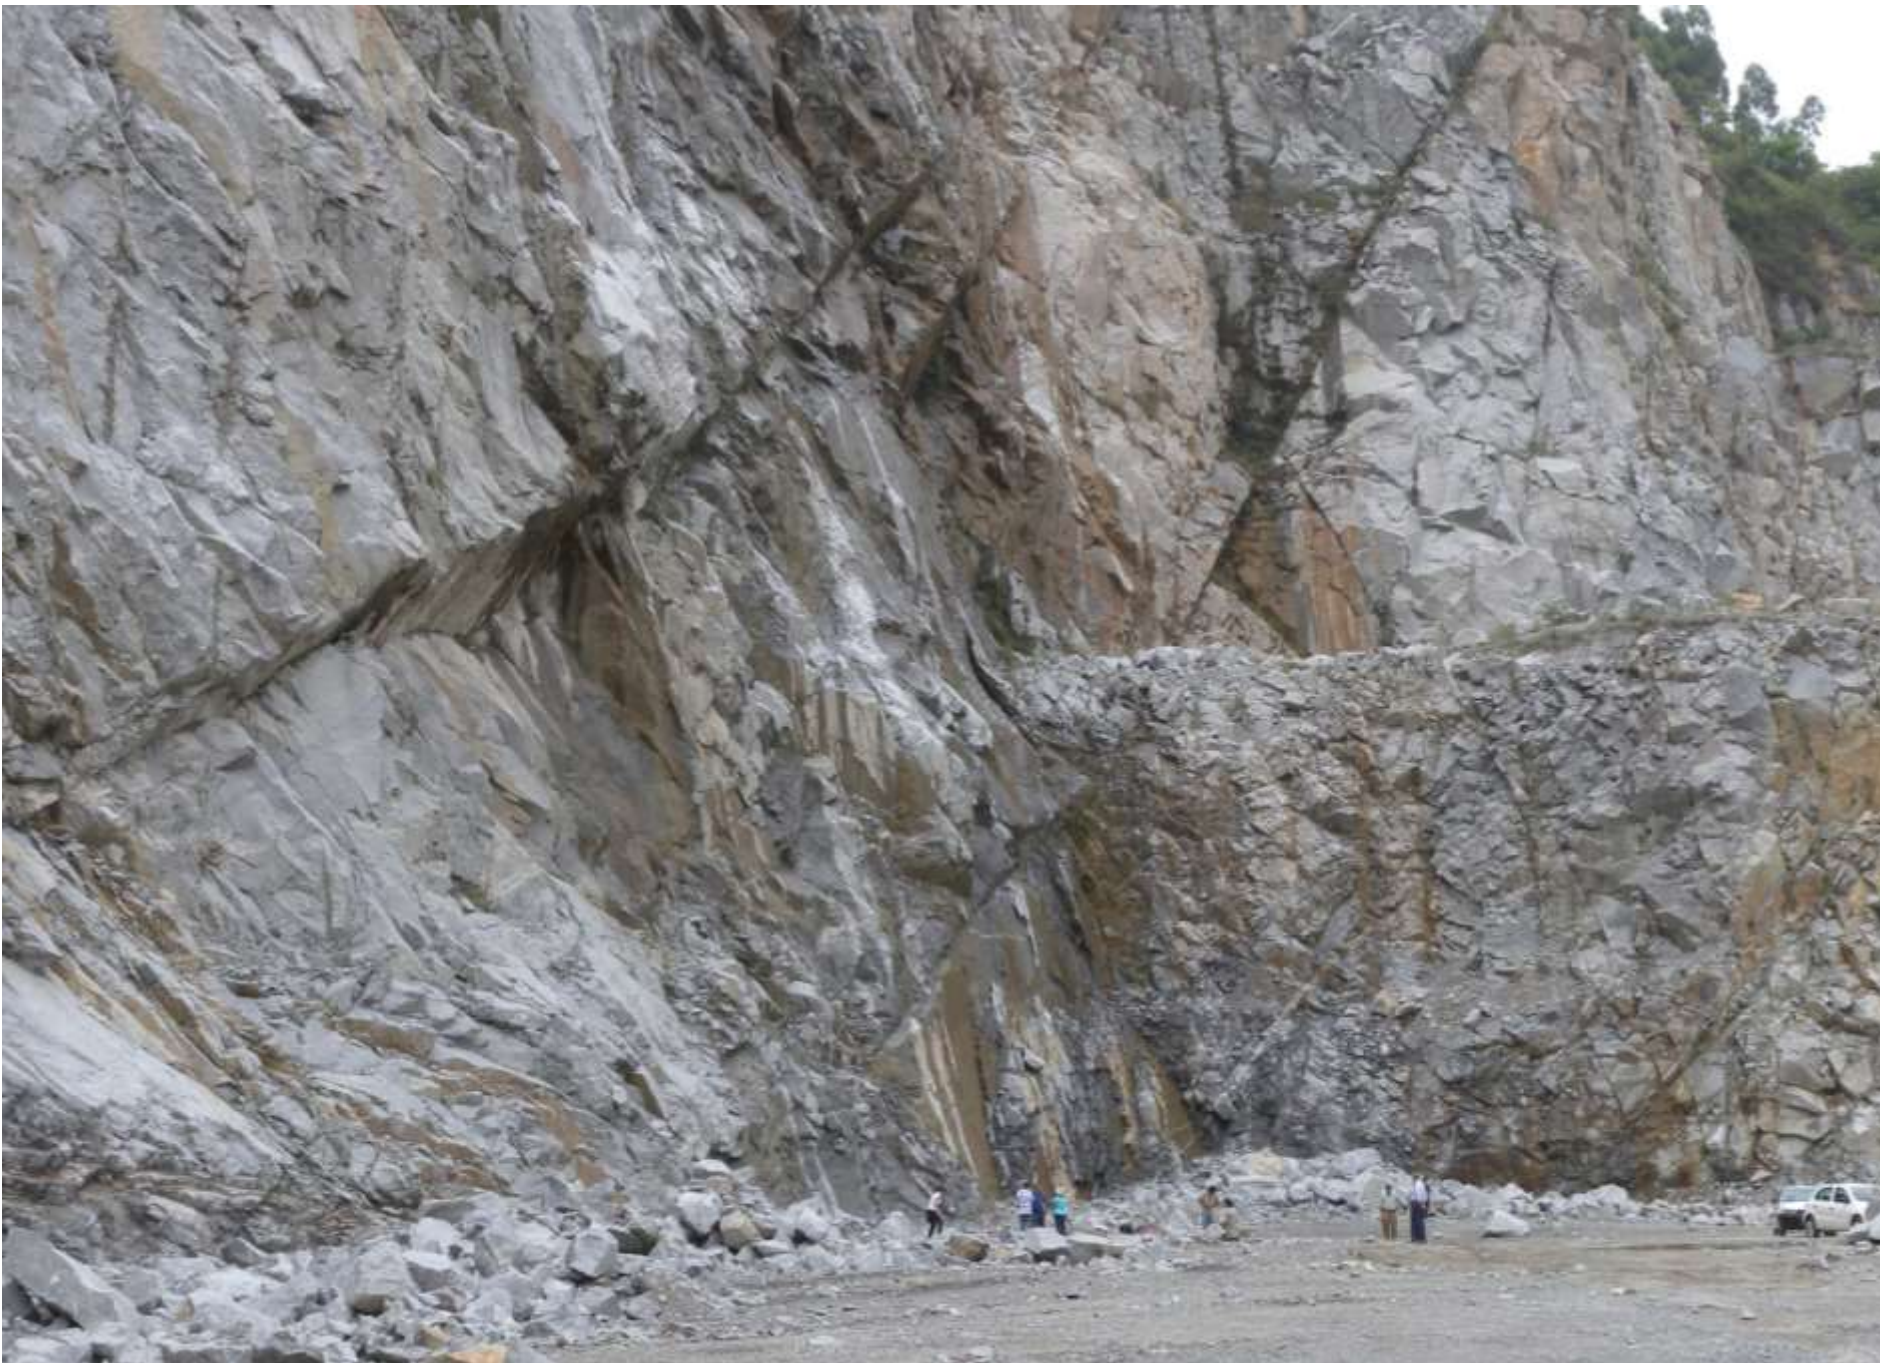
WHAT  
HAPPENS  
TO LATTICE  
GIRDERS  
WHEN A  
TUNNEL (OR  
CAVERN)  
CROSSES A  
MAJOR JOINT  
OR FAULT?

**HIGHLY NON-  
UNIFORM  
LOADING IS  
INEVITABLE.**

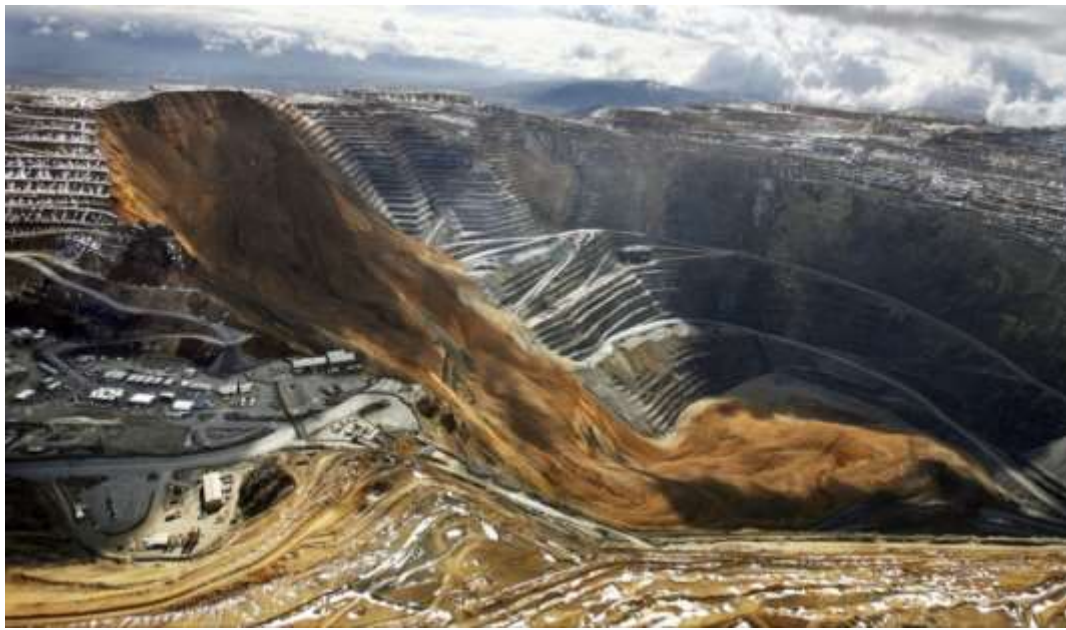
**BIGGEST OPEN-PIT MINE FAILURE EVER: KENNEKOTT COPPER BINGHAM MINE IN UTAH – MAYBE 70,000,000 m<sup>3</sup> OF WASTE ROCK AND ORE. CAUSED 5.1 Mag. AND 4.1 Mag. SEISMIC EVENTS, WITH 1½ HOURS SEPARATION.**

***NO LOSS OF LIFE – DUE TO MONITORED PROGRESSIVE FAILURE. SO FAILURE WAS PRESUMABLY STEP-BY-STEP OVER-COMING OF THE VARIOUS AVAILABLE STRENGTH (OR WEAKNESS) COMPONENTS.***
