International Meeting of CSRME 14th Biennial National Congress, 14-17  
December 2016, Hong Kong, China

# **Characteristics on Rock Fractures Induced by Different Excavation Methods of Deep tunnels**

**Shaojun Li**

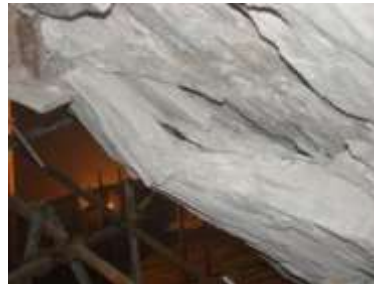
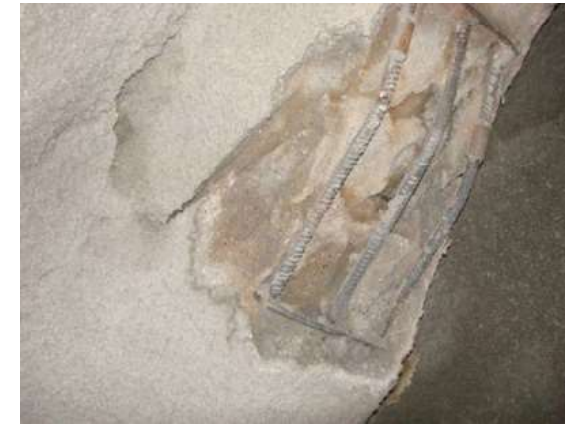
- Large deformation
- Big fractures

Fall of sprayed concrete

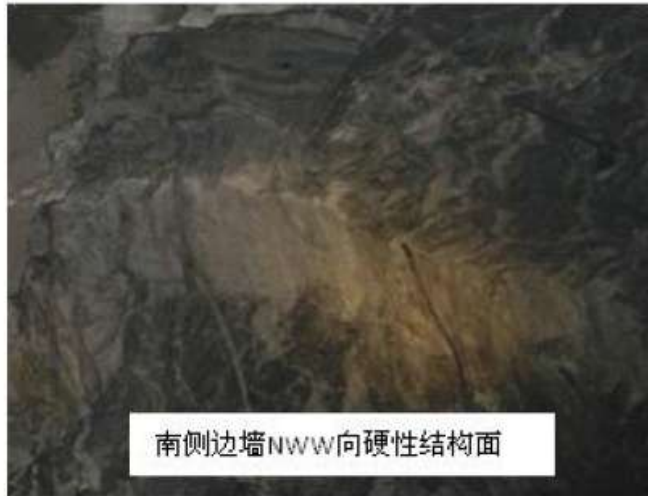
Sidewall  
rockburst

Notch left.  
depth : 2.0m

Steel mesh  
destroyed

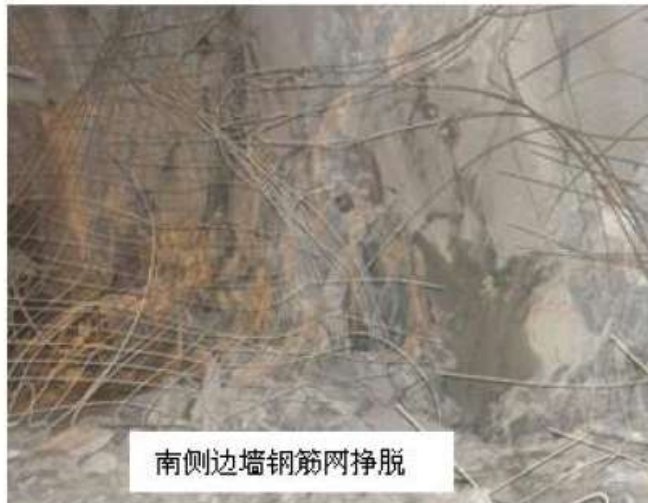
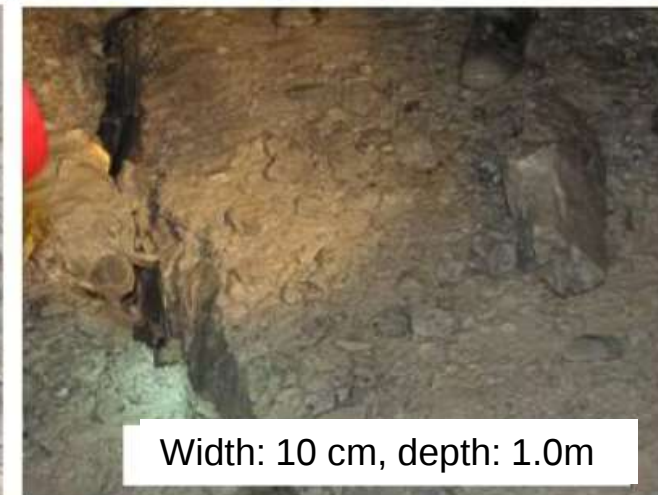
Tunnel floor  
Fractured

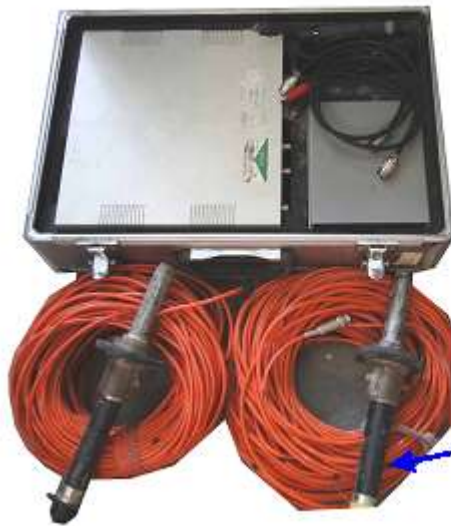
**Acoustic wave apparatus  
(single or cross-hole method)**

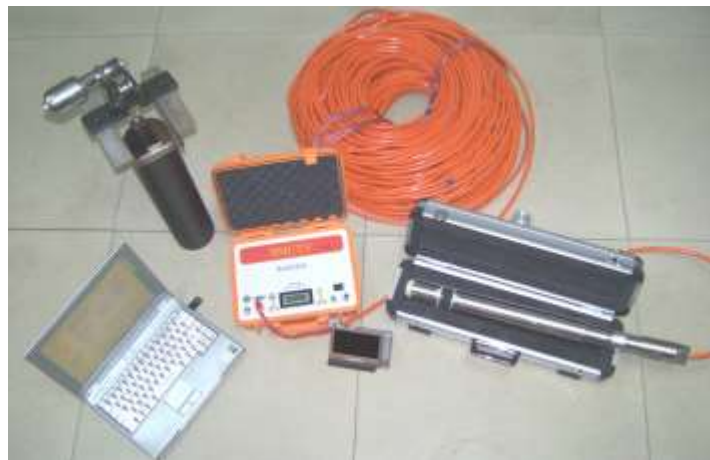
## Digital borehole televiewer system

Image of borehole wall and fractures

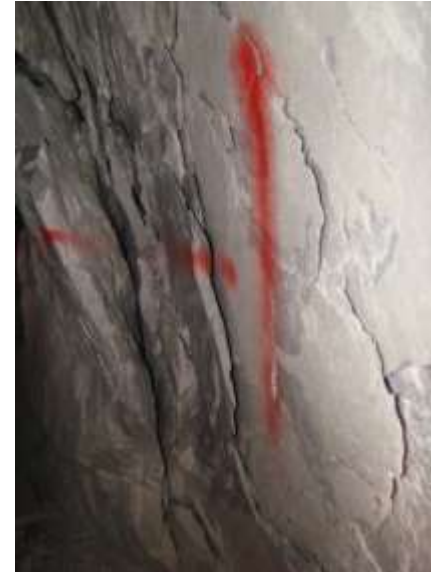
**Test  
tunnel C**

- *In situ* observation on tunnel sidewalls
- Rock spalling occurred but fractures can also be found in deep rock mass

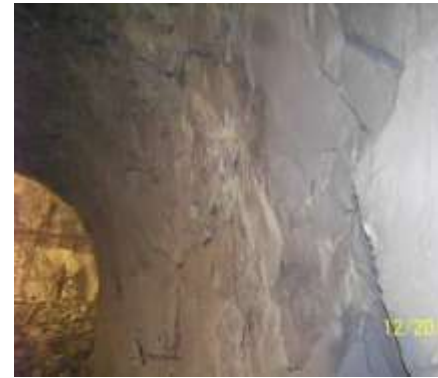
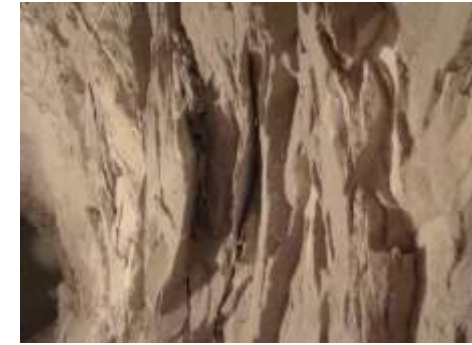
## Test tunnel F

Northern sidewall

Southern sidewall

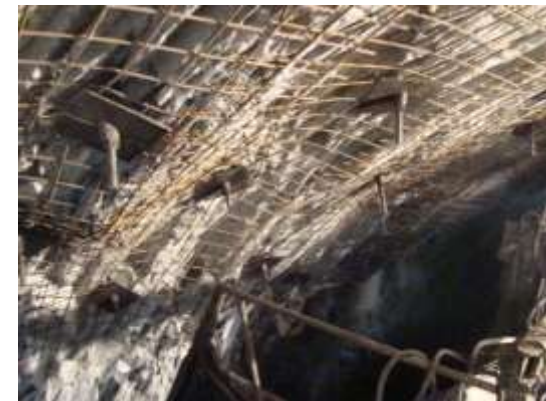
## No.3 headrace tunnel

- Different direction of fracture can be found in D&B tunnels
- Fractures in TBM tunnel are almost parallel to axis

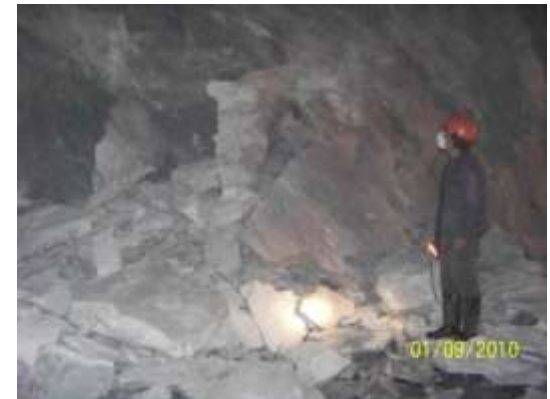
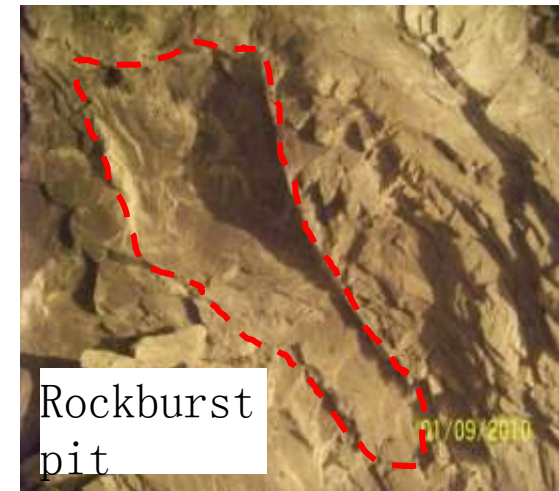
Rockburst occurred on January 09, 2010, with the volume about 6.3 m<sup>3</sup>

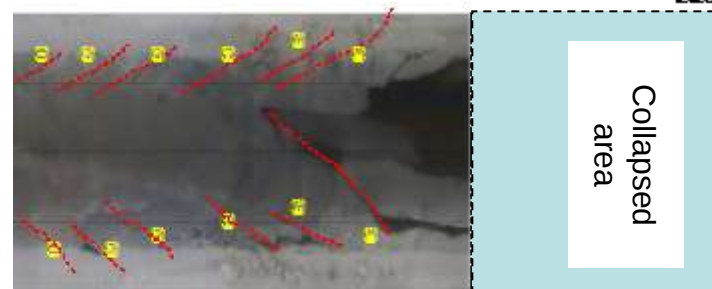
Rockburst occurred on Jan 09

2.0m to the tunnel sidewall

(a) Oct. 13, 2009, Pre-existed cracks before excavation

(b) Jan. 03, 2010, New cracks appeared in red line, the upper layer excavation finished

(c) Jan. 04, 2010, Abundant of new cracks appeared, 10.0 m excavated at the bottom layer

(d) Jan. 07, 2010, cracks run through, 21.0 m excavated at the bottom layer
