# Completely-Weathered Sandstone Slope Failure During Highway Construction and its Remedy

Wu Zhenjun

Institute of rock and soil mechanics, Chinese academy of sciences

Dec. 16, 2016

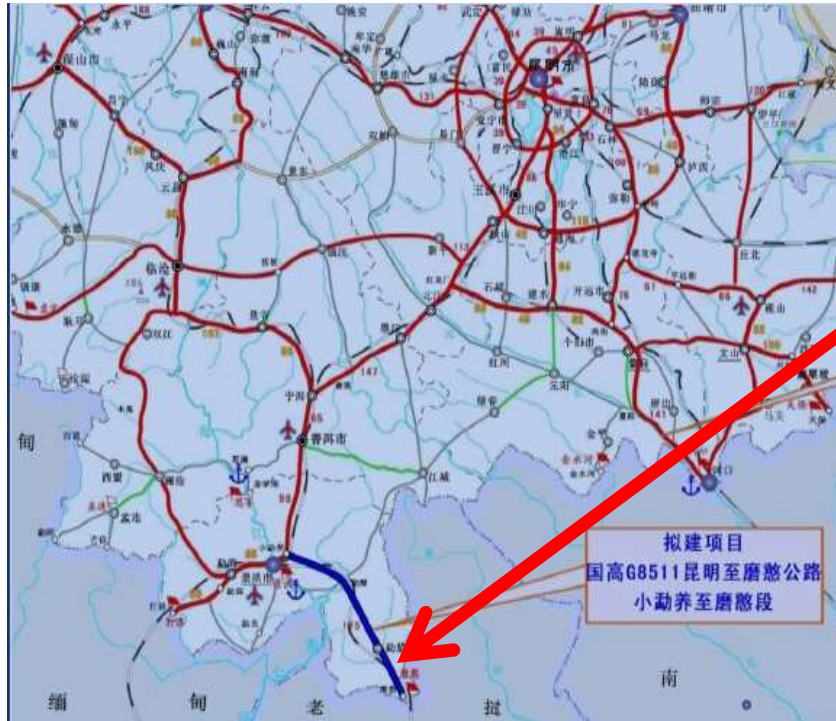
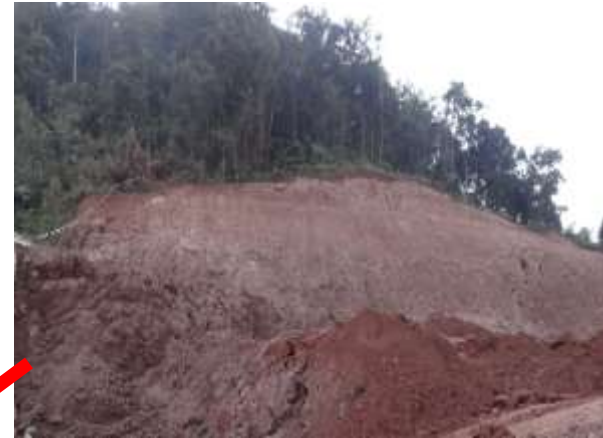
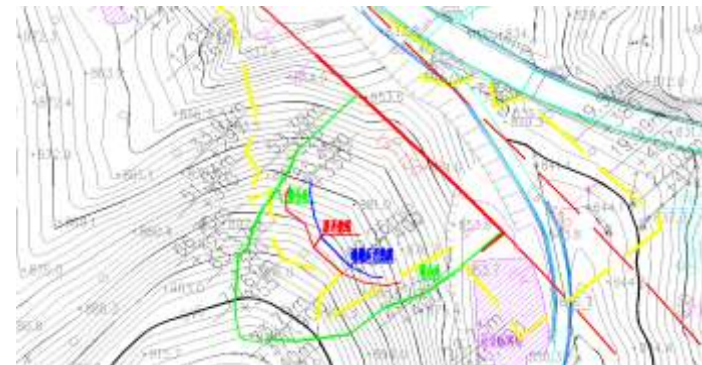
Completely-Weathered Sandstone

The slope is located in xiao-mo highway, Yunnan, China

- The slope is 100m high weathered sand stone slope.
- Slope failure occurred during excavation. Volume is About 300,000m<sup>3</sup>.
- No reinforcement is employed before the slope failure.

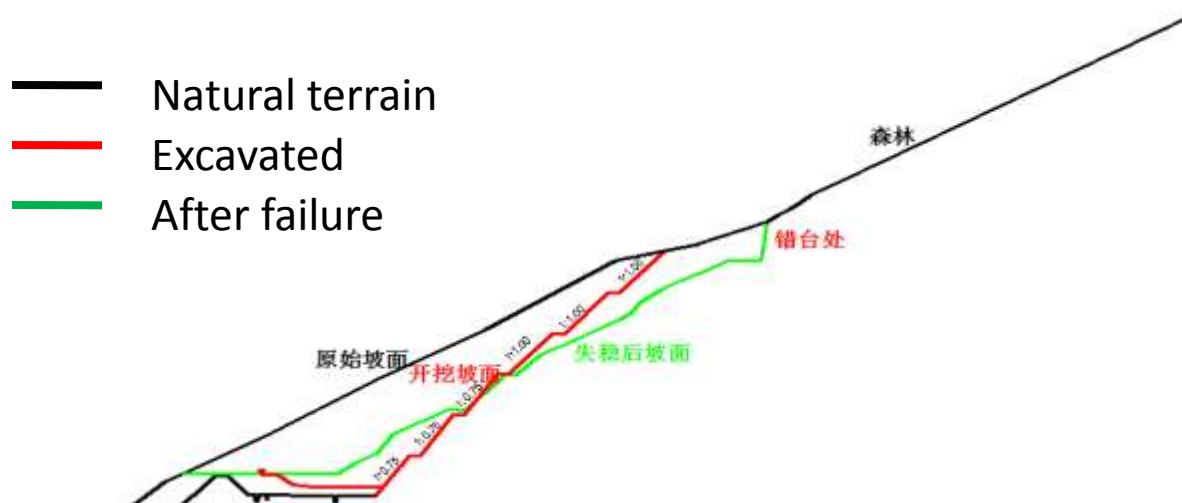
# CWS shear strength deterioration process

- The strength deterioration process is obtained by back-analysis using limit equilibrium method (LEM).
- 4 stages are considered:
  - natural slope, shear strength  $C_1, \phi_1$
  - excavated slope, shear strength  $C_2, \phi_2$
  - failed slope, shear strength  $C_3, \phi_3$
  - Potential deterioration shear strength  $C_4, \phi_4$
