Cause and Mechanism of Fatal Zhenxiong Landslide of January 11, 2013

Zhong-qi Quentin Yue

Civil Engineering Department, The University of Hong Kong, Hong Kong, P.R. China

International Geotechnics Symposium cum
International Meeting of CSRME 14th Biennial National Congress
November 14-17, 2016, Hong Kong

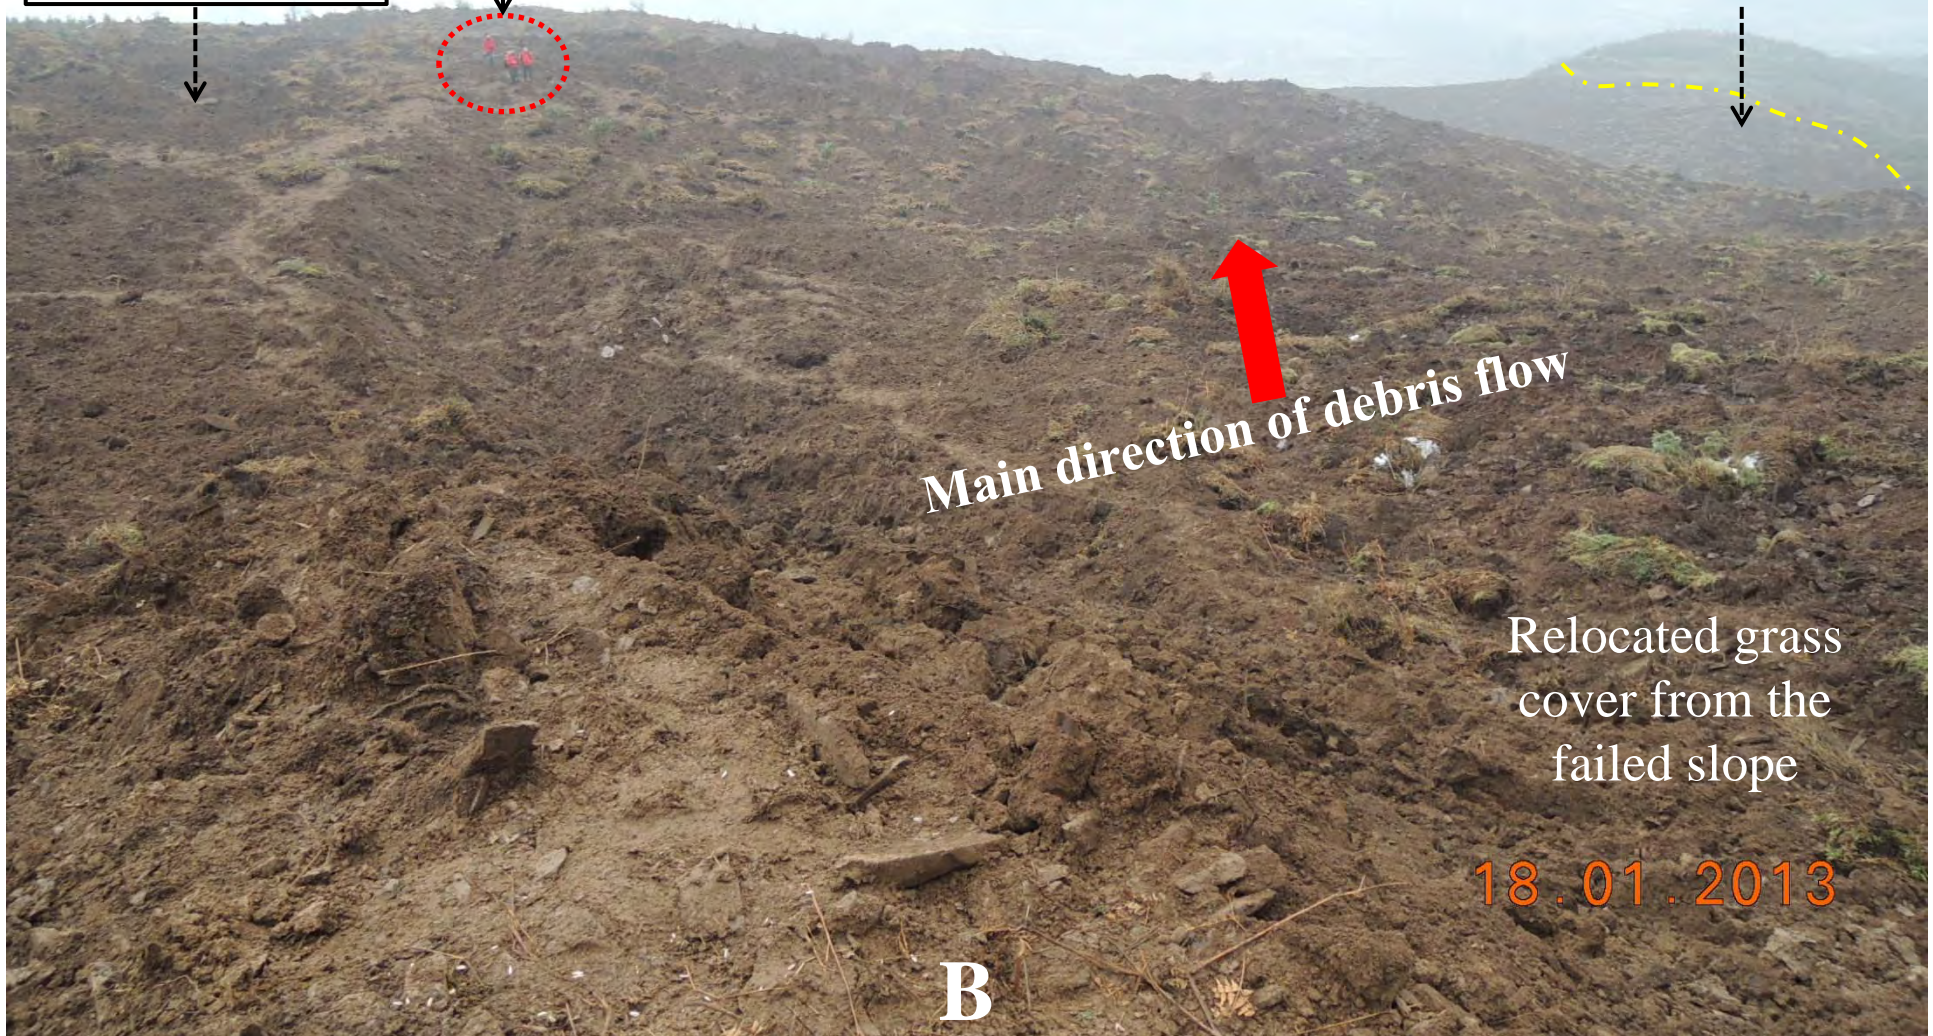
Video 1 on January 18, 2016
Landslide and debris source zone A to B area

Deposition of
Soil-rock
mixtures on
north gentle
slope side

Deposition of
Soil-rock
mixtures on
south gentle
slope side

Main direction of debris flow

Relocated grass
cover from the
failed slope

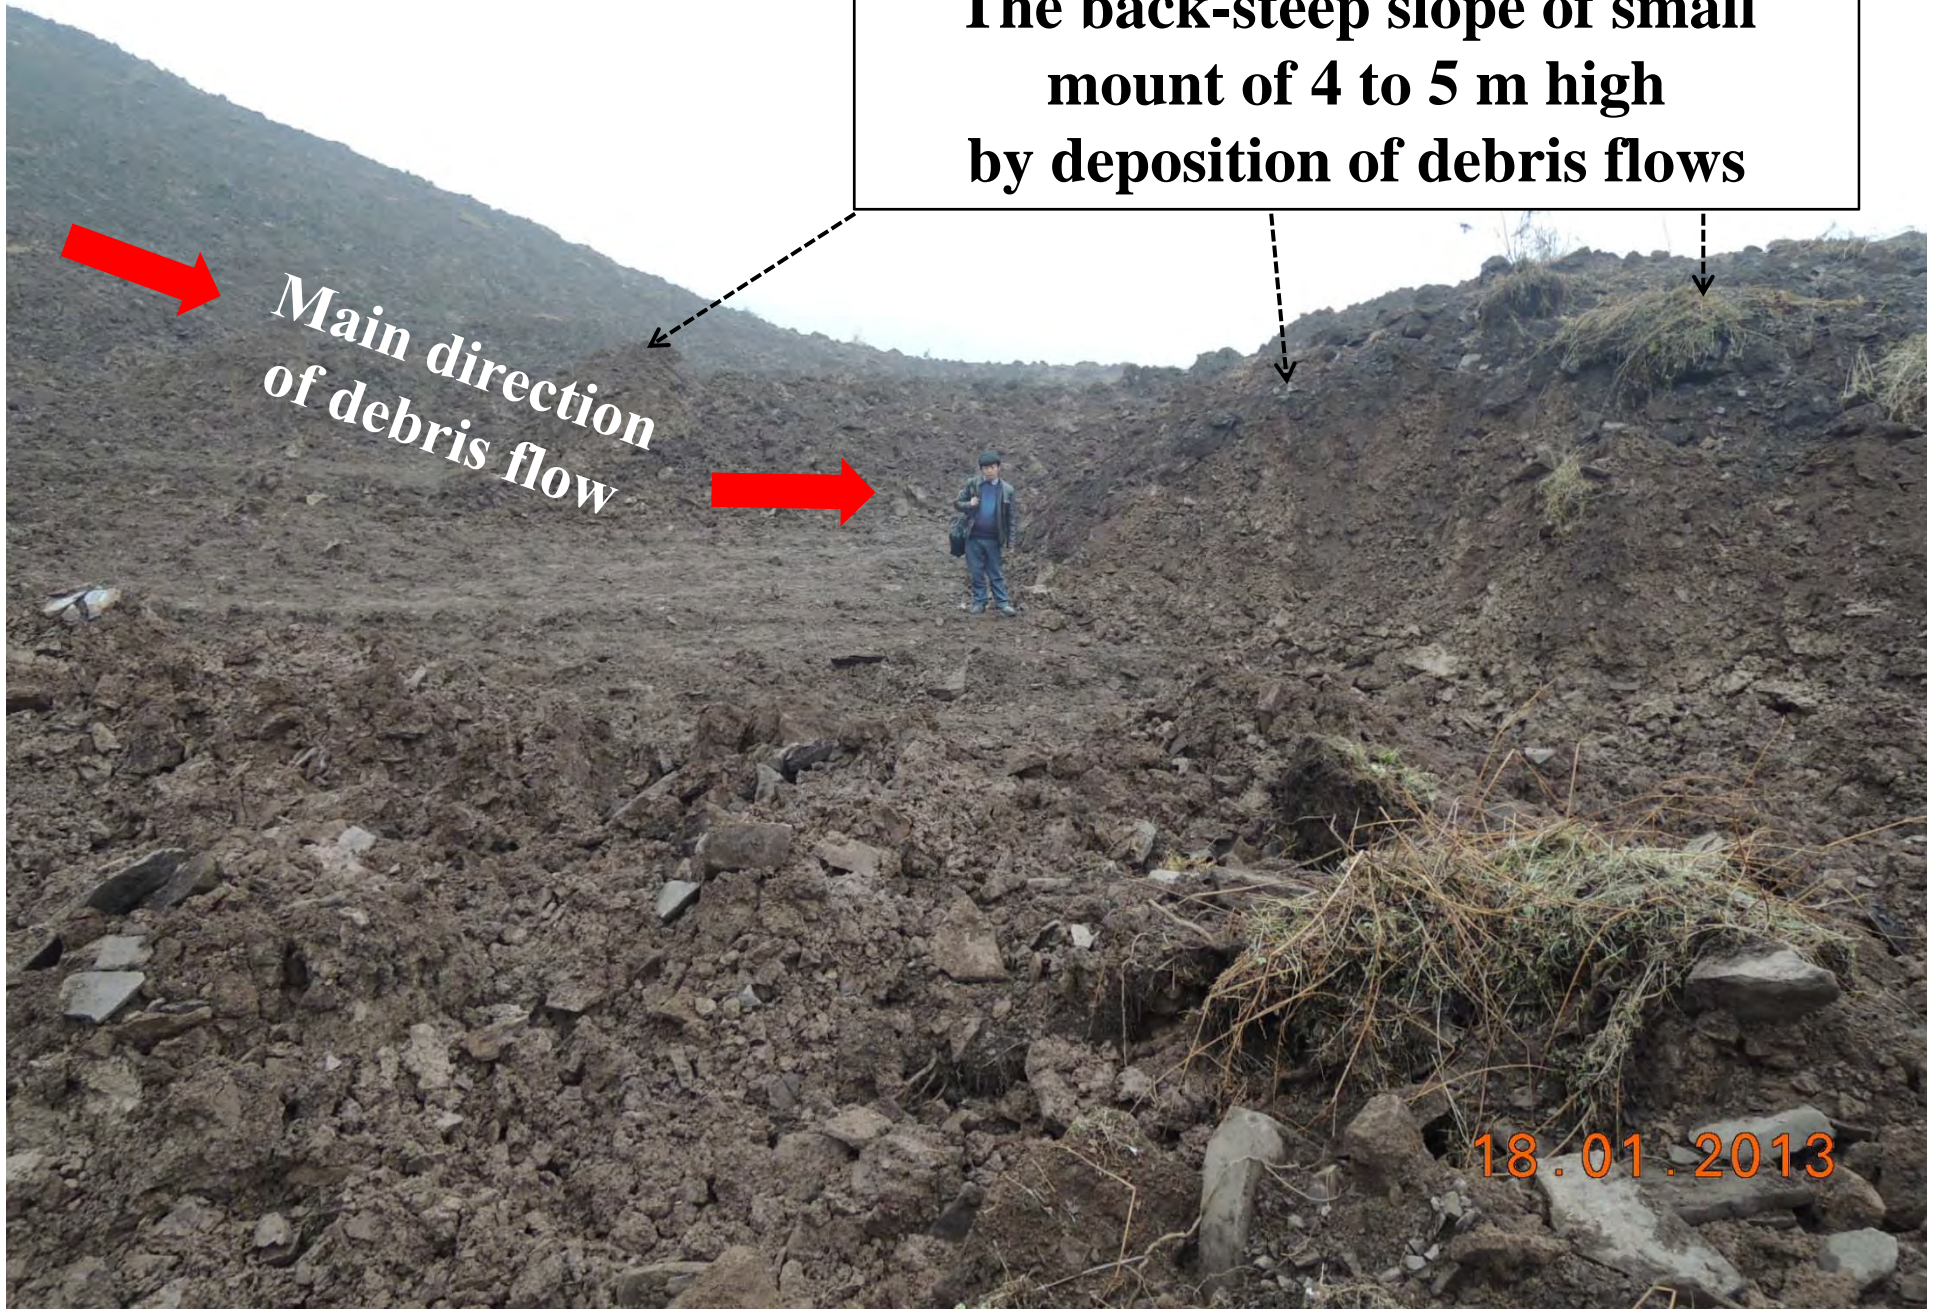
Video 2 on January 18, 2016
Debris flow and deposition B to D area

at C to D
**The back-steep slope of small
mount of 4 to 5 m high
by deposition of debris flows**

**Main direction
of debris flow**

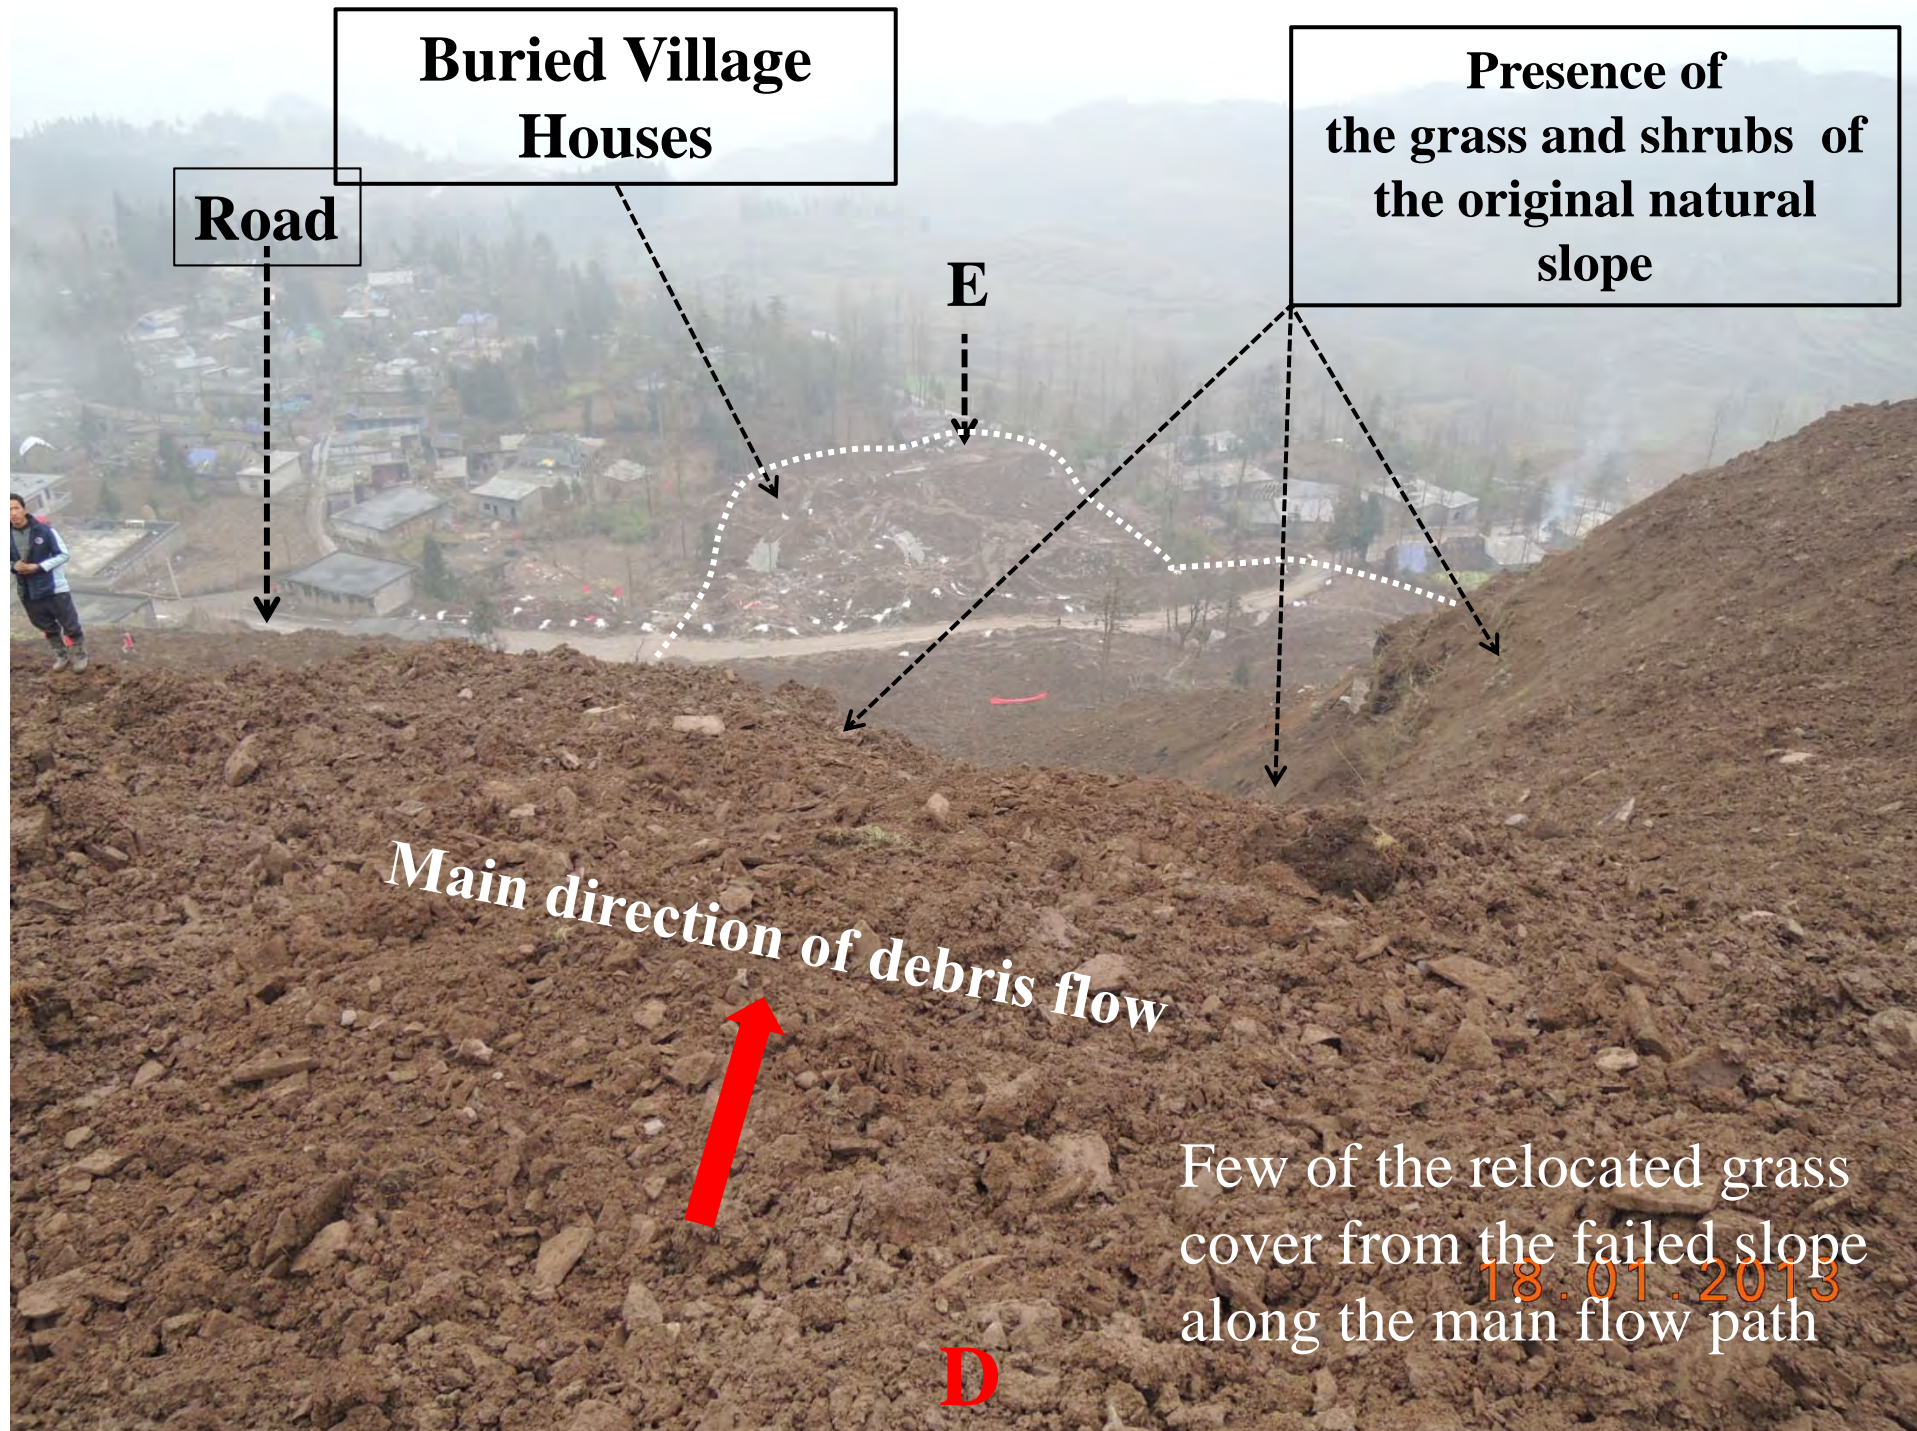
Buried Village Houses

**Presence of
the grass and shrubs of
the original natural
slope**

Few of the relocated grass
cover from the failed slope
along the main flow path

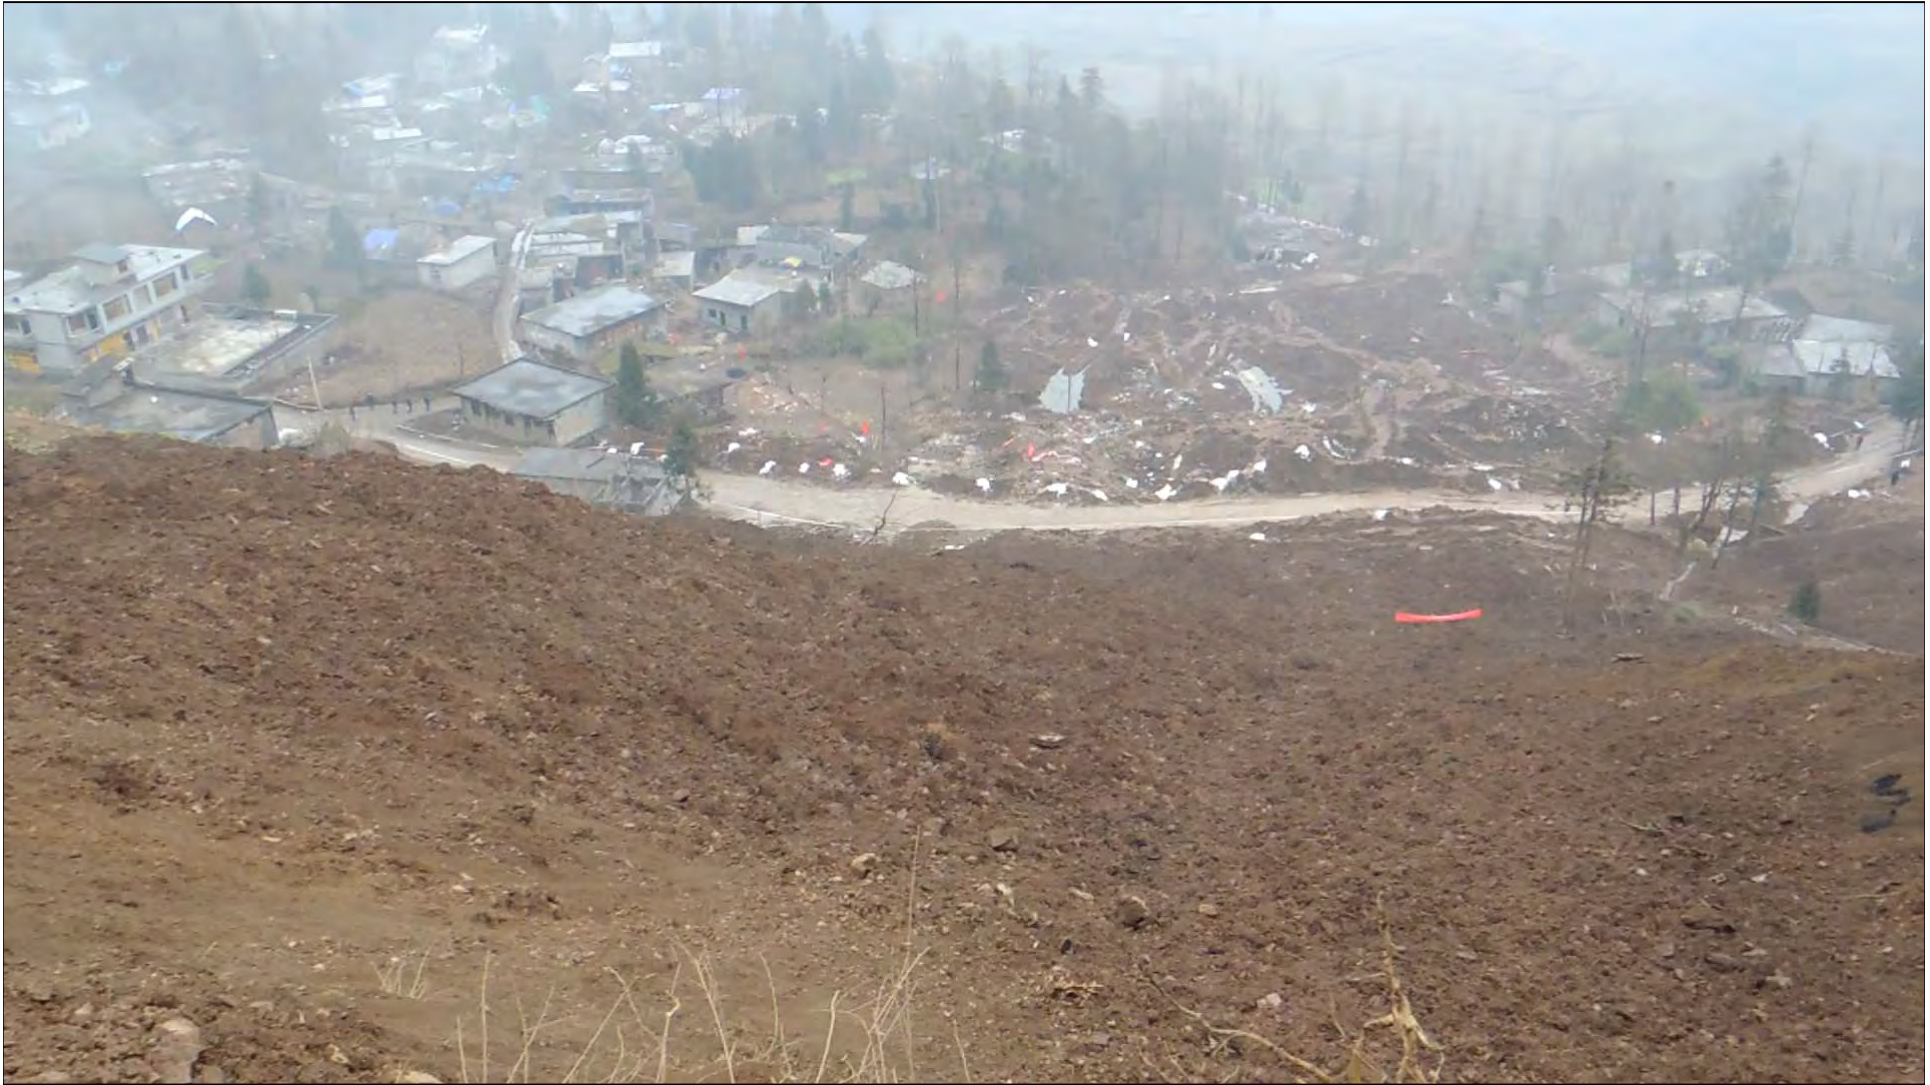
Video 3 on January 18, 2016
Debris Flow & Deposition D to E area

Boundary of debris deposition

Bedrock Horizontal bedding

Old slide scarp

Village Buried Village Zone

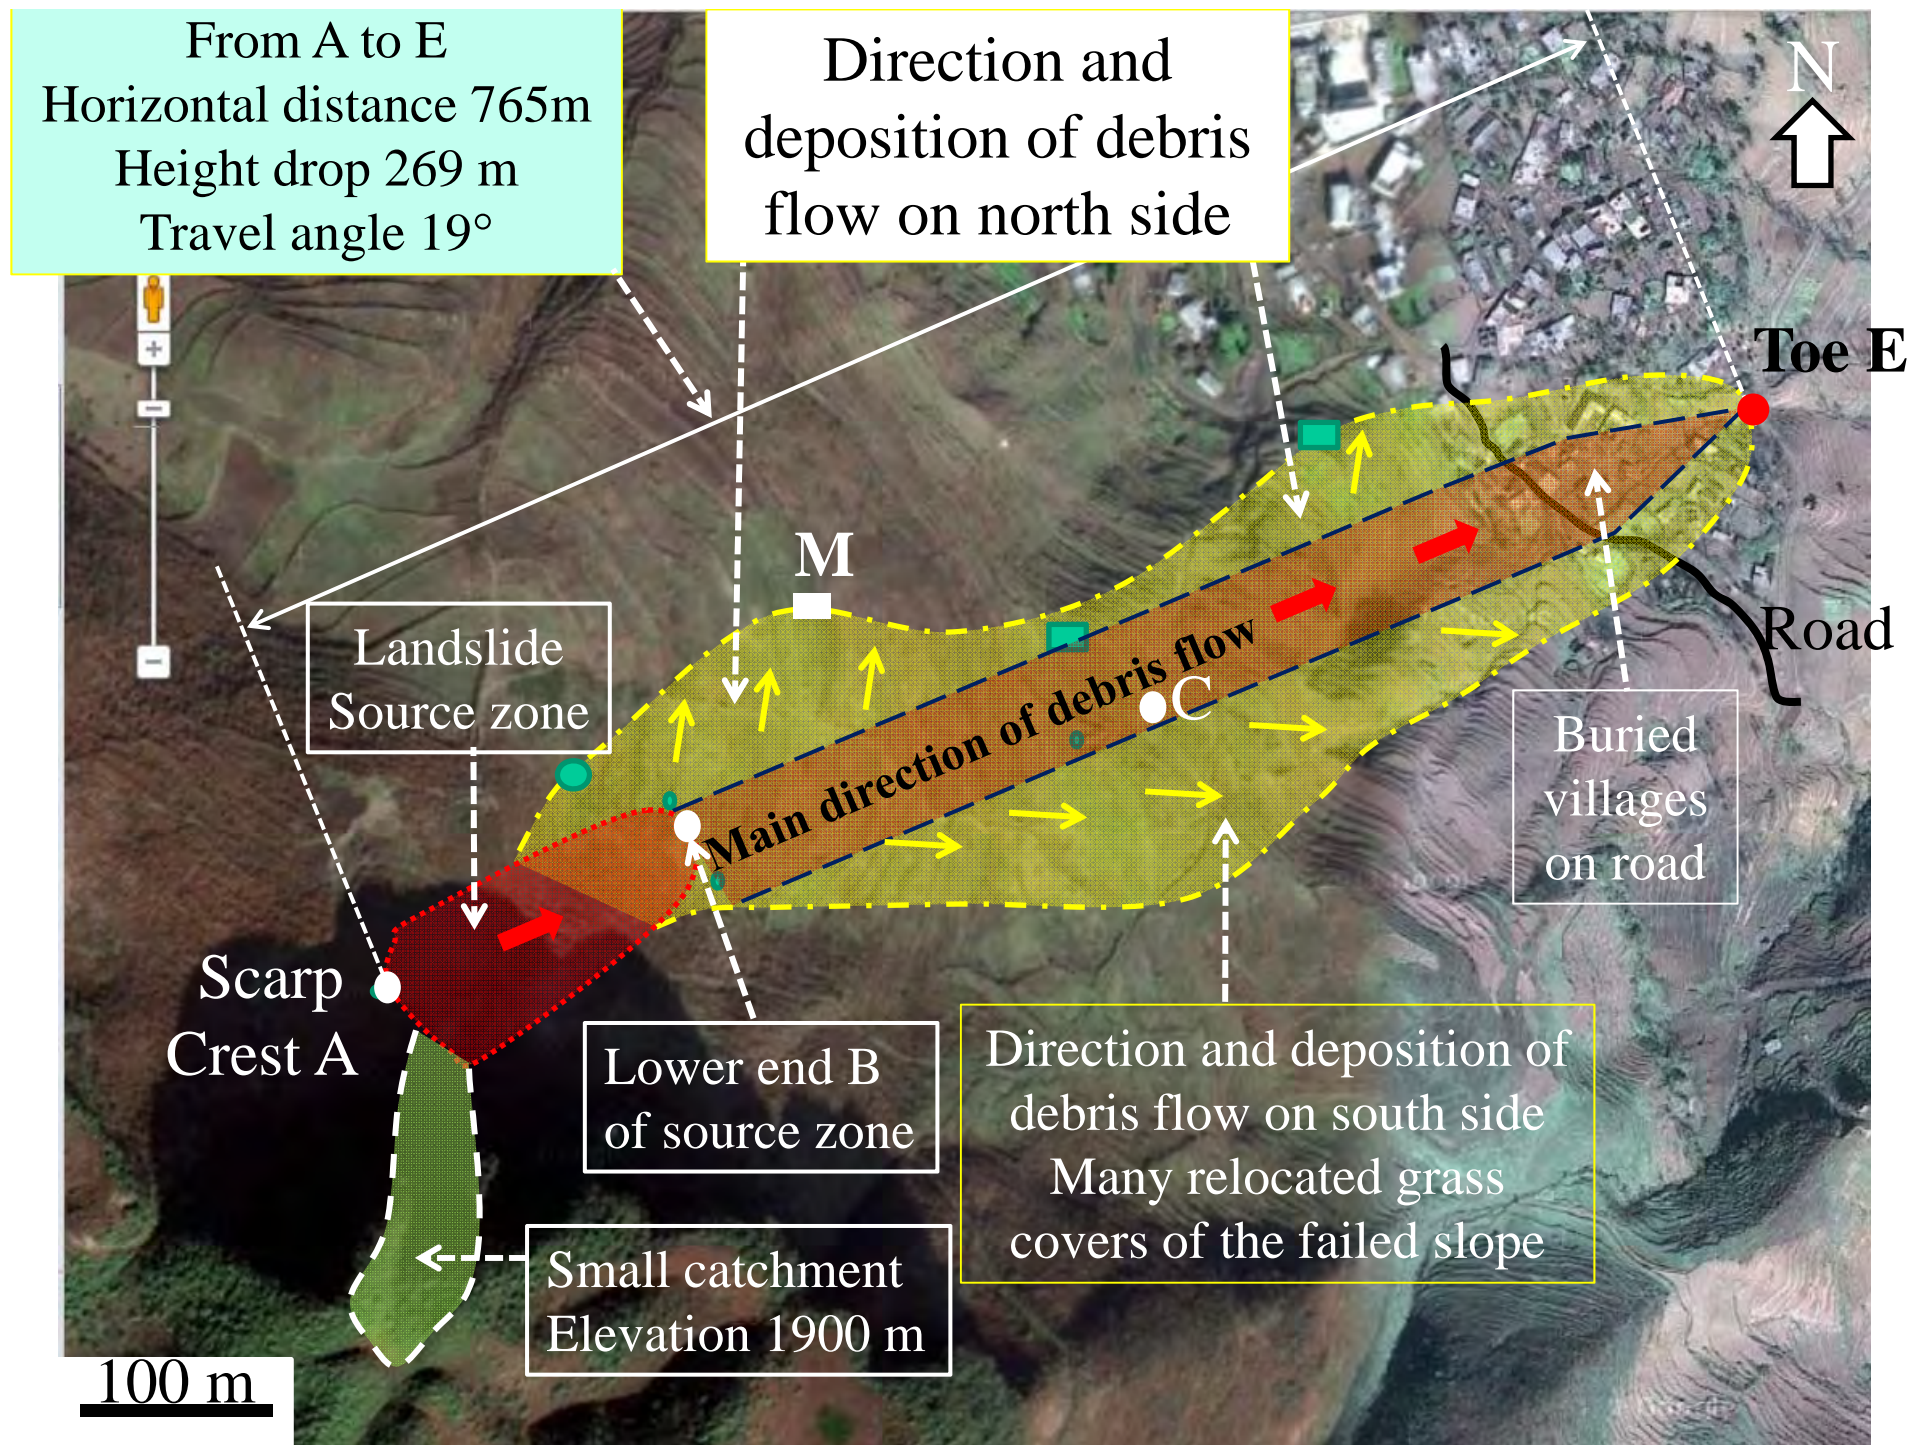
Likely mode and sequence of the fatal landslide

**Failed slope: $14^\circ \sim 30^\circ$ &
volume $\sim 0.25 \times 10^6 \text{ m}^3$**

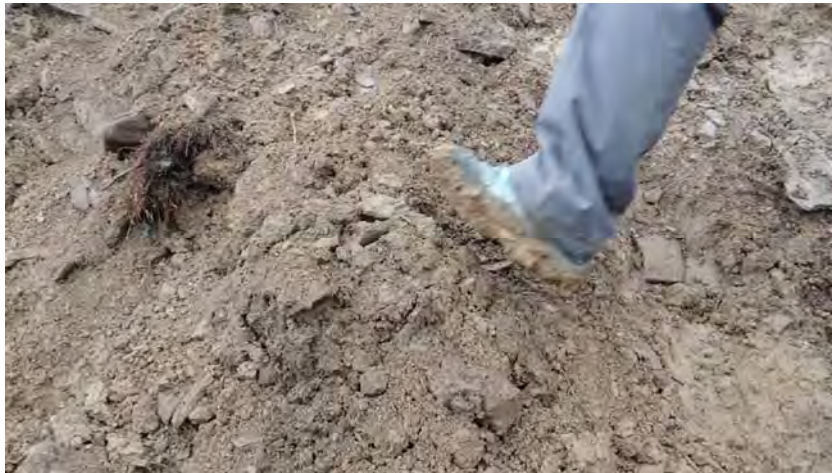
Video 4 for dry debris

**In dry season and no free water,
so, water was not the main cause
factor!**

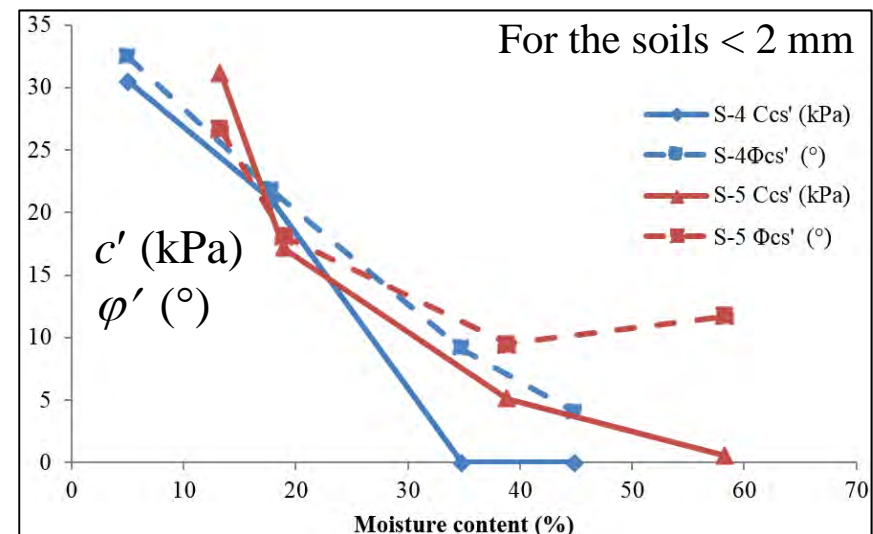
For the soils,
Liquid limit 50-60%
Plastic limit 30-40%
