# Nipigon River Landslide, Ontario, Canada

A. Abdelaziz, S. Besner, R. Boger, B. Fu, J. Deng, and A. Farina

Centre of Excellence for Sustainable Mining and Exploration,  
Lakehead University, Canada

# Nipigon River Landslide

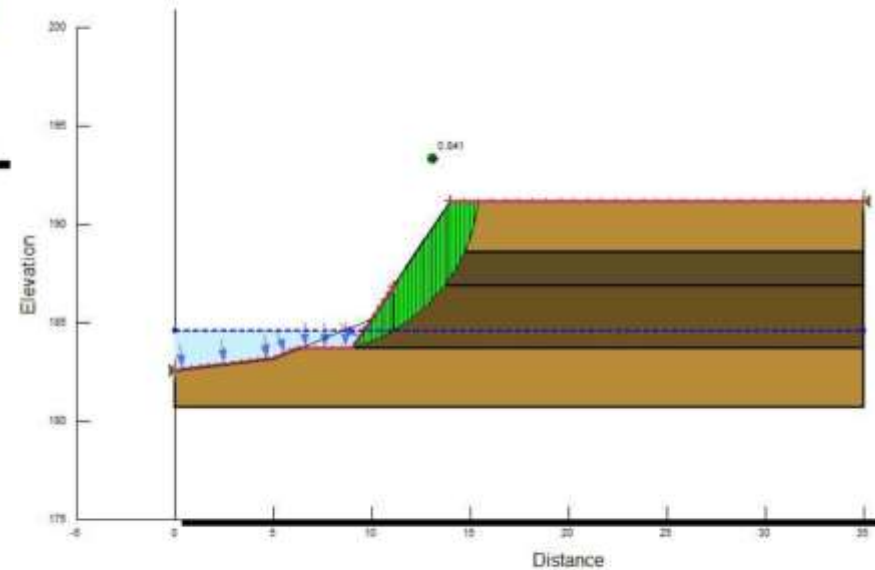
Figure A-4: Bishop's Simplified Nipigon River Slope Stability Analysis Case 4

| Case # | Parameter Changed | Change | Factor of Safety | Effect on FS |
|---|---|---|---|---|
| Case 4 | River Level | Elevated to 185.7m | 1.179 | + 0.097 |

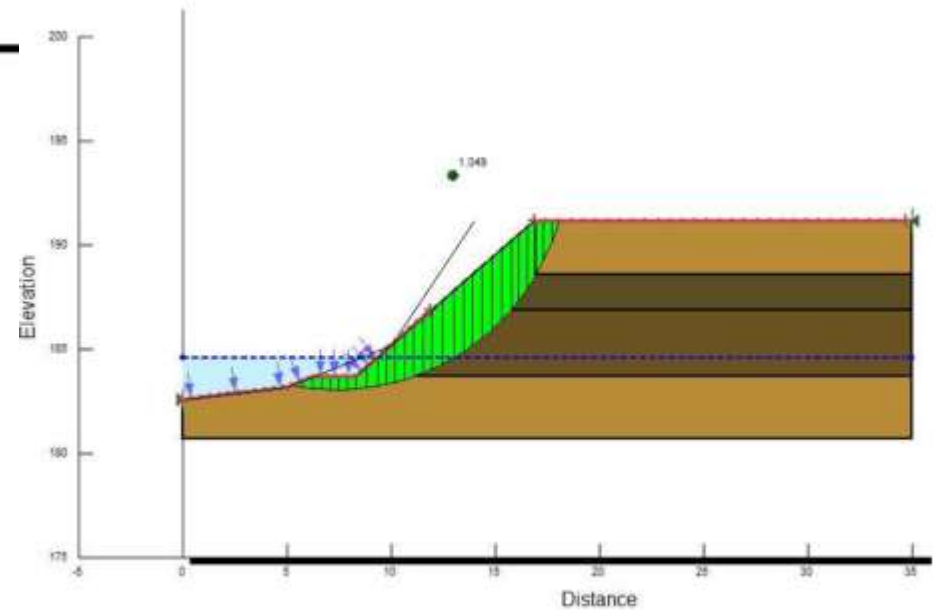
Figure A-5: Bishop's Simplified Nipigon River Slope Stability Analysis Case 5

| Case # | Parameter Changed | Change | Factor of Safety | Effect on FS |
|---|---|---|---|---|
| Case 5 | | Lowered to 183.4m | 1.033 | - 0.049 |

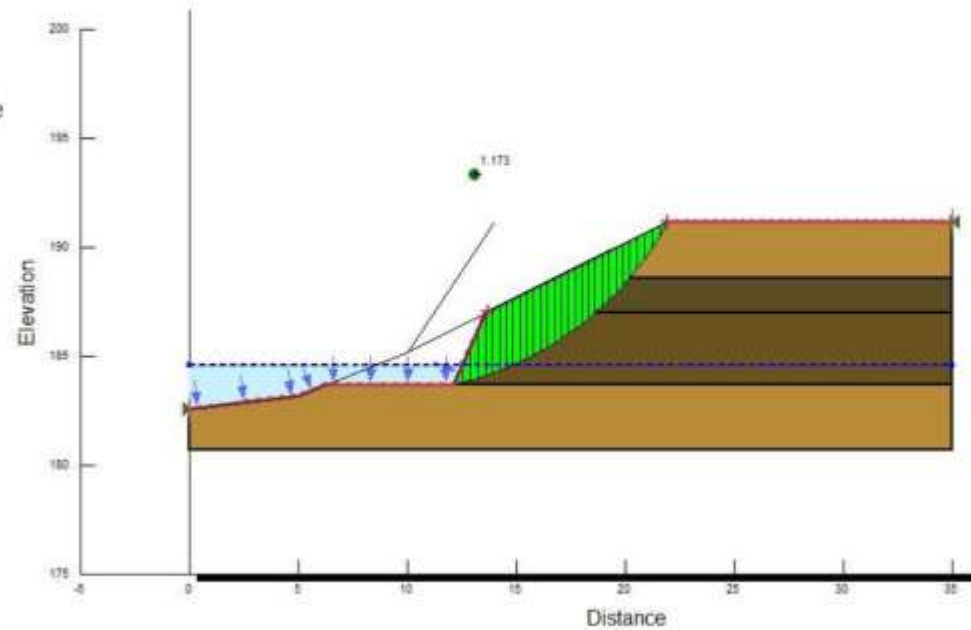
Figure A-6: Bishop's Simplified Nipigon River Slope Stability Analysis Case 6

| Case # | Parameter Changed | Change | Factor of Safety | Effect on FS |
|---|---|---|---|---|
| Case 6 | Ground Water and River Level | Low river level with high GW | 0.943 | - 0.139 |

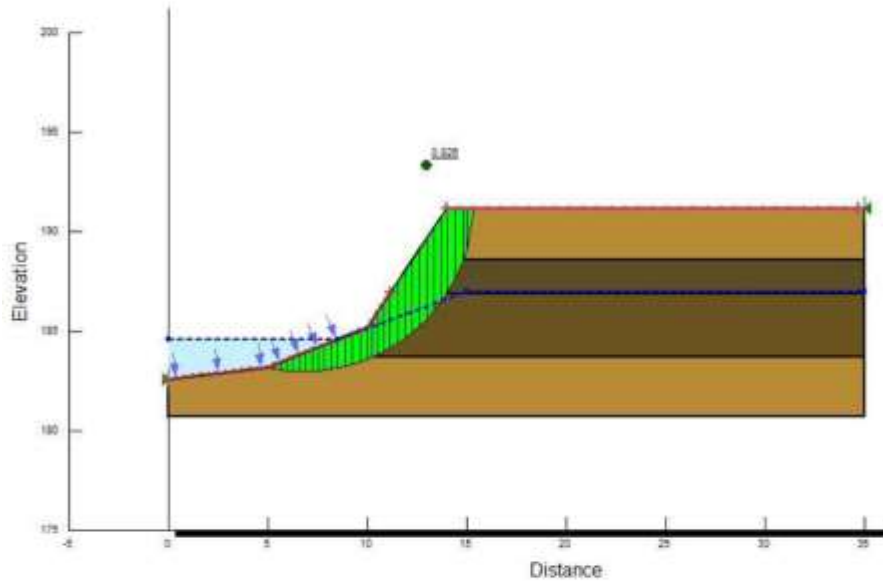
Figure A-7: Bishop's Simplified Nipigon River Slope Stability Analysis Case 7

| Case # | Parameter Changed | Change | Factor of Safety | Effect on FS |
|---|---|---|---|---|
| Case 7 | | Low river with low GW | 1.219 | + 0.137 |

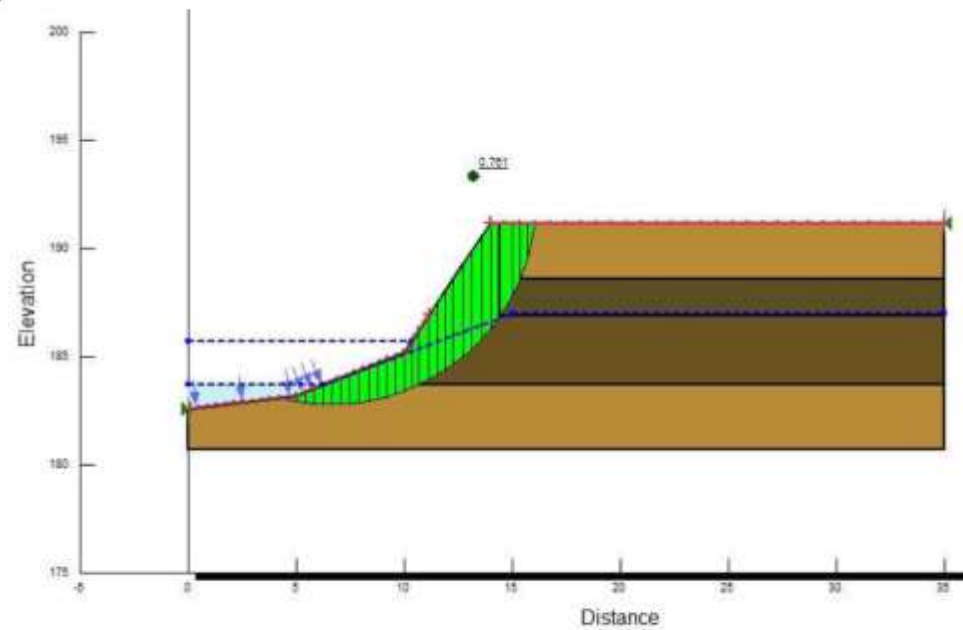
Figure A-10: Bishop's Simplified Nipigon River Slope Stability Analysis Case 10

| Case # | Parameter Changed | Change | Factor of Safety | Effect on FS |
|---|---|---|---|---|
| Case 10 | Cohesion of upper clay layers | Decrease $C'$ By 3 KPa | 1.002 | - 0.080 |

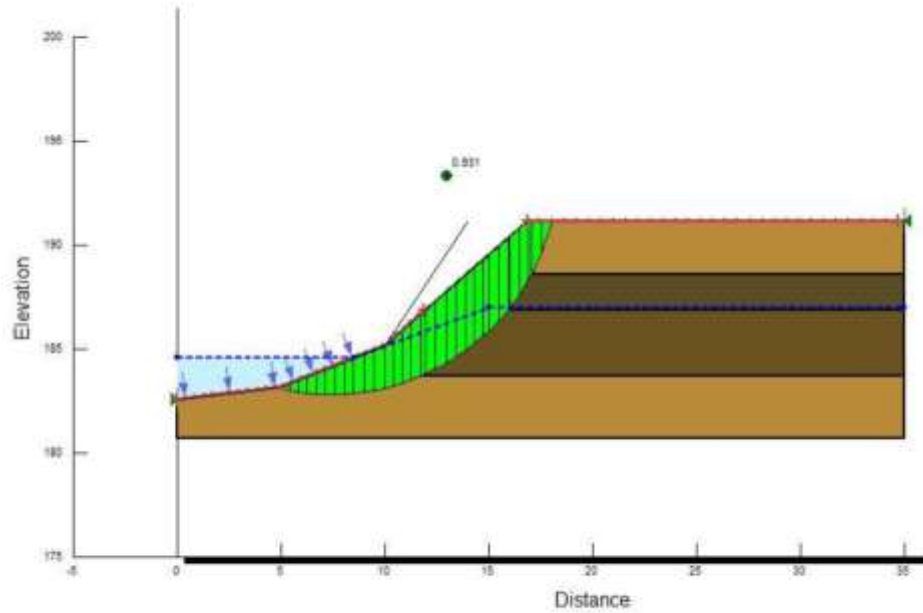
Figure A-8: Bishop's Simplified Nipigon River Slope Stability Analysis Case 8

| Case # | Parameter Changed | Change | Factor of Safety | Effect on FS |
|---|---|---|---|---|
| Case 8 | Friction angle of Sandy Silt Layer | Decrease From 35 to 25 | 0.900 | - 0.182 |

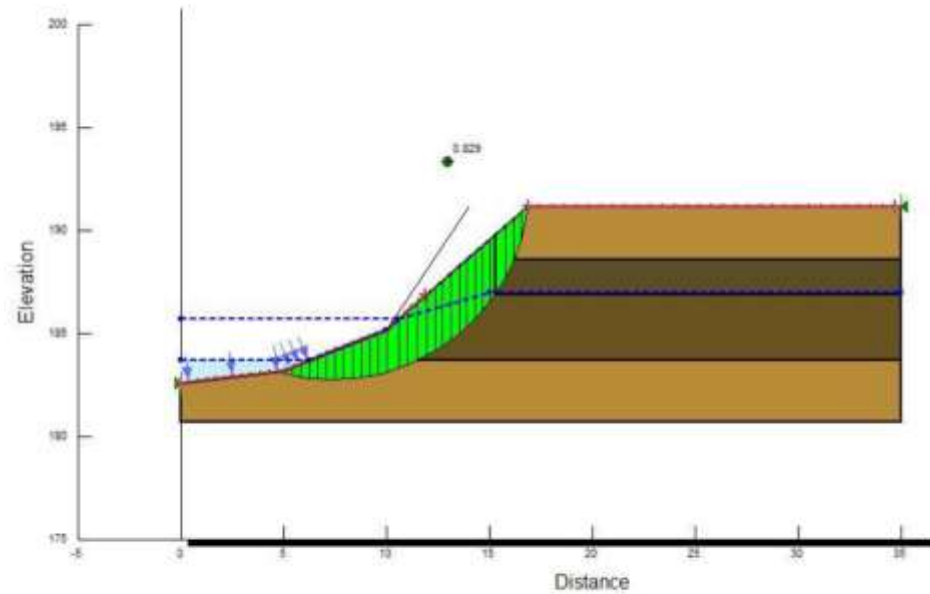
Figure A-11: Bishop's Simplified Nipigon River Slope Stability Analysis Case 11

| Case # | Parameter Changed | Change | Factor of Safety | Effect on FS |
|---|---|---|---|---|
| Case 11 | | Increase $C'$ By 3 KPa | 1.148 | + 0.066 |

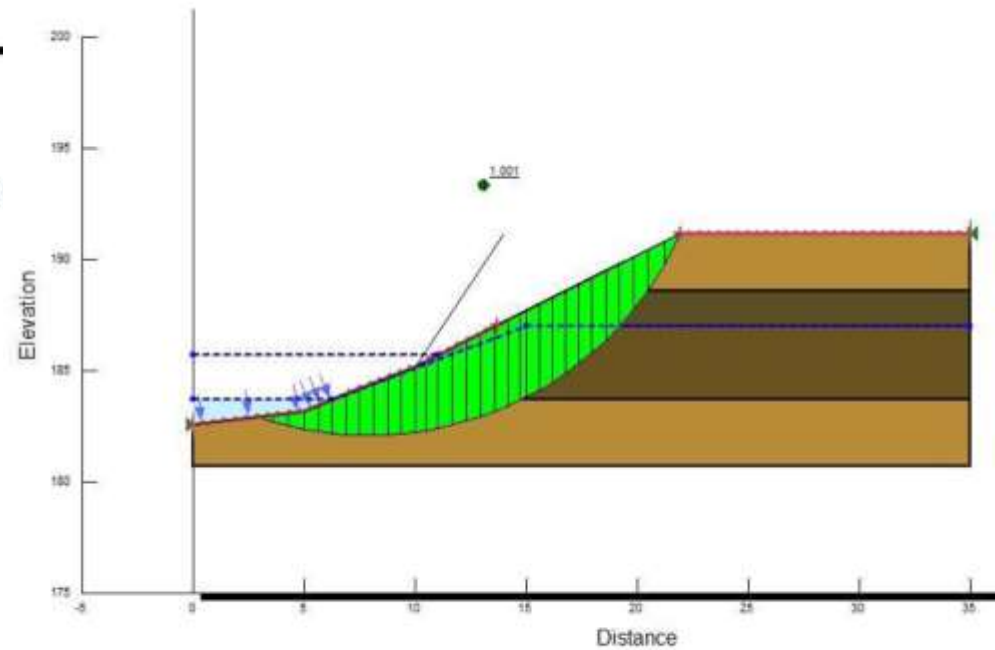
Figure A-12: Bishop's Simplified Nipigon River Slope Stability Analysis Case 12

| Case # | Parameter Changed | Change | Factor of Safety | Effect on FS |
|---|---|---|---|---|
| Case 12 | Changes in unit weights | Increase Top two layers by $2\text{KN/m}^3$ | 1.052 | - 0.030 |
