The Catastrophic Shenzhen Landslide of December 20, 2015

Zhong-qi Quentin Yue

Civil Engineering Department, The University of Hong Kong, Hong Kong, P.R. China

International Geotechnics Symposium cum
International Meeting of CSRME 14th Biennial National Congress
November 14-17, 2016, Hong Kong

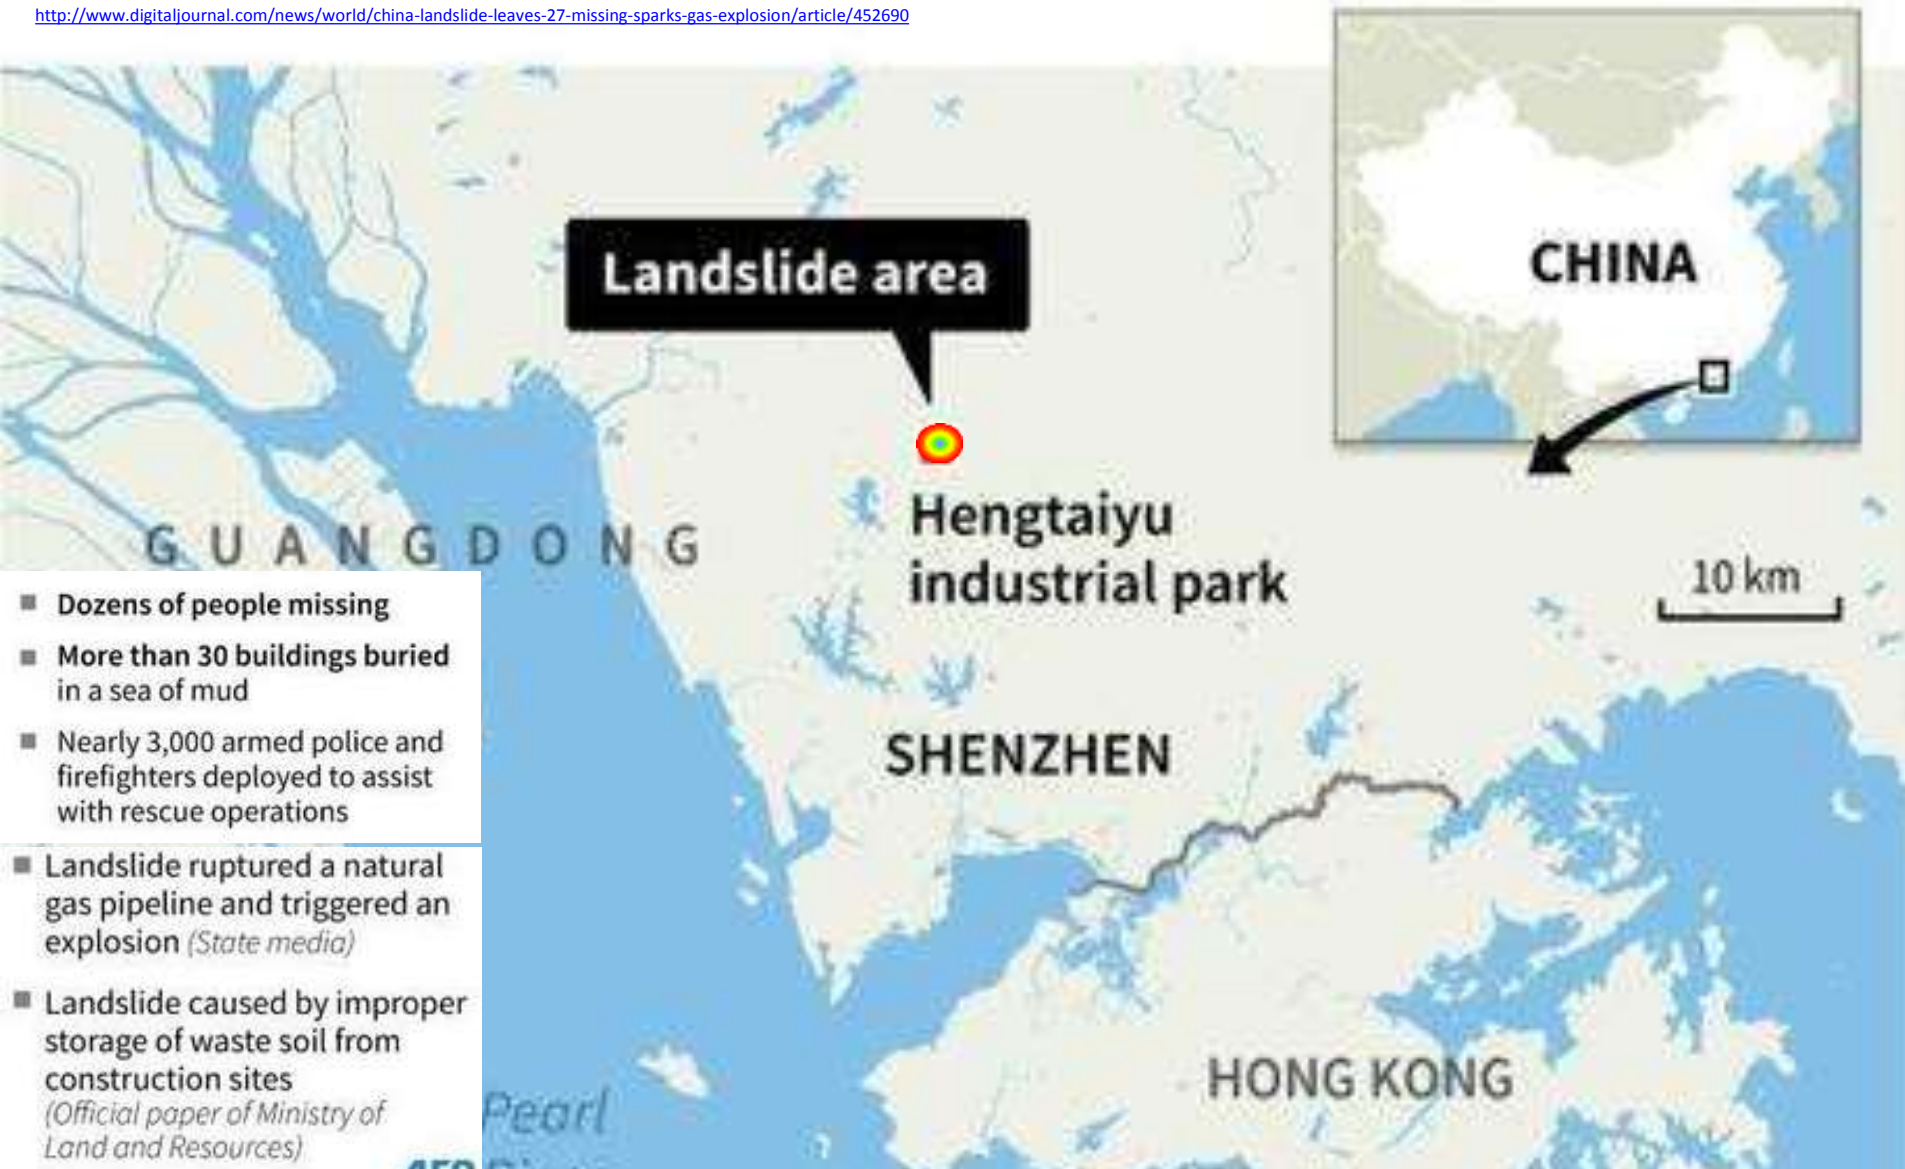
Landslide swept through an industrial park in Shenzhen city on Dec 20

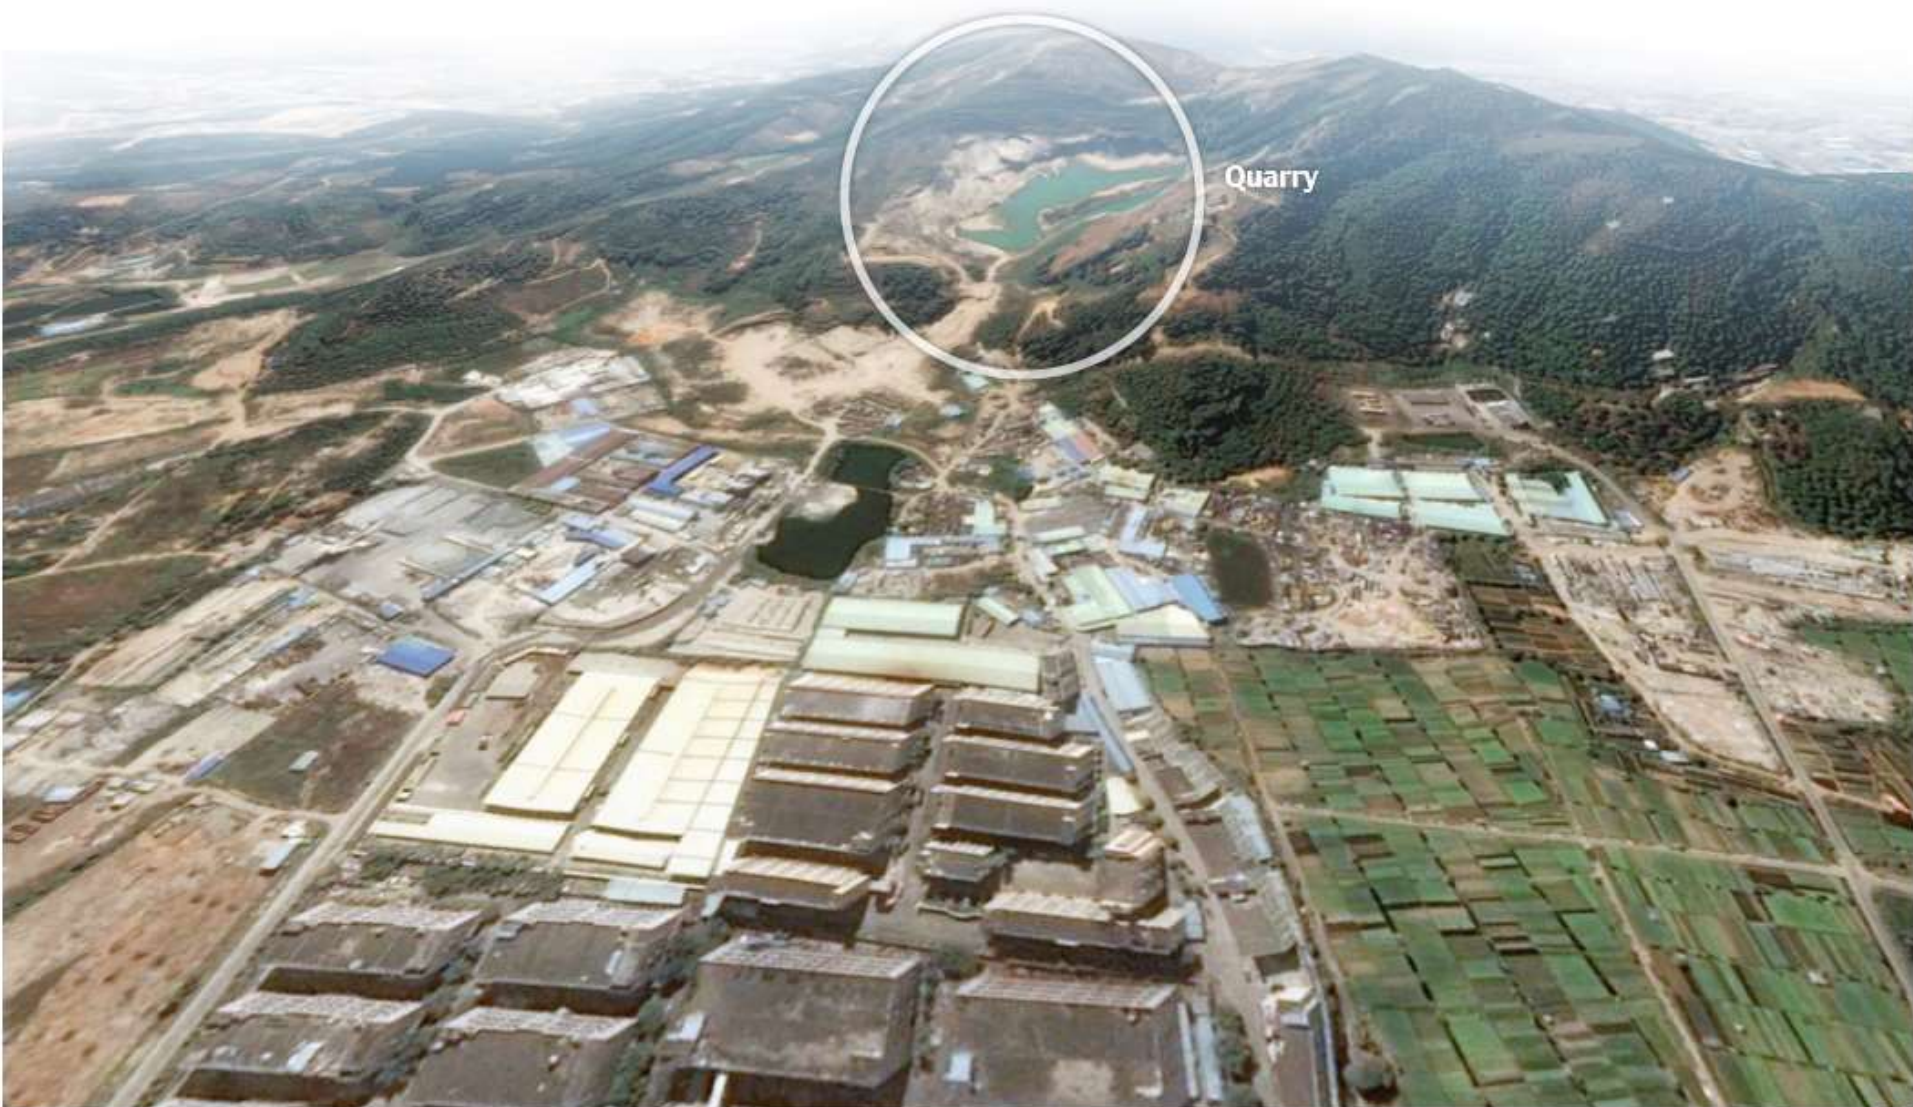
November 2013, two years ago, it was a **quarry** pit with pool.

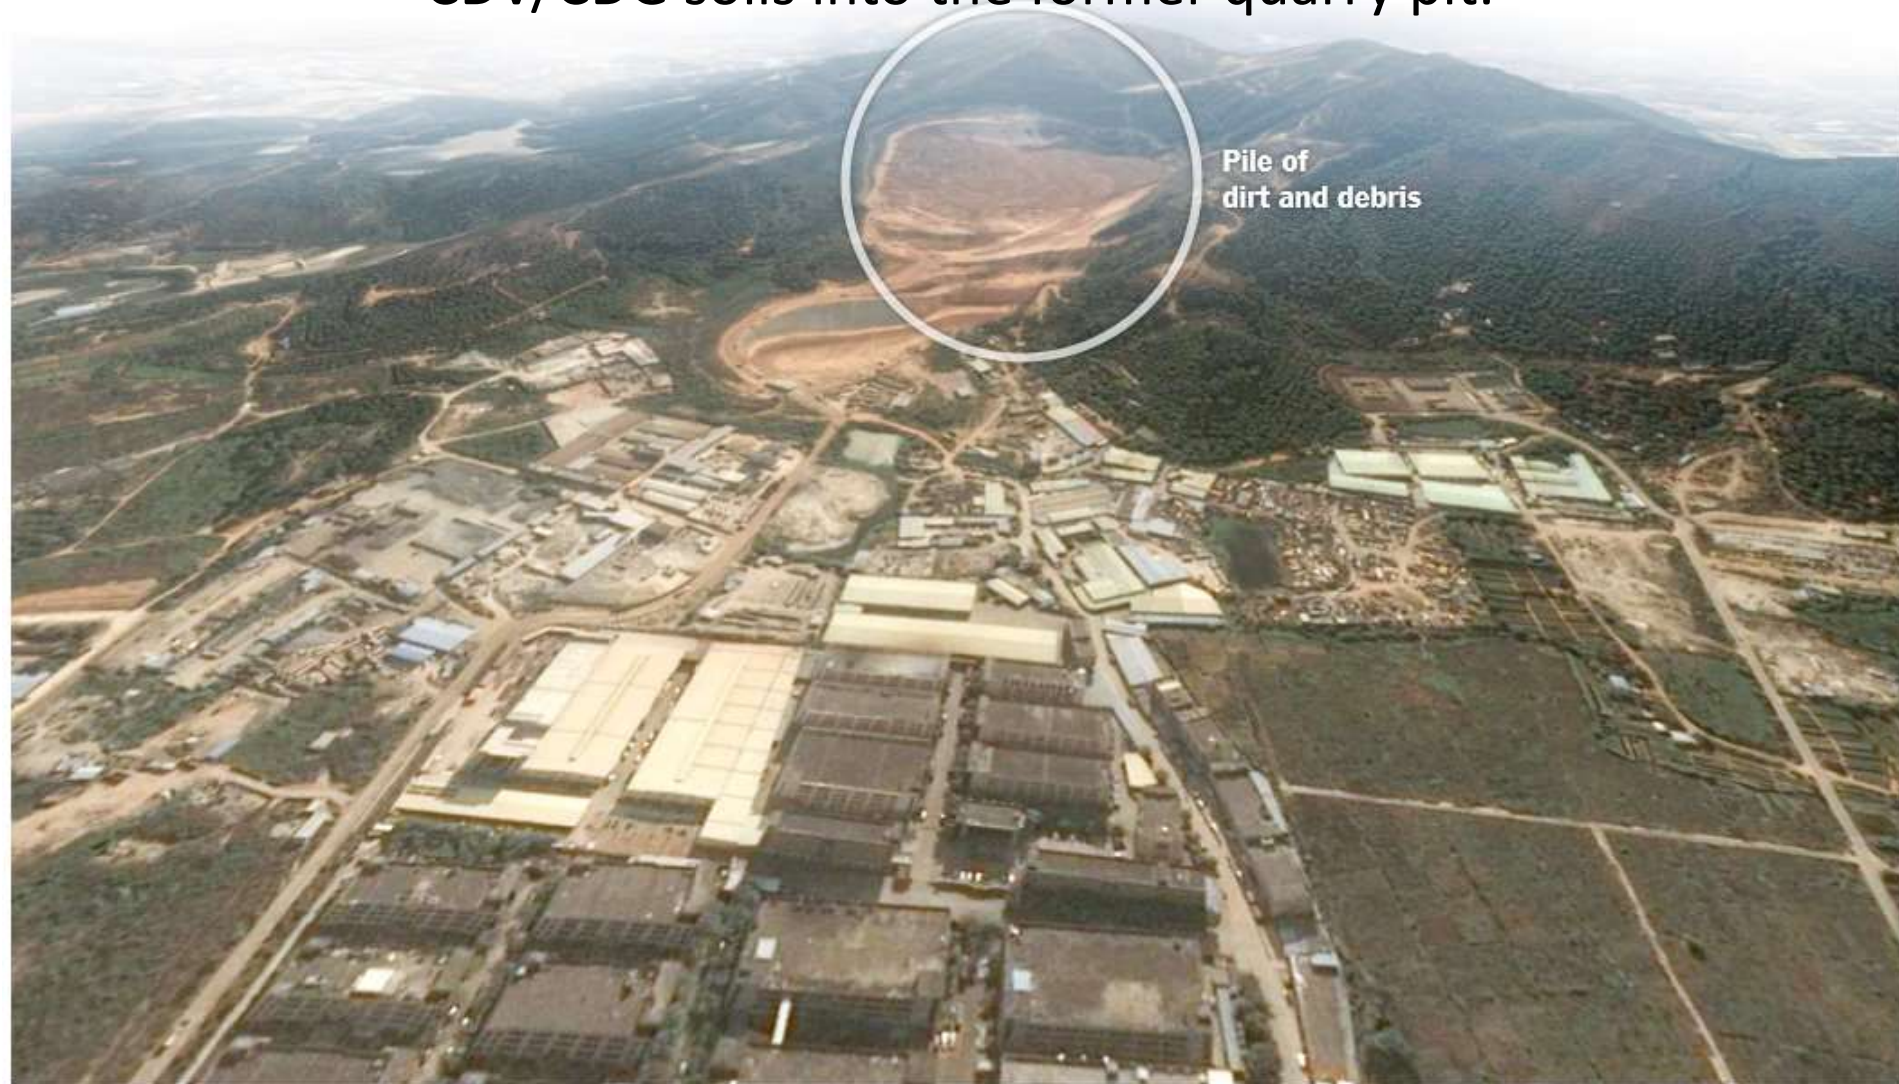
November 2014, a man-made fill slope grew as filling of excavated CDV/CDG soils into the former quarry pit.

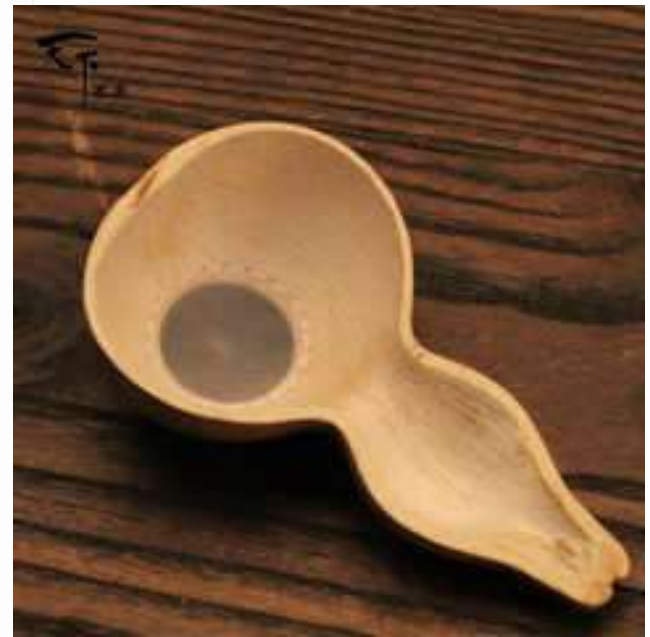
葫蘆瓢

Gourd-shape

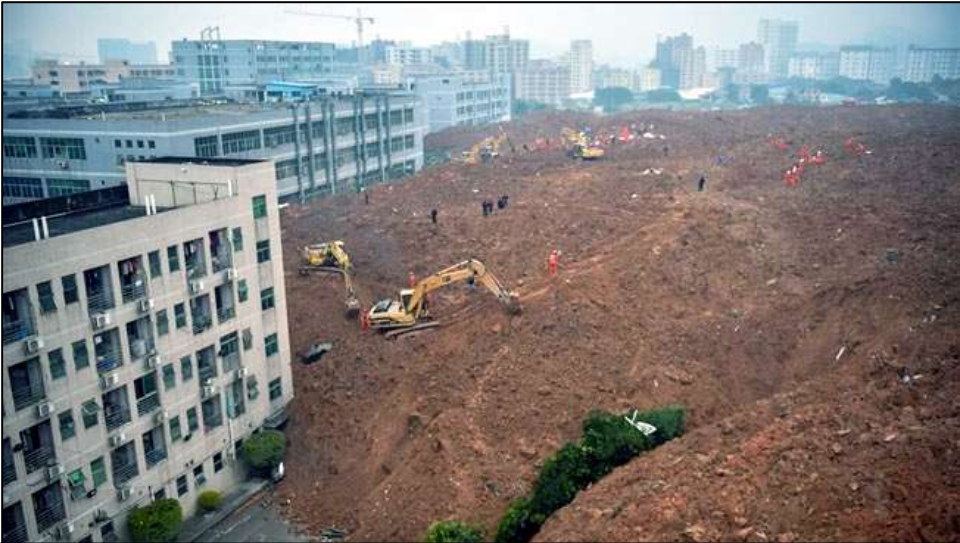
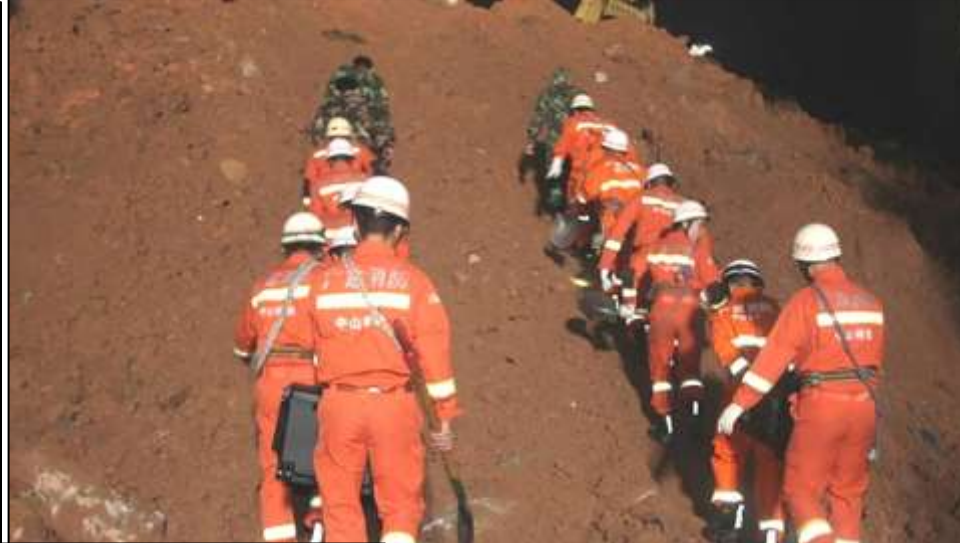
**Little free water and no mud/slurry
at front of thick debris toe**

**> 20° slope angle at
thick debris far toe**

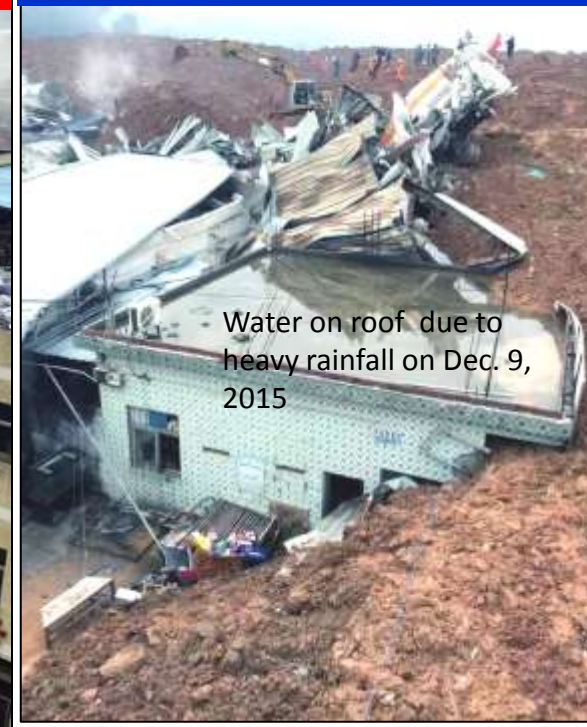
Water on roof due to
heavy rainfall on Dec. 9,
2015

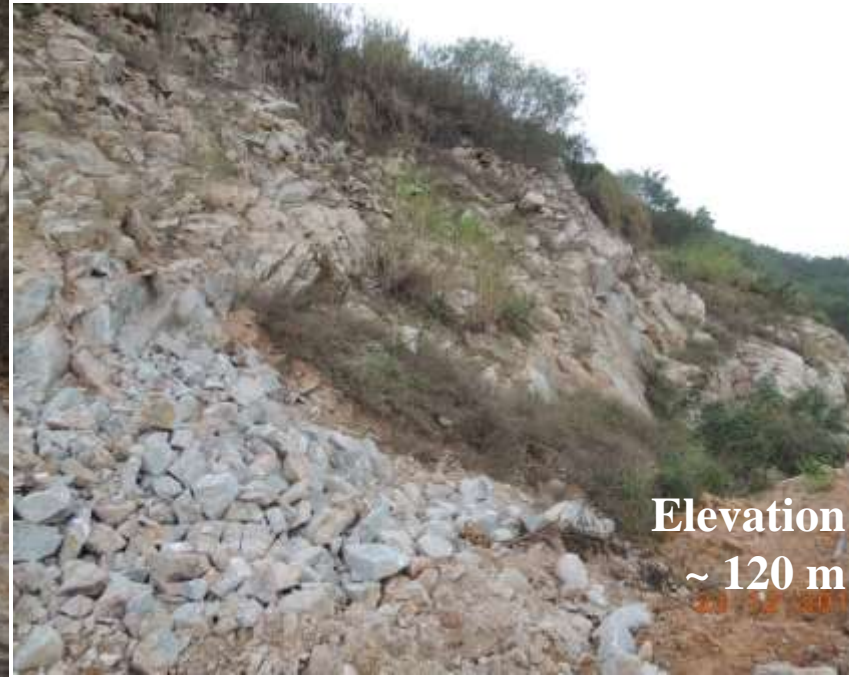
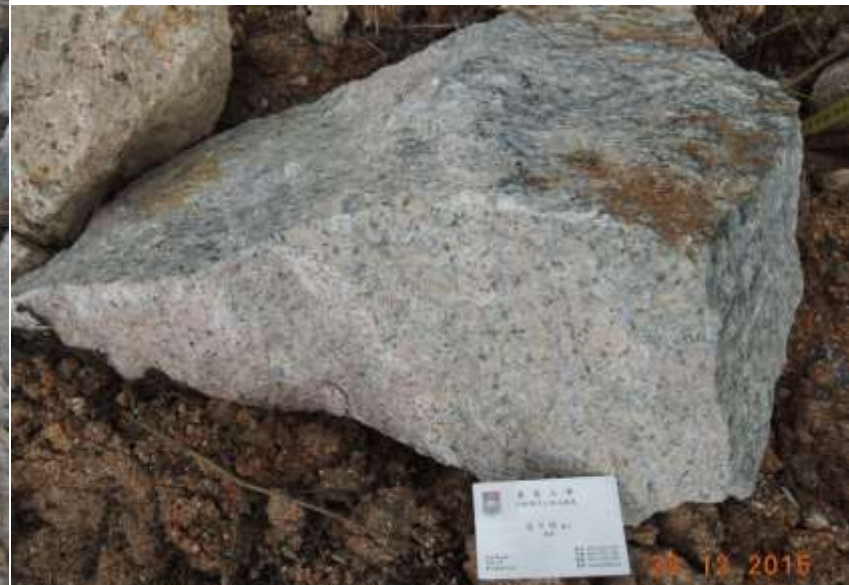
Samples and cores of drillholes in failed fill pit in Jan. 2016

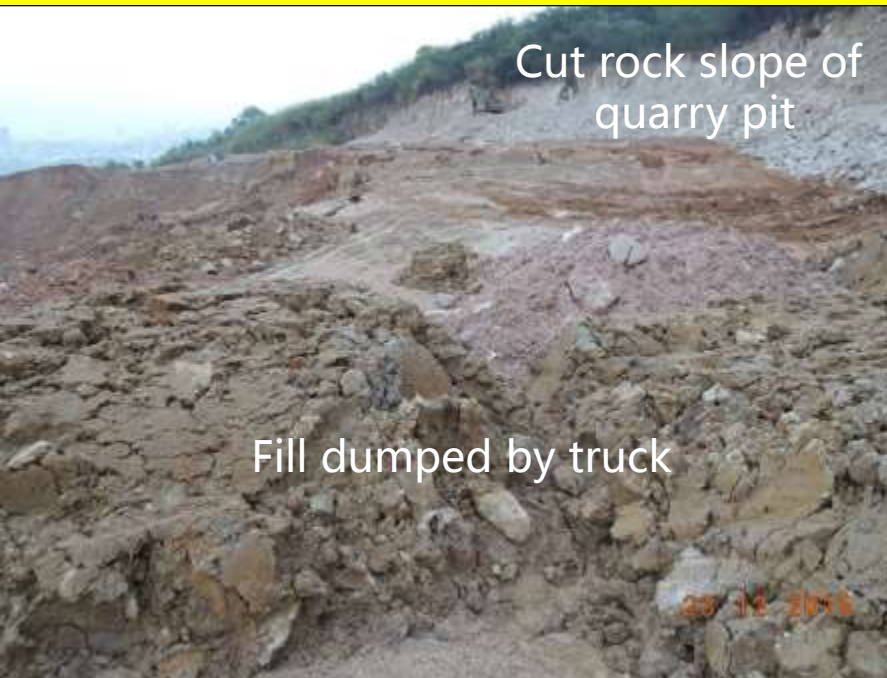
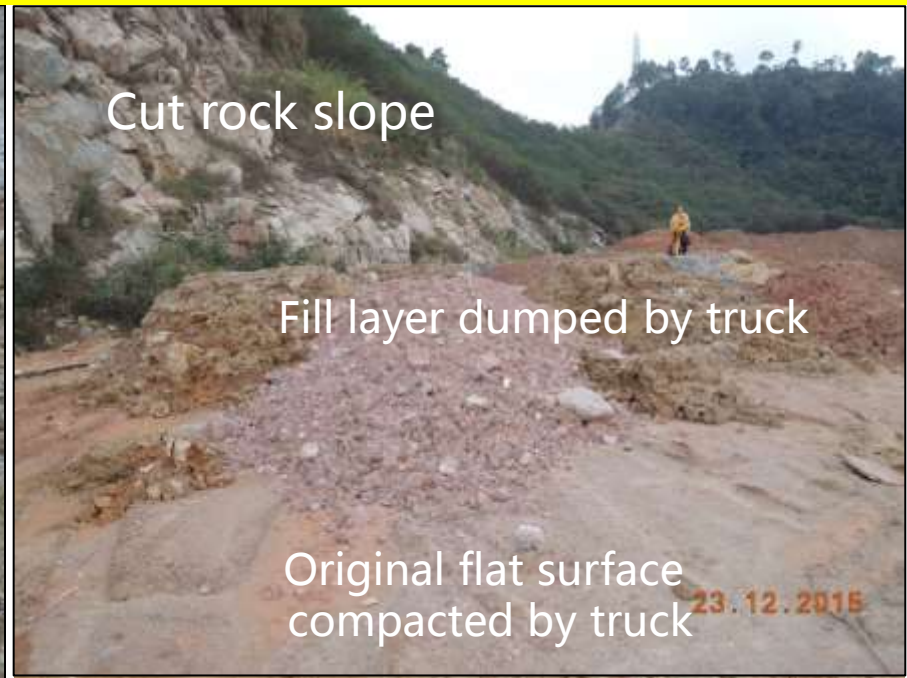
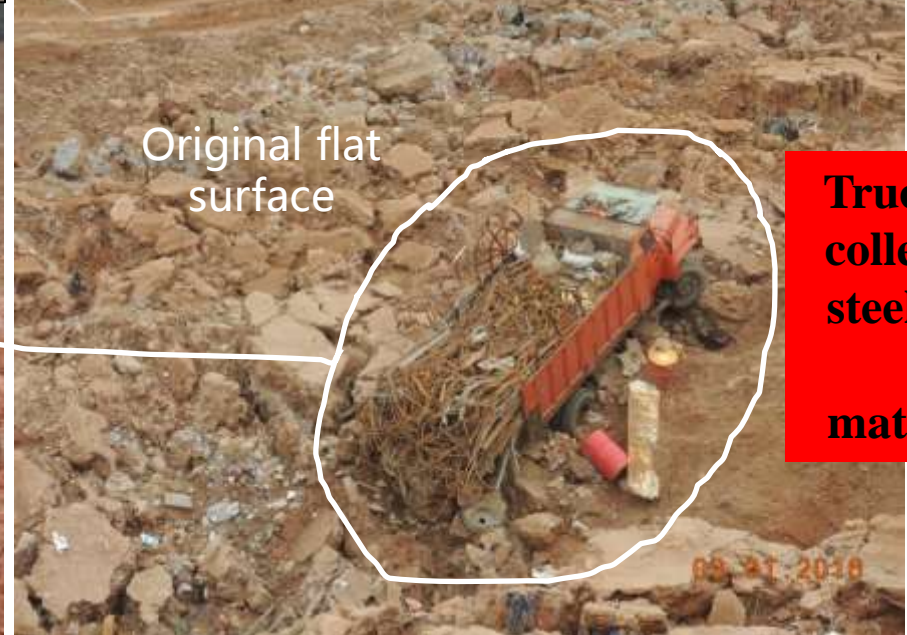
September 29, 2015

Gourd-shaped
quarry pit being
filled with excavated
soil by trucks and
compaction

Gentle fill
slope ($< 25^\circ$)
with vegetation
cover

Pit Platform Filling Method of Layer by Layer

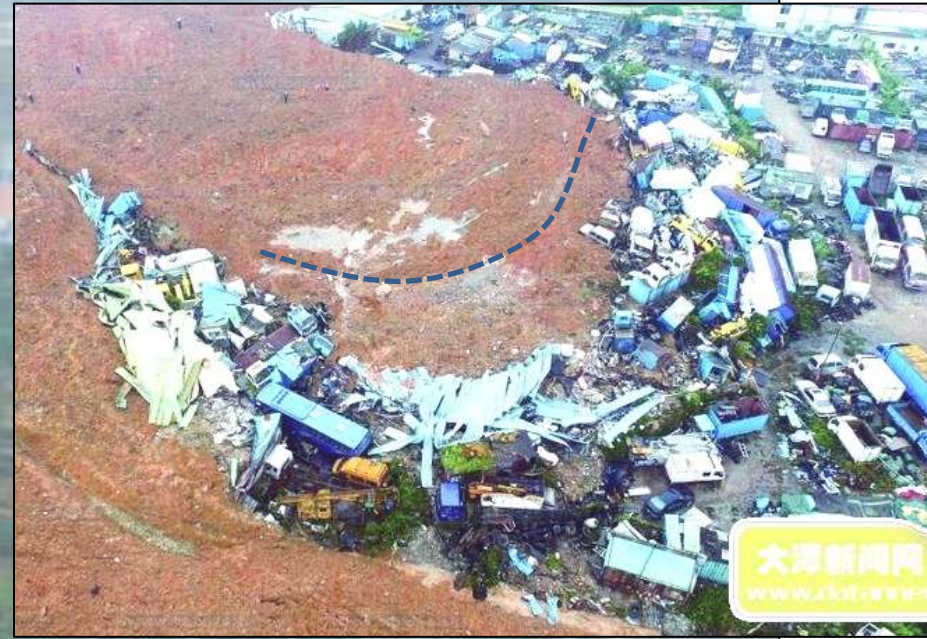
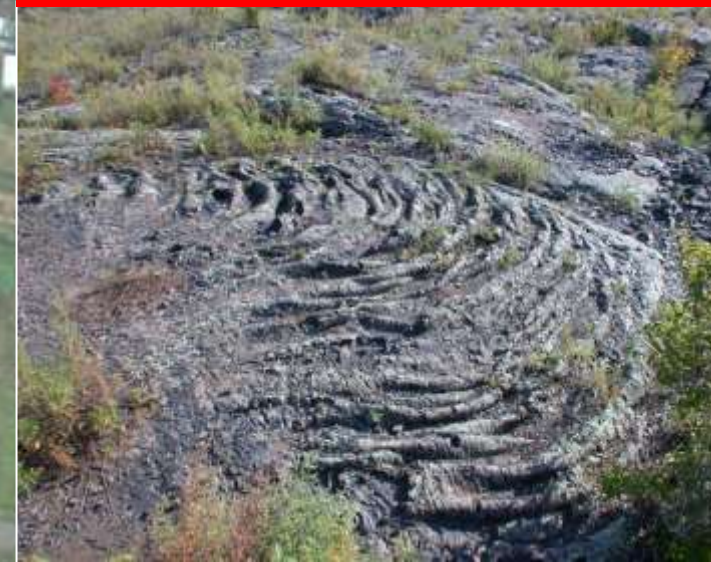
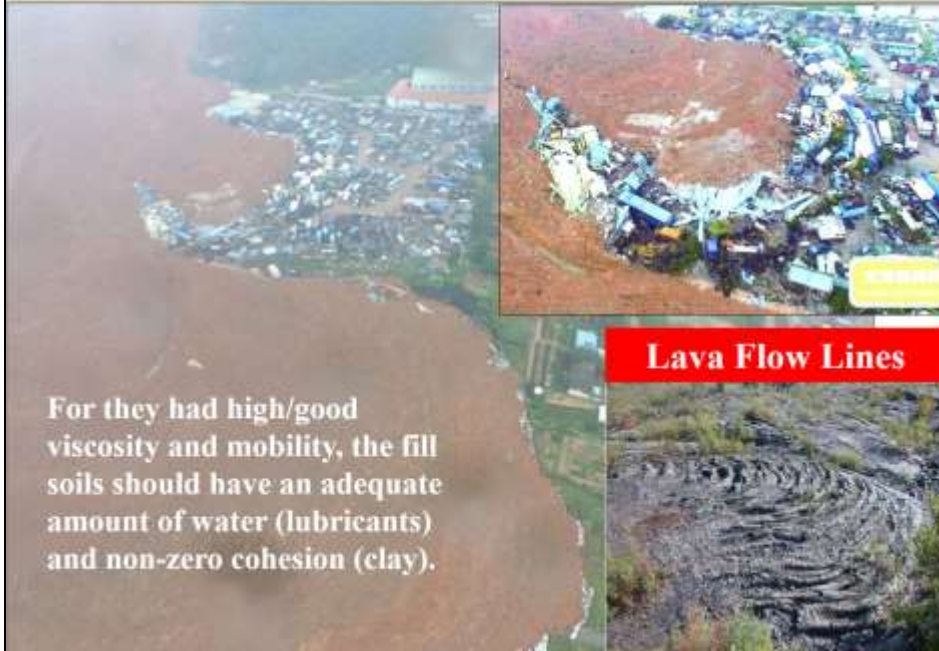
Convex Curves of Flow Wave Lines Showing High Viscosity

For they had high/good viscosity and mobility, the fill soils should have an adequate amount of water (lubricants) and non-zero cohesion (clay).

Lava Flow Lines

Permanent Underground Water

Convex Curves of Flow Lines Showing High Viscosity

- 1) The permanent underground water in bottom/lower portion of loose fill soils should be an important factor causing the landslide.
- 2) It could be a confined aquifer of high pressure due to the upper high mountain and lower permeability of the soil fills.
- 3) However, the amount of water should not have any sudden increase since it was in the middle of dry season of the year. Or it should keep constant or be slowly reducing due to seepage.
- 4) It could not have any substantial abrupt change causing or triggering the huge devastating landslide.

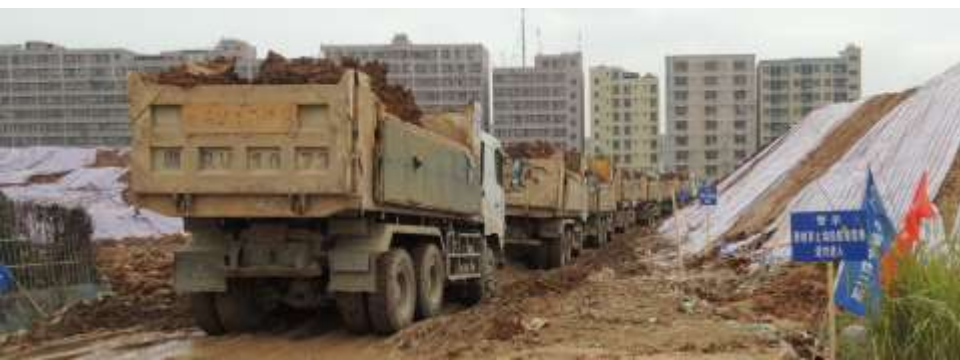
Dec. 23, 2015 on debris

- 1) In recent years, Shenzhen has been undertaking massive construction of civil infrastructure (e.g., MTR tunnels) and buildings.
- 2) The excavated soils are about 36 million m³ per year.
- 3) Similar to Hong Kong, Shenzhen soils are mainly weathered volcanic and granitic rocks (i.e., CDV and CDG).
- 4) Therefore the huge and deep gourd-shaped pit of the abandoned quarry site was quickly filled up in less than 2 years.
- 5) The filling of excavated soils by trucks might not be well compacted.
- 6) The fill might be loose but should not be very loose since it could support the running and loading of many heavy trucks.

**The fill soils
should be
typical
CDG/CDV
soils**

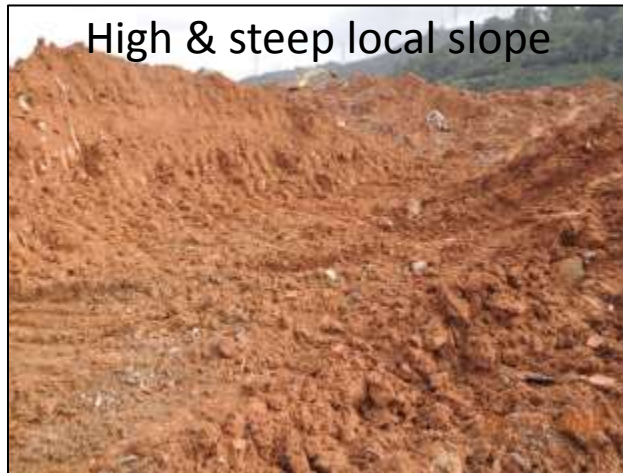
High & steep local slope

Loose and dry CDV or CDG soils with gravels on Dec. 23, 2015 in dry season

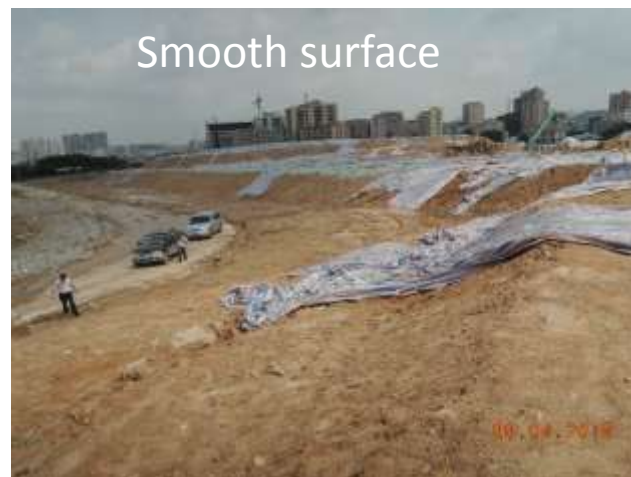
Smooth surface

Wetted and dense CDV or CDG soils on April 8, 2015 in wet season
These soils were the landslide debris and removed to stockpiling nearby
their original deposition areas

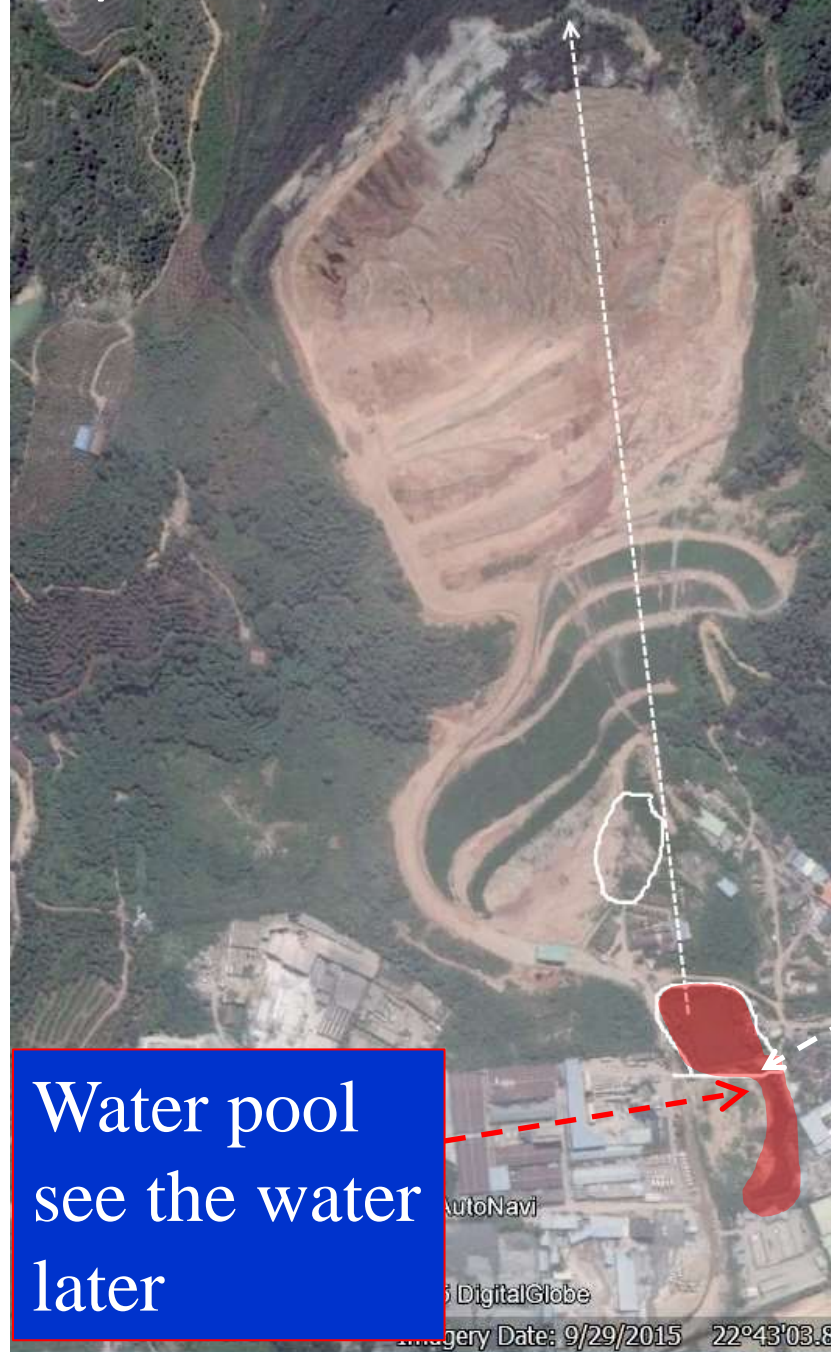
**The unusual factor
could be
the gas in the fill soils**

Video showing the bubbling of gas in the water pool of an deep excepted pit in the debris soils at the original water pool (video taken on Dec. 23, 2015, 3 days after the landslide)

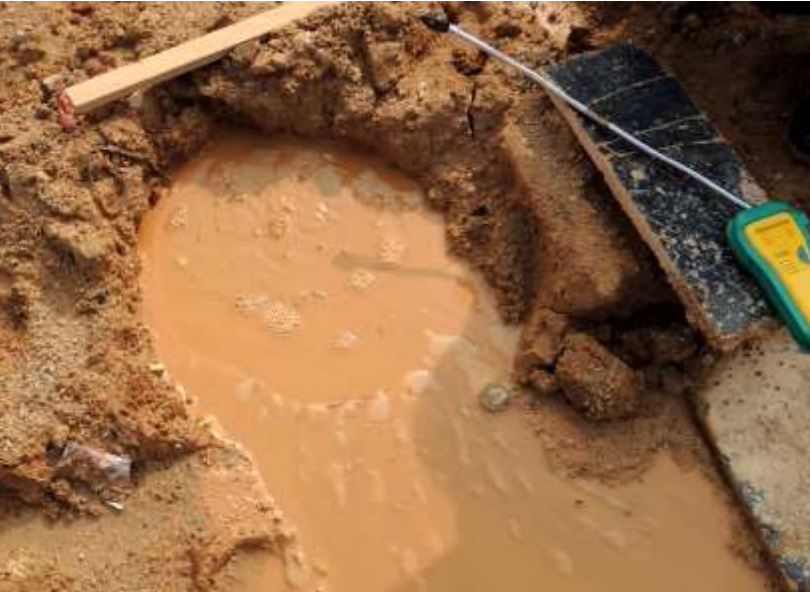
Drillhole No. K13 on Jan. 9, 2016

**The gas out of the
drillhole had strong
odour or foul smell.**

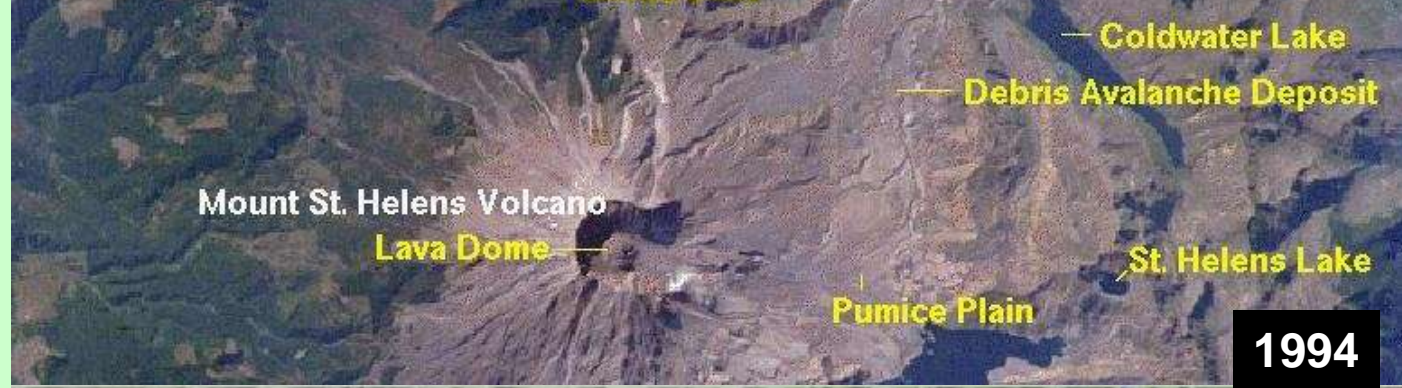
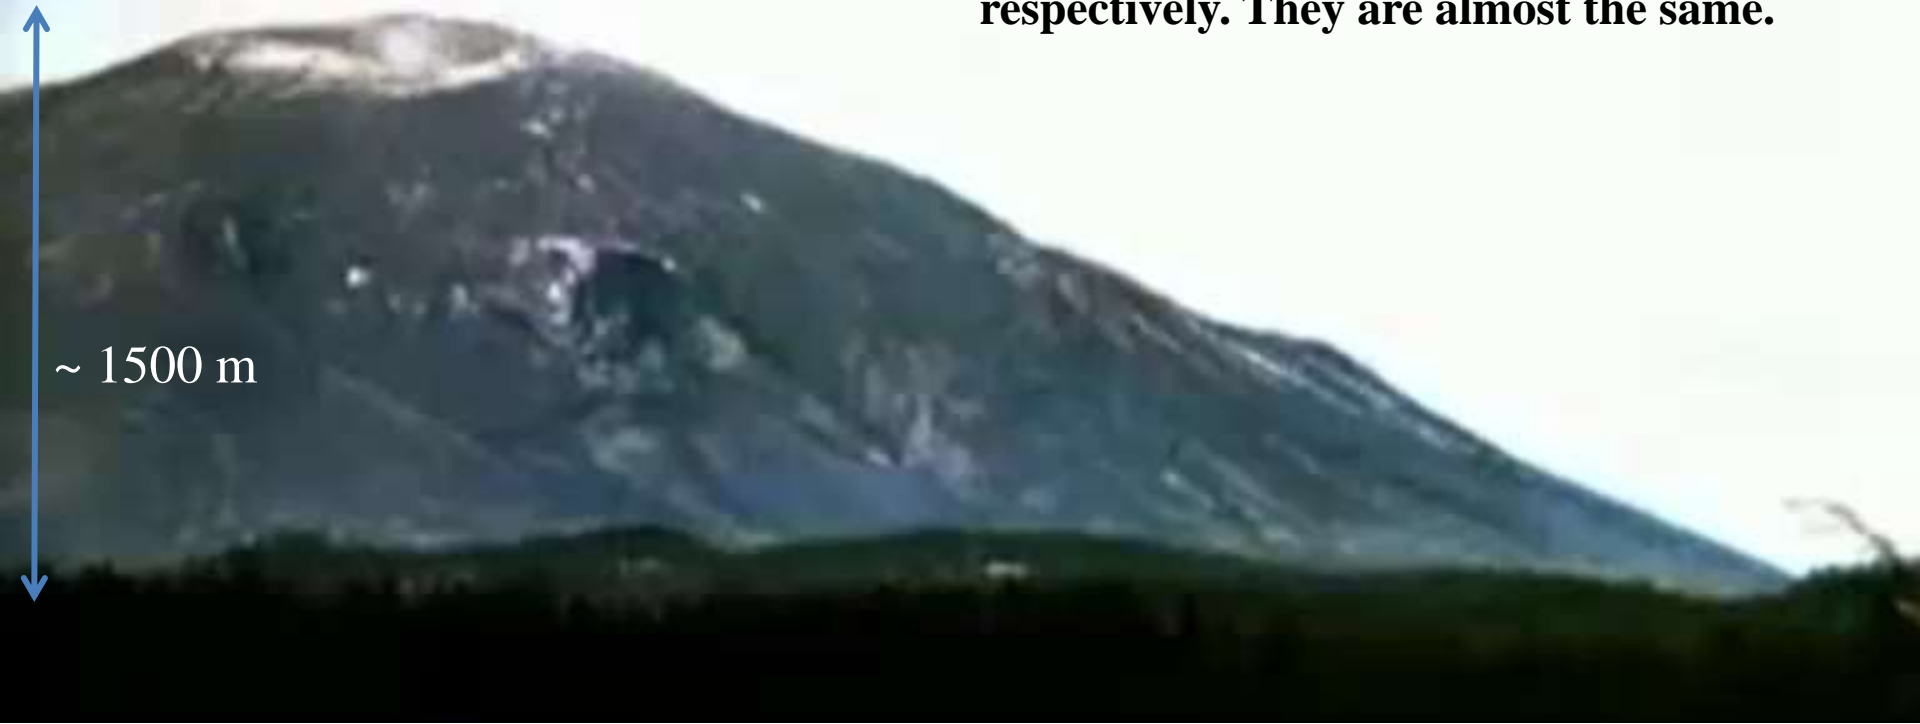
On May 18, 1980,
debris $3 \times 10^6 \text{ m}^3$
flowed/slipped
27 km into
Columbia River.

This mountain landslide by compressed gas is exactly similar to the above landslide happened on Dec. 20, 2015 in Shenzhen.

Their travel angles are 4.8° and 4.3° , respectively. They are almost the same.
